WOOD DESTROYING PESTS AND ORGANISMS INSPECTION REPORT

BUILDING NO. 343	STREET CERRO ST	CITY SAN DIEGO	ZIP 92024	Date of Inspection 05/03/2021	NUMBER OF PAGES 1 of 5
---------------------	--------------------	-------------------	--------------	----------------------------------	---------------------------

PRECISION TERMITE AND CARPENTRY
P.O. BOX 762
LEMON GROVE, CA 91946
PH# (619) 403-8223 precision@precisiontermite.net
PR 8412

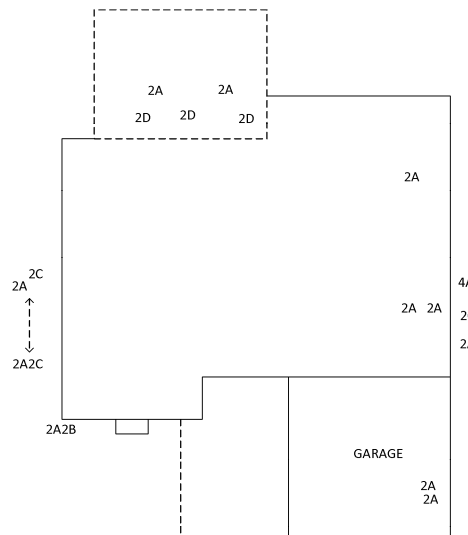
Evidence of DRYWOOD TERMITES as indicated by 2A on the diagram.
Evidence noted in or near: GARAGE, ATTIC, PATIO, EAVES.

DRYWOOD TERMITE DAMAGE indicated by 2B on diagram. The damage was noted at: BEAM.

DRYWOOD TERMITE DAMAGE indicated by 2C on diagram. The damage was noted at: RAFTER TAILS.

DRYWOOD TERMITE DAMAGE indicated by 2D on diagram. The damage was noted at: PATIO BLOCKING.

Vacate the premises and fumigate the structure with Vikane gas for the extermination of dry wood termite infestations. Air out the structure to prepare for occupancy. Remove or cover accessible evidence of infestation. This company is not responsible for delays or schedule changes due to inclement weather or other agencies, nor is it responsible for damage to roof or plants as a result of the fumigation. It is the responsibility of the property owner/agent to make sure all plant life around the exterior of the structure is properly cut back in order to facilitate tarps during fumigation. Refer to the occupant's fumigation notice/preparation sheet (sent separately) for additional information.

Remove damage material with wood filler.

Remove and replace and or repair termite damaged wood as deemed necessary. Minor damage may be filled and repaired.
