Inspection Report
1745 South Harvard Boulevard, Los Angeles 90006

Report ID
NXT-229-001696

Inspection Date
June 17, 2021 at 10:00 AM

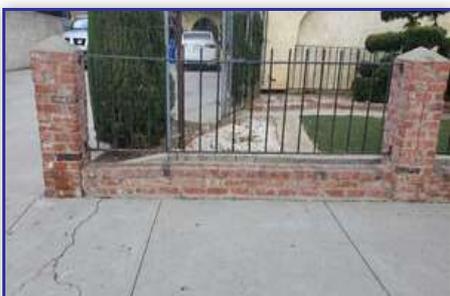
Location: FRONT FENCE

3.4.1 Damaged fence

Areas of the fencing are deteriorated and damaged. Fencing should be repaired as needed.

1.1 Damaged

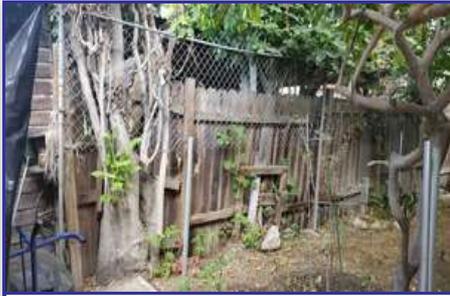
Location: EXT GROUNDS /REAR PATIO

3.4.2 Loose/damaged chain link fence

The chain link fence was disconnect, loose or damaged in areas. The inspector recommends repair or replacement of the fence as needed by a professional fence repair company.

2.1 Damaged fencing

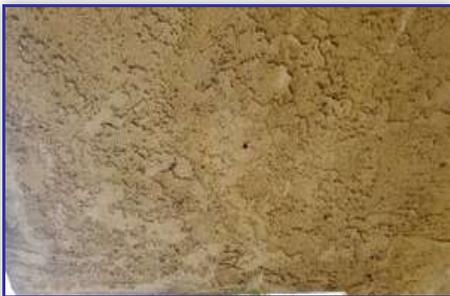
Location: EXT BUILDING

5.1.1 Hairline Stucco Cracking

One or more minor hairline cracks were found in the stucco or wall areas. It is unknown the age of these cracks. At the time of inspection nothing out of the ordinary of normalized cracking was noticed. Recommend caulking and painting these areas, along with monitoring for future movement/widening. Stucco cracks over framing can allow moisture penetration behind wall areas and can potentially damage sheathing/framing. Note that areas concealed behind walls are not able to be evaluated without invasive testing and cannot be evaluated.

1.1 Typical stucco cracks

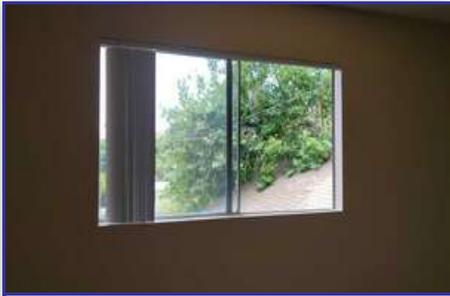
Location: 2ND FLOOR UNIT 1747 /BEDROOM 1

5.3.2 Missing and/or damaged screens

At the time of inspection, one or more exterior window screens were missing or damaged. The Inspector recommends that the damaged screens be evaluated, replaced or repaired, as needed, by a professional contractor, and missing screens replaced. Should you consider doing the repair yourself, see the DIY linked video, to assist you in your decision.

2.1 Missing screen

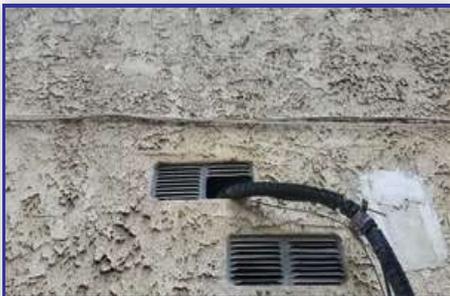
Location: EXT BUILDING

5.6.1 Loose or missing vents

At the time of inspection, one or more exterior vents was loose or missing and can allow rodents to enter the structure. The Inspector recommends that the missing and loose vents be replaced.

1.1 Damaged vents cover

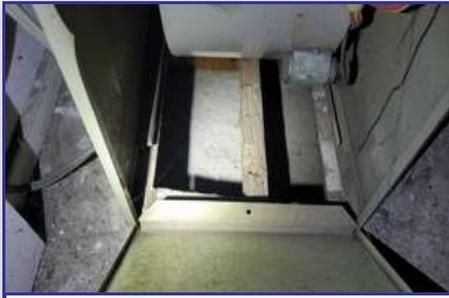
Location: 1745/ FURNACE

7.5.1 Return / Filter Register Fastener Missing / Damaged / Faulty

The fastener(s) at one or more return air / filter registers was missing, damaged and/or faulty. Recommend repairs be made.

1.1 Missing filter

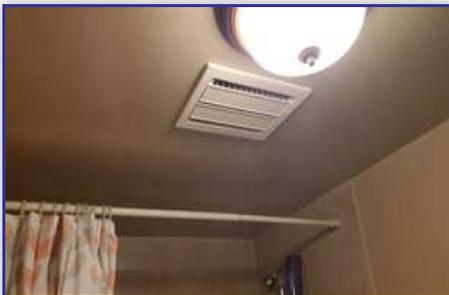
Location: 1745/ HALLWAY BATHROOM

The bathroom fan was not operable or responding to the switch. We recommend that it be repaired or replaced if needed by a professional electrical contractor.

1.1 Inoperable

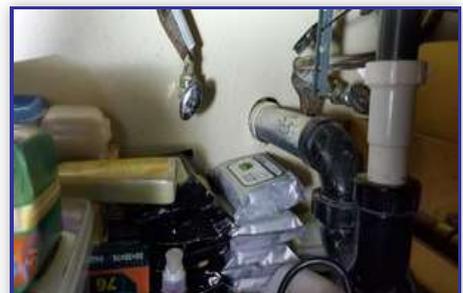
Location: 2ND FLOOR UNIT 1749/HALLWAY BATHROOM

10.4.1 WATER SHUT-OFF VALVES INOPERATIVE/RUST/LEAKS/BROKEN

Water shut-off valves under the sink were inoperative/rust/leaking/broken which makes plumbing repairs for the sink difficult to work on. Recommend that water shut-off valves replaced for both cold and hot water lines by a professional plumbing contractor.

1.3 Replace shutoff valve

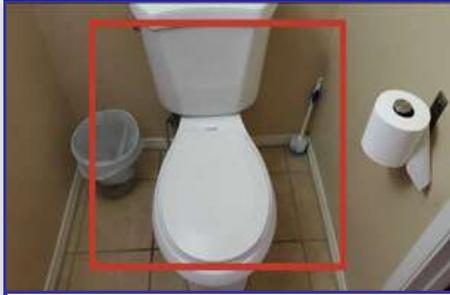
Location: 1745/ BEDROOM 1/BATHROOM

The toilet seat was loose. There are small bolts on the side of the seat that can be tightened or in other cases may need to be replaced.

2.1 Loose toilet

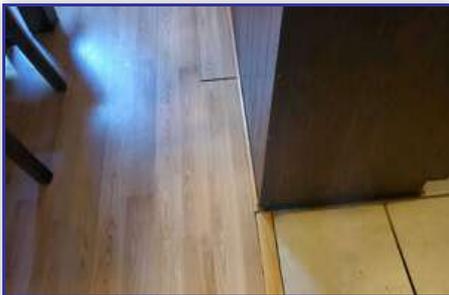
Location: UNIT 1745/ DINNING AREA

One or more gaps were found in laminate flooring joints/seams. This is indicative of improper installation or a thin, lower quality laminate that is prone to movement. Recommend consulting with a qualified flooring contractor for repair/replacement options.

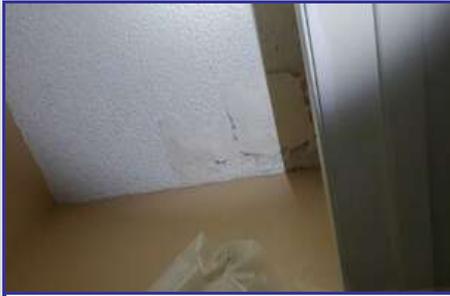
Location: UNIT 1745

12.5.2 Ask Owner About Repairs / Patching

Patches or evidence of prior repairs were found in one or more ceilings. Recommend asking the property owner about the repairs (e.g. why necessary, whether prior leaks have occurred).

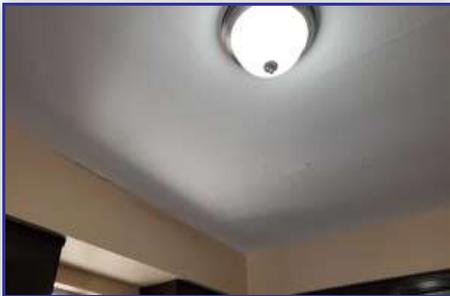
Location: 2ND FLOOR UNIT 1747 /KITCHEN

12.5.3 Ask Owner About Repairs / Patching

Patches or evidence of prior repairs were found in one or more ceilings. Recommend asking the property owner about the repairs (e.g. why necessary, whether prior leaks have occurred).

3.1 Failing paint /patched ceiling

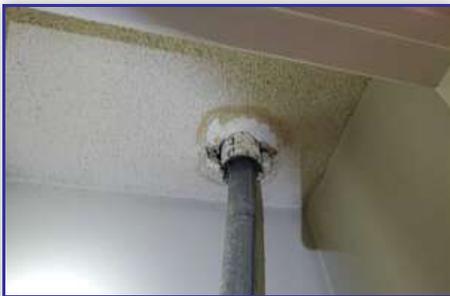
Location: 2ND FLOOR UNIT 1747 /WATER HEATER

12.5.4 Wet Stains Ceiling - Roof

Stains and/or elevated levels of moisture were found in one or more ceiling areas. The stains appear to be due to an active roof leak. Recommend that a qualified contractor evaluate and repair as necessary.

4.1 Stains

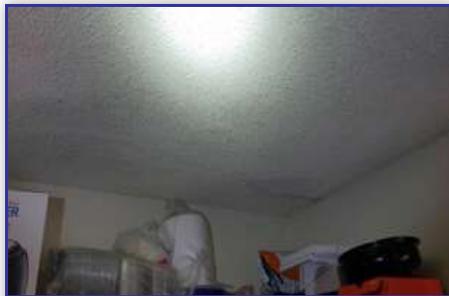
Location: 2ND FLOOR UNIT 1749/LIVINGROOM

4.2 Microbial growth /roof water stains

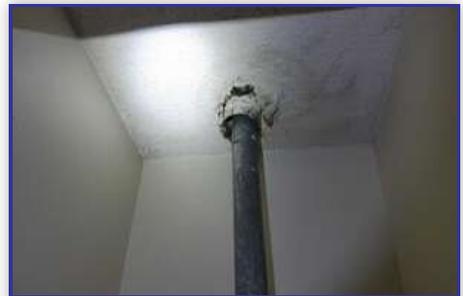
Location: 2ND FLOOR UNIT 1749/WATER HEATER

4.3 roof water stains

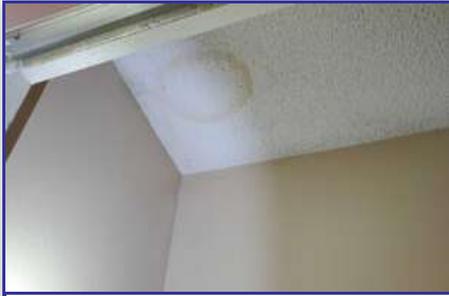
Location: 2ND FLOOR UNIT 1747 /BEDROOM 1

12.5.5 Wet Stains Ceiling - Roof

Stains and/or elevated levels of moisture were found in one or more ceiling areas. The stains appear to be due to an active roof leak. Recommend that a qualified contractor evaluate and repair as necessary.

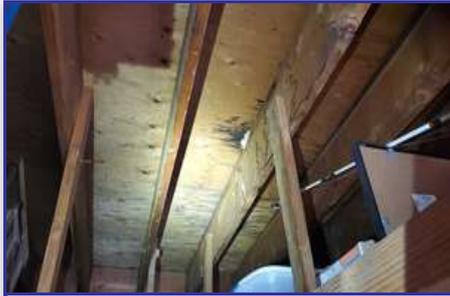
Location: GARAGES

Microbial like growth or musty odor was found at one or more locations. We did not test the substance through a lab so proper verification was not made. Growth is normally cause by moist conditions, plumbing or Roof/exterior moisture issues, and issues with improper ventilation. We recommend that after the areas are verified as mould, mitigation, for mold/moisture should be done by a professional contractor.

1.1 Water stains roof sheathing

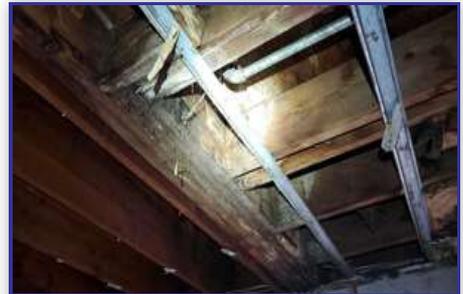
Location: GARAGES

1.6 Wood damage

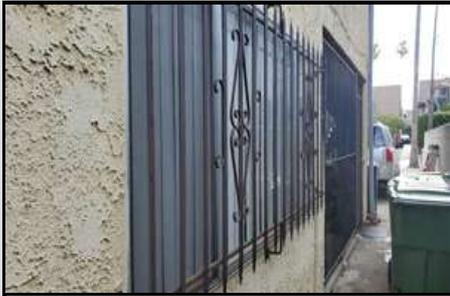
Location: EXT BUILDING

Fixed security bars around windows, does not allow security bars to open. This poses a fire safety concern as it prevents exit from the home in case of fire. The Inspector recommends that the security bars be evaluated, replaced or repaired, as needed, by a professional contractor, to allow opening bars without special tools or keys.

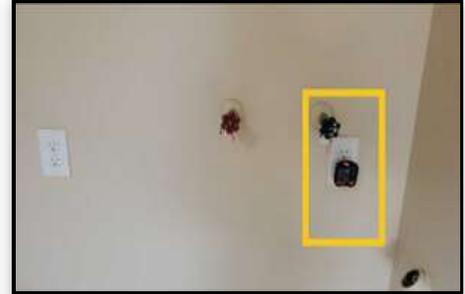
Location: 2ND FLOOR UNIT 1747 /KITCHEN

Kitchen electrical outlets were operable at the time of the inspection but no Ground Fault Circuit Interrupter (GFCI) protection were installed. GFCI protection should be installed for outlets within 6 feet of plumbing fixtures or on kitchen counters, as they were required in kitchens starting in 1987 by the NEC. Recommended this be done by a professional electrical contractor.

1.2 Missing gfci (update)

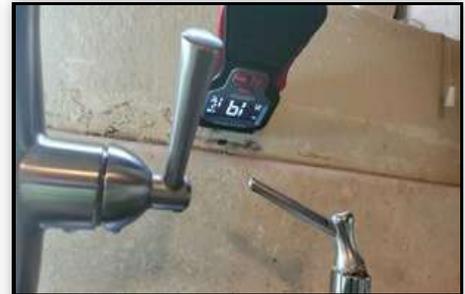
Location: KITCHEN 1745

1.3 Moisture present

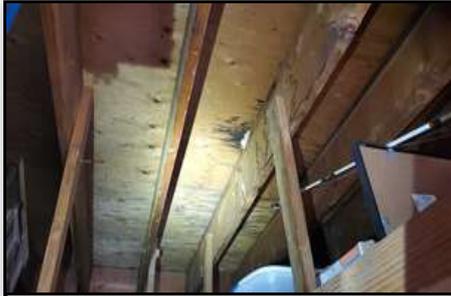
Location: GARAGES

Microbial like growth or musty odor was found at one or more locations. We did not test the substance through a lab so proper verification was not made. Growth is normally cause by moist conditions, plumbing or Roof/exterior moisture issues, and issues with improper ventilation. We recommend that after the areas are verified as mould, mitigation, for mold/moisture should be done by a professional contractor.

1.1 Water stains roof sheathing

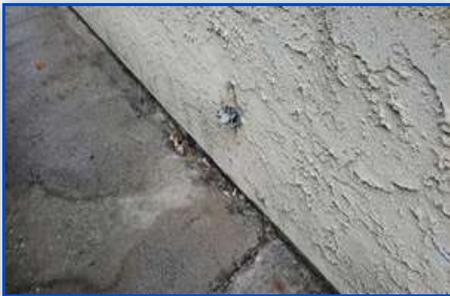
Location: EXT BUILDING

At the time of inspection, the hose bib handles are broken and/or missing. The Inspector recommends that the affected area(s) be evaluated, replaced or repaired, as needed, by a professional contractor.

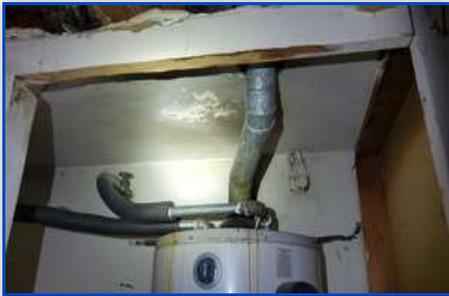
Location: 1745 WATER HEATER/GARAGE

Some or all of the water supply pipes were made of galvanized steel. Based on the age of this structure and the 40-60 year useful life of this piping, it will likely need replacing in the future. Leaks can develop, flow can be restricted due to scale accumulating inside the piping, and water may be rusty. Note that it is beyond the scope of this inspection to determine what percentage of the piping is older, galvanized steel, as much of it is concealed in wall, floor and/or ceiling cavities. Some insurance companies in the state do not insure galvanized plumbing. Recommend the following: ~ Budget for replacement in the future ~ Monitor these pipes for leaks and decreased flow in the future ~ Consider replacing old, galvanized steel piping proactively as client sees fit

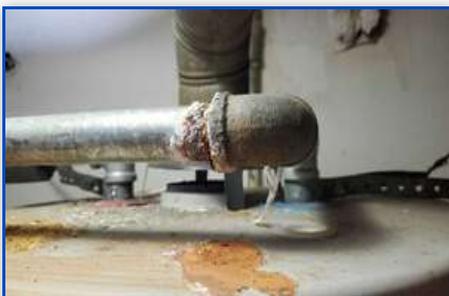
Location: 1745 WATER HEATER/GARAGE

Corrosion was found at water supply pipes, water shut offs, and/or fittings. This can indicate past leaks, or that leaks are likely to occur in the future. Recommend that a qualified plumber evaluate and replace components as necessary.

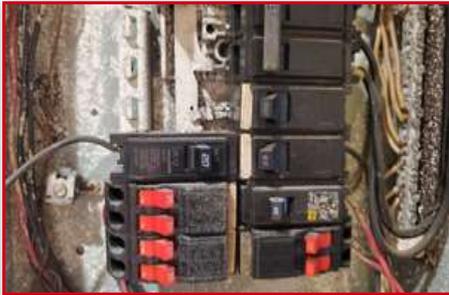
Location: 1745/ HALLWAY/ DISTRIBUTION PANEL

The homes electrical panel breaker was manufactured by a company other than the panel manufacturer, as this may void the panels warranty and could be a safety concern. The inspector recommends an evaluation by a professional electrical contractor.

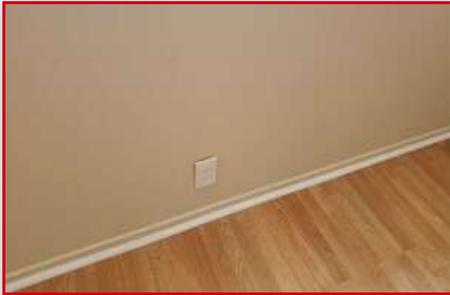
Location: 2ND FLOOR UNIT 1747
/LIVINGROOM

One or more cover plates servicing outlets were missing, loose and/or damaged. We recommend that the affected cover plates be replaced.

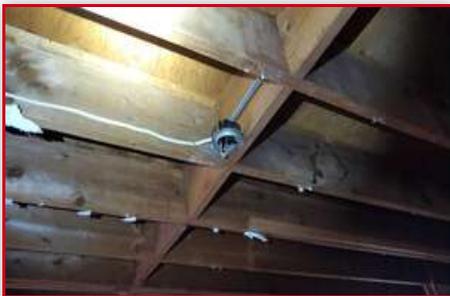
Location: GARAGES

Cover plate(s) are missing from electric boxes, in the garage. They are intended to contain fire and prevent electric shock from exposed wires. This is a safety concern due to the risk of fire and shock. Cover plates should be installed where missing.

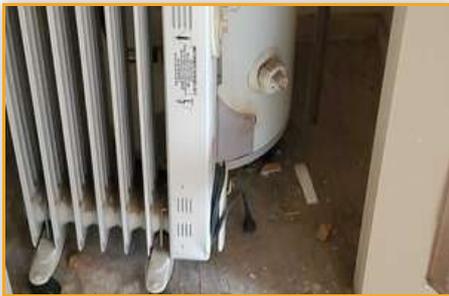
Location: 2ND FLOOR UNIT 1747 /WATER HEATER

There were scorch marks above the burner chamber indicating flame roll out. This unit needs to be serviced as soon as possible.

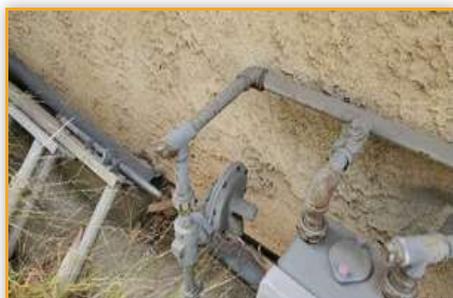
Location: EXT BUILDING /DRAIN LINE

One or more drain or waste pipes or fittings were damaged. Repairs needed.

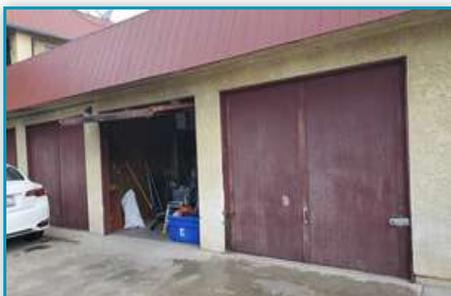
Location: EXT BUILDING

At the time of the inspection, exterior door was weathered or damaged. Weathering includes fading of paint and deterioration of the threshold, jamb and trim. The Inspector recommends that the affected area(s) be evaluated, replaced or repaired, as needed, by a professional contractor.

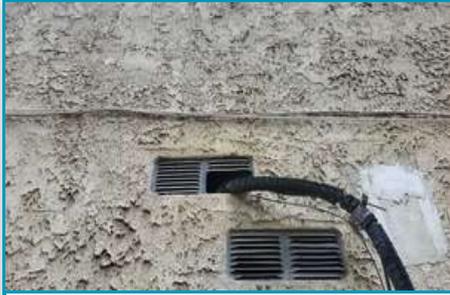
Location: EXT BUILDING

At the time of inspection, one or more exterior vents was loose or missing and can allow rodents to enter the structure. The Inspector recommends that the missing and loose vents be replaced.

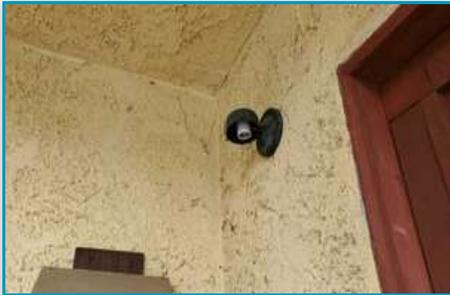
Location: EXT BUILDING

At the time of inspection, the glass which surrounds the exterior light fixture, was missing. The Inspector recommends that this be evaluated and repaired or replaced by a professional contractor.

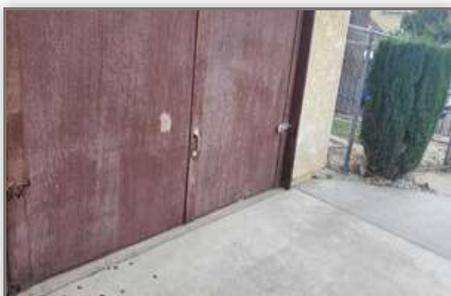
Location: GARAGES

No photo sensors were installed servicing the garage door. We recommend that they be installed.

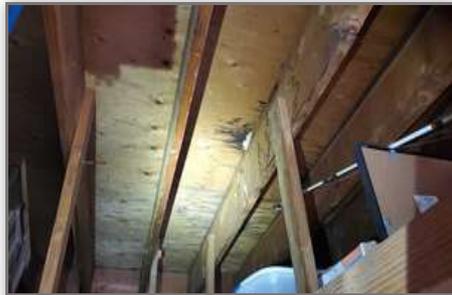
Location: GARAGES

Microbial like growth or musty odor was found at one or more locations. We did not test the substance through a lab so proper verification was not made. Growth is normally cause by moist conditions, plumbing or Roof/exterior moisture issues, and issues with improper ventilation. We recommend that after the areas are verified as mould, mitigation, for mold/moisture should be done by a professional contractor.

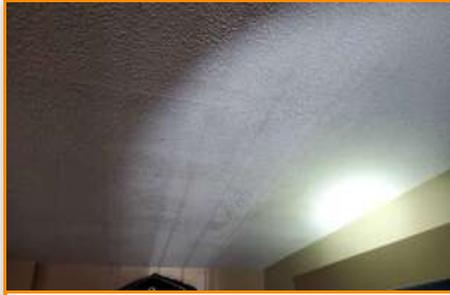
Location: UNIT 1745/LIVINGROOM

Stains and/or elevated levels of moisture were found in one or more ceiling areas. The stains/moisture appear to be due to an active plumbing leak. Recommend that a qualified contractor evaluate and repair as necessary.

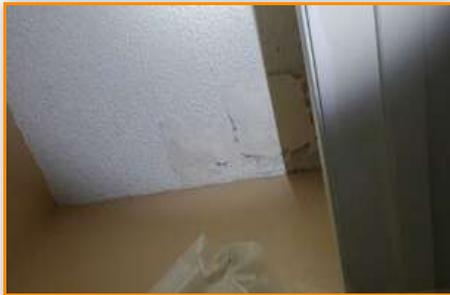
Location: UNIT 1745

Patches or evidence of prior repairs were found in one or more ceilings. Recommend asking the property owner about the repairs (e.g. why necessary, whether prior leaks have occurred).

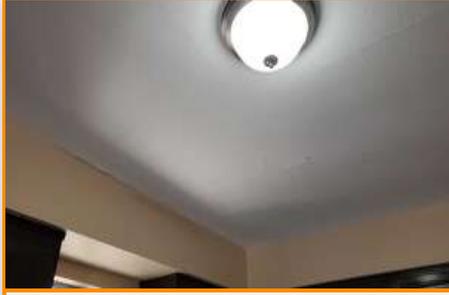
Location: 2ND FLOOR UNIT 1747 /KITCHEN

Patches or evidence of prior repairs were found in one or more ceilings. Recommend asking the property owner about the repairs (e.g. why necessary, whether prior leaks have occurred).

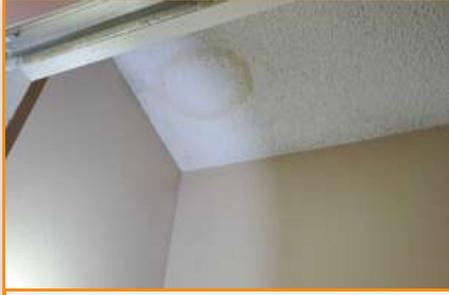
Location: 2ND FLOOR UNIT 1747 /BEDROOM 1

Stains and/or elevated levels of moisture were found in one or more ceiling areas. The stains appear to be due to an active roof leak. Recommend that a qualified contractor evaluate and repair as necessary.

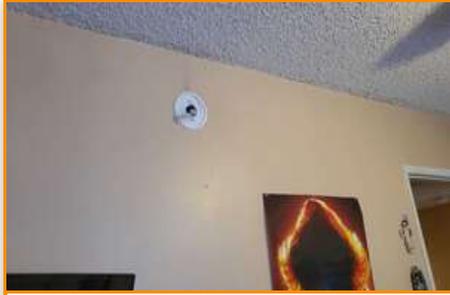
Location: 1745/ BEDROOM 2

One or more smoke detectors have been disconnected from the system. There may be issues with the system and with out a smoke detector you will not be alerted when there is a fire. The missing detectors will need to be installed and tested for proper operation.

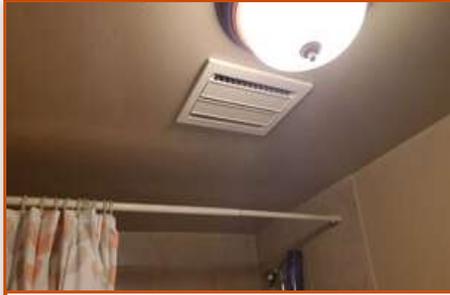
Location: 1745/ HALLWAY BATHROOM

The bathroom fan was not operable or responding to the switch. We recommend that it be repaired or replaced if needed by a professional electrical contractor.

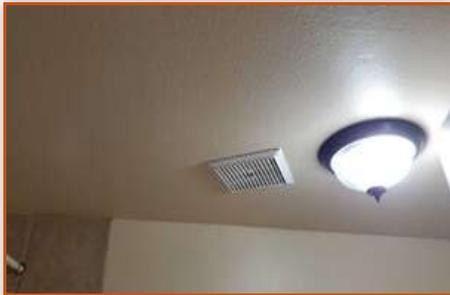
Location: 2ND FLOOR UNIT 1747 /HALLWAY

At the time of the inspection, the bathroom exhaust vent fan made unusual noises when turned on. The Inspector recommends that the bathroom exhaust vent fan is evaluated, replaced or repaired, as needed, by a professional contractor.

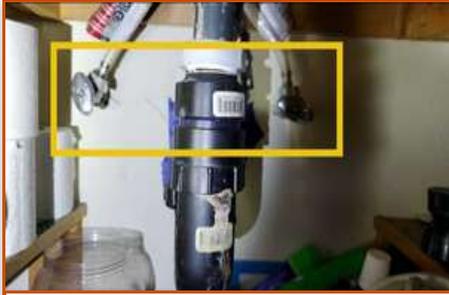
Location: 1745/ BEDROOM 1/BATHROOM

Water shut-off valves under the sink were inoperative/rust/leaking/broken which makes plumbing repairs for the sink difficult to work on. Recommend that water shut-off valves replaced for both cold and hot water lines by a professional plumbing contractor.

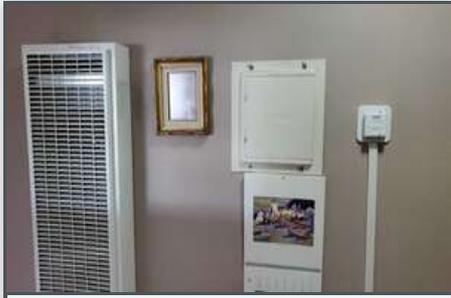
Location: 2ND FLOOR UNIT 1749 /FURNACE

At the time of inspection, the furnace was not responding to the thermostat. The Inspector recommends that the furnace and thermostat be evaluated and repaired as needed by a HVAC contractor.

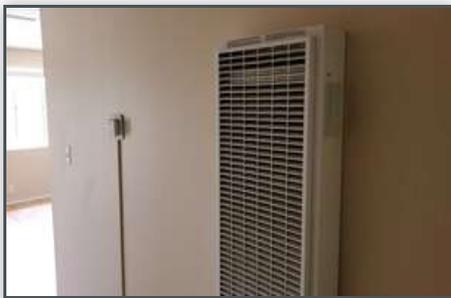
Location: 2ND FLOOR UNIT 1747 /FURNACE

At the time of inspection, the Inspector recommends the furnace be serviced by a professional HVAC contractor, based on its condition. Annual servicing is necessary for systems fueled by gas or oil and for safety reasons, as a professional HVAC contractor will inspect, clean, and make any necessary repairs. A certification should be given to the homeowner after service and repairs are performed.

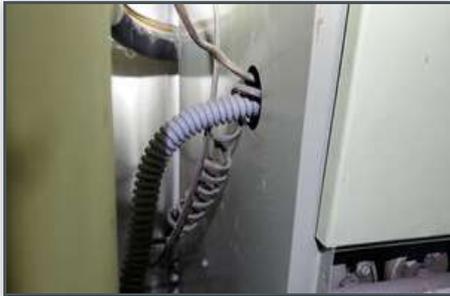
Location: 1745/ FURNACE

The gas-fired furnace flex connector was installed through the cabinet. This should be replaced with an approved hard pipe connection extended outside of the furnace cabinet that the flex connector connects to, and cannot be damaged sharp edges of the unit. All work should be performed by a professional plumbing contractor.

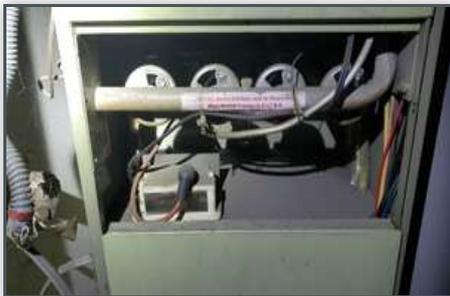
Location: 1745/ FURNACE

The furnace was at or past its recommended lifespan. It was visibly old and dirty and should be serviced at the least. The Inspector recommends that the furnace is evaluated, serviced or replaced, as needed, by a professional HVAC contractor, to ensure the best possible working condition.

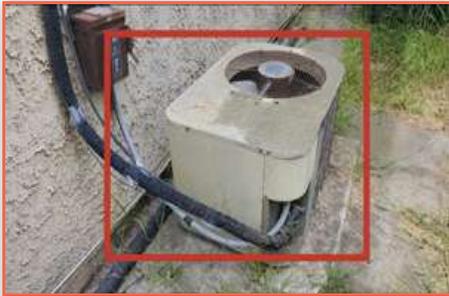
Location: EXT BUILDING/ AC

At the time of inspection, the air-conditioning system was old and inoperable. The Inspector recommends that the affected area(s) be evaluated, replaced or repaired, as needed, by a professional contractor.
