Sunset Property Inspection

Confidential - Property Inspection Report - Confidential

3640 Promontory St
Inspection Prepared For: Robert Blumenshine
Agent: -

Date of Inspection: 2/18/2022
Year Built: 1983 Size: 1680

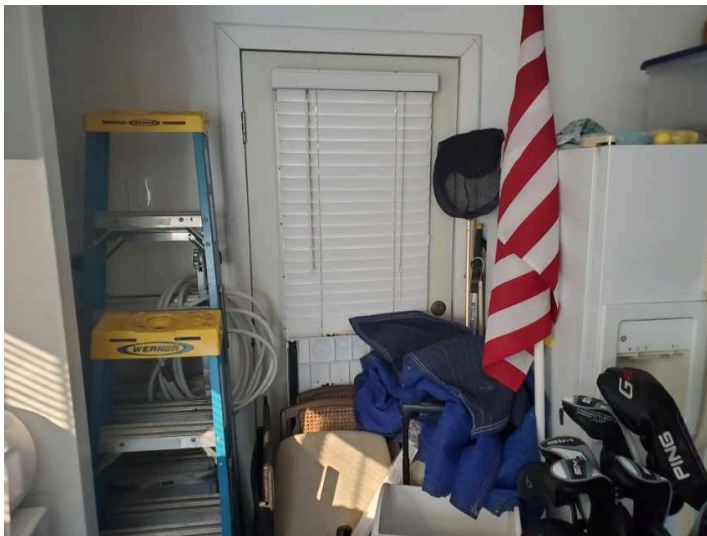
- Garage service door not tested due to storage blocking the door.
- Emergency Egress Concern. Exterior door has a double-sided keyed dead bolt lock set. This type of lock requires a key to unlock the door from the inside and can present an obstacle to anyone trying to evacuate the home in the event of a fire. Recommend replacing with a lever style deadbolt.

Door blocked

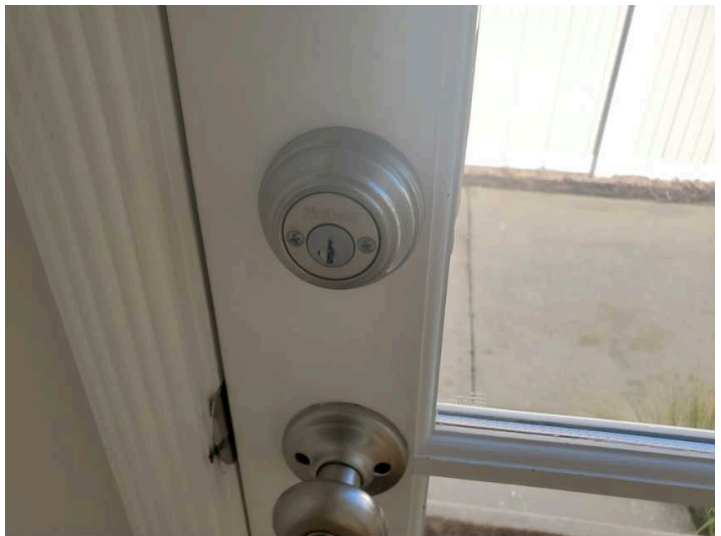
Keyed dead bolt

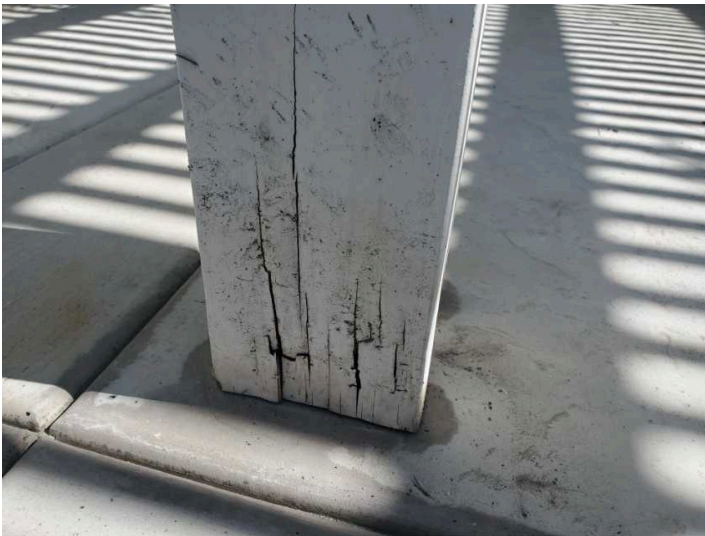
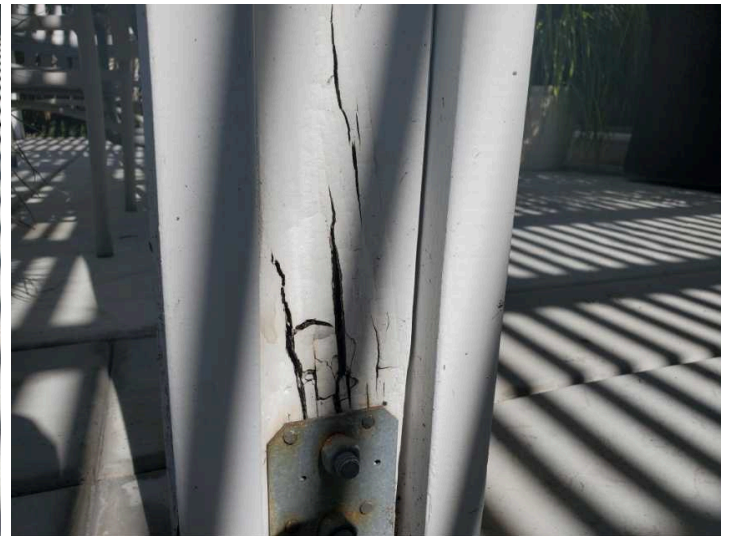
- Posts in contact with the concrete patio at the rear of the house have experienced moisture damage. Posts should be elevated off the ground on a footing/strap system to prevent moisture damage. Repairs are needed by a qualified contractor.

Moisture damage

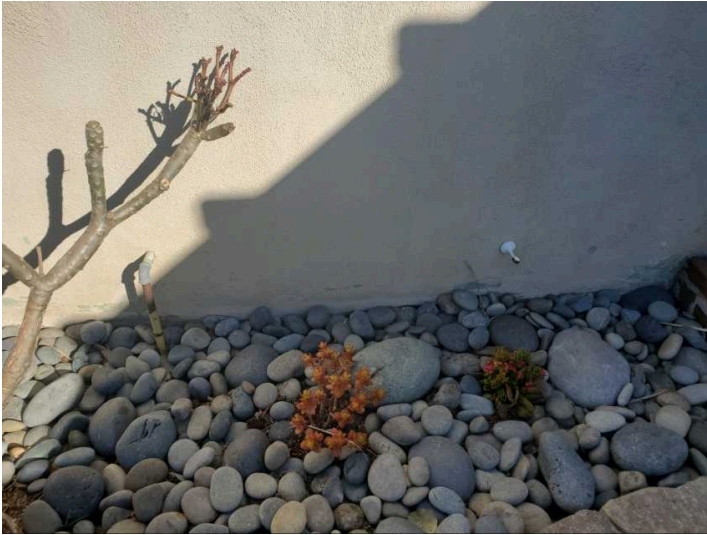
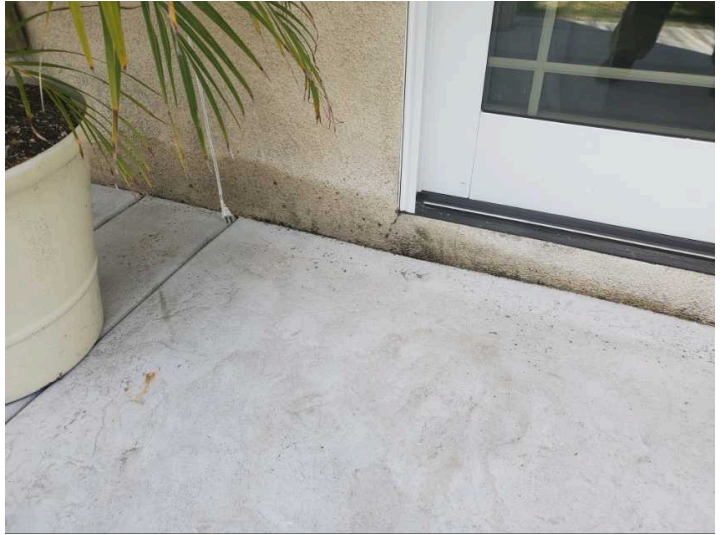
- No weep screed visible or improper clearance to soil/concrete. The present standard distance is 4" to soil and 2" to concrete. Weep screeds are necessary for proper moisture drainage from behind stucco and prevent premature deterioration to the stucco, framing or moisture entry into the interior. We recommend correcting the condition(s) noted.

- Stucco on older homes built prior to the 1970's were installed without a weep screed. Since the stucco traverses the junction of the concrete foundation and the wood frame walls, a horizontal crack is common. This is due to the inevitable movement of the walls in relation to the concrete foundation. This crack is unlikely to cause damage if it remains small. Patching this crack is a temporary measure. Installing a weep screed will be needed to avoid cracking. The Weep screed flashing will allow for movement between the wood frame wall and the foundation stem wall. (The weep screed is a metal band at the bottom of the stucco.) We recommend installing a weep screed by a licensed stucco repair contractor.

No weep screed

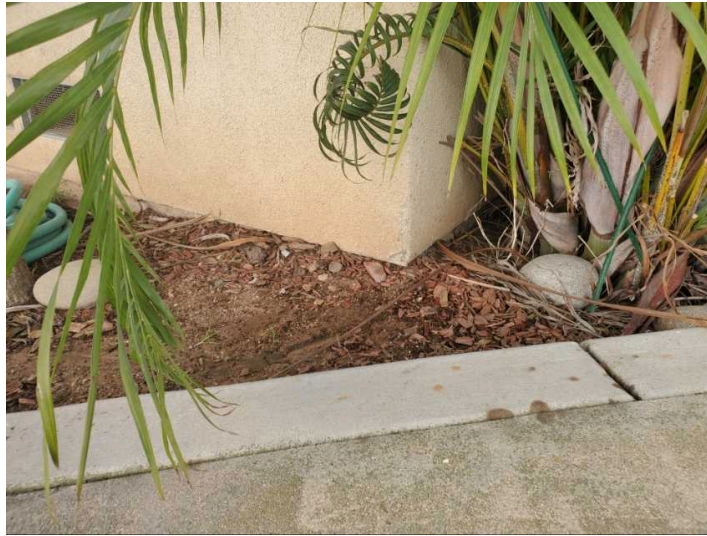
improper clearance

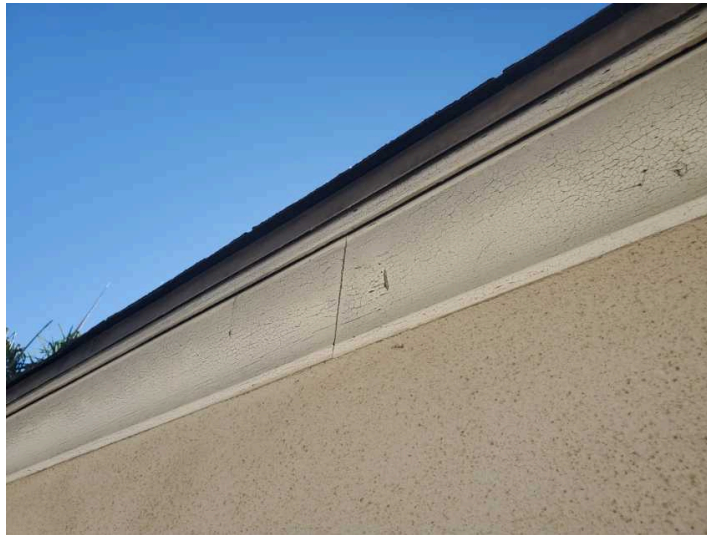
- Portions of painted wood surfaces at the eaves and fascias showed some signs of cracking, peeling, and blistering.

Weathered paint

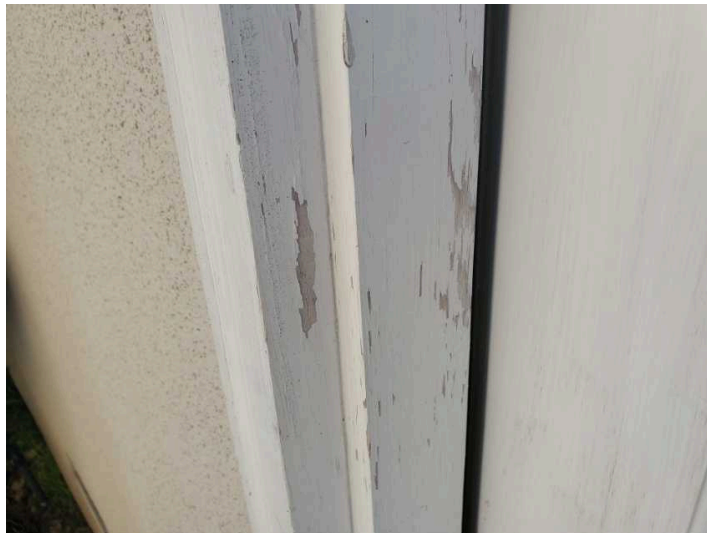
- Exposed wood surfaces observed. Wood rot & deterioration can occur. Prep, prime and paint wood trim surface where paint is peeling or missing.

Exposed wood

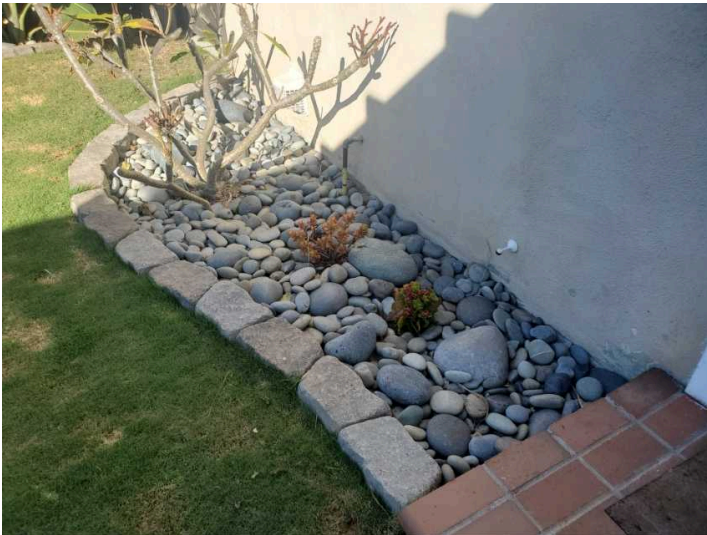
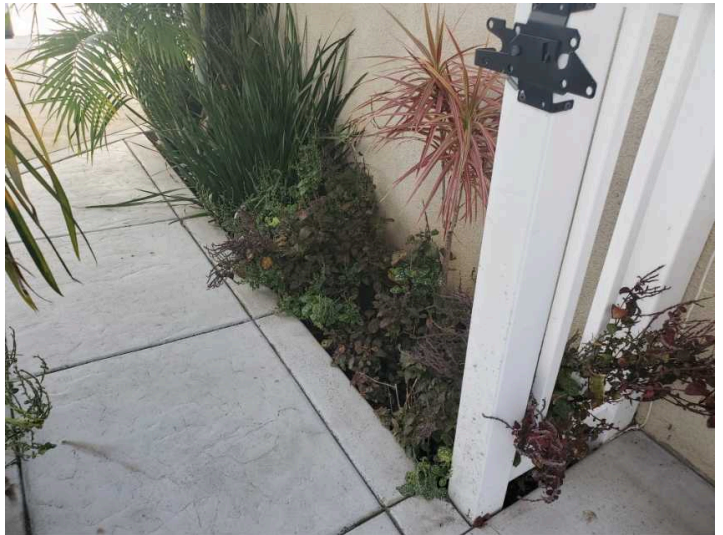
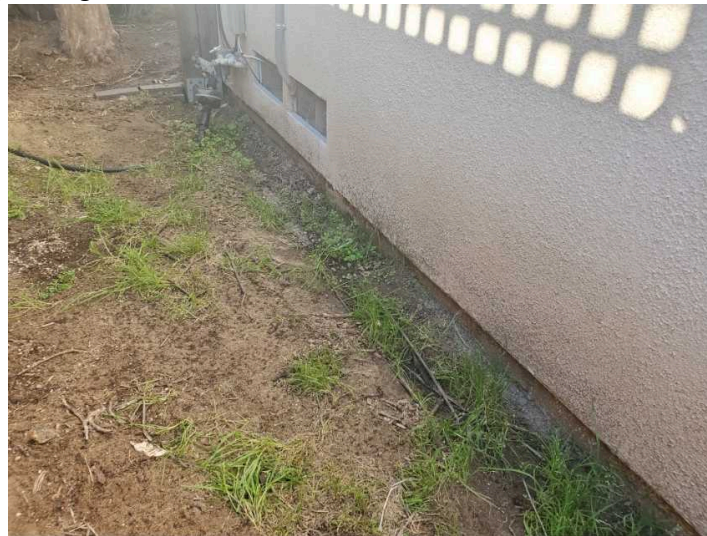
- Lot grading and drainage have a significant impact on the building, simply because of the direct and indirect damage that moisture can have on the foundation. It is very important, therefore, that surface runoff water be adequately diverted away from the home. Lot grading should slope away and fall a minimum of one (1) inch every foot for a distance of six (6) feet around the perimeter of the building. A soil gradient sloping away from the foundation was not established. The soil gradient was essentially flat at planter beds and/or lawn areas next to the foundation. Correcting the soil pitch is needed to improve drainage so that surface drainage is directed away from the foundation.

Poor grading

Poor drainage

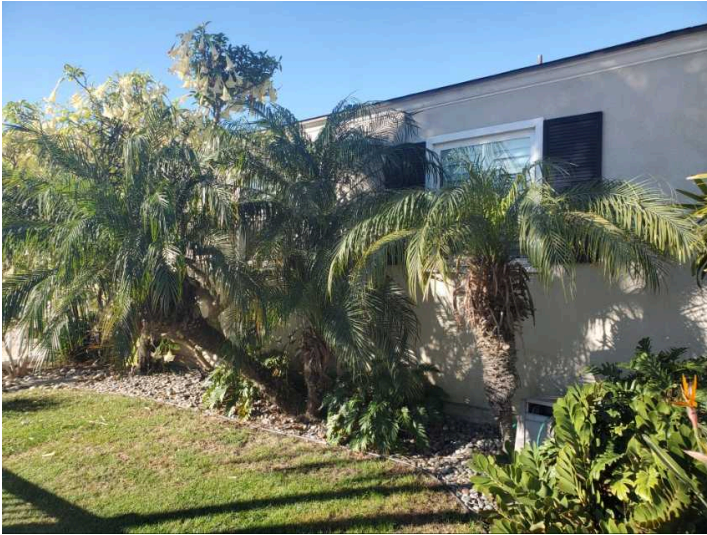
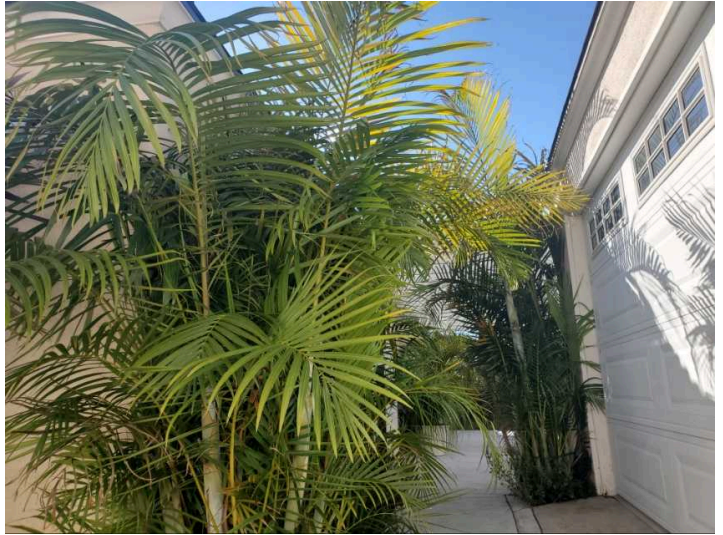
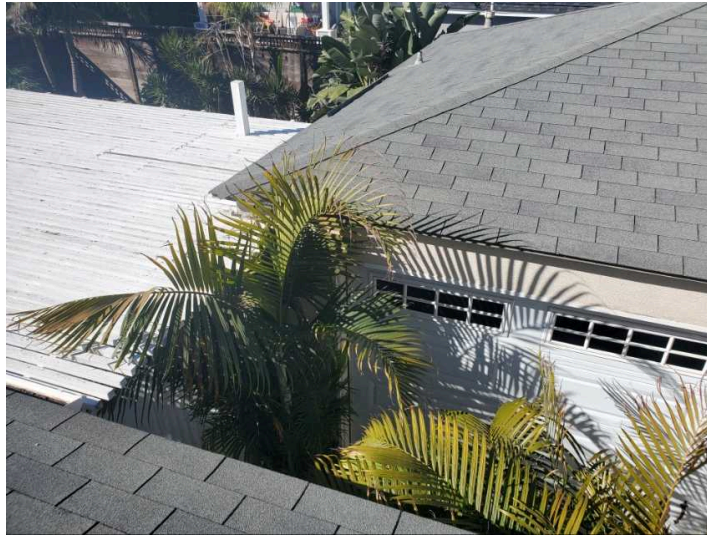
- Vegetation observed to be touching roof. Condition can promote excessive damage and deterioration by movement of branches, root growth and/or attachment, moisture retention, and can promote pest infestations. Recommend having vegetation trimmed, pruned, or removed from affected areas, and regular homeowner monitoring and landscaping maintenance thereafter.

Vegetation in contact with house

Tree in contact with roof

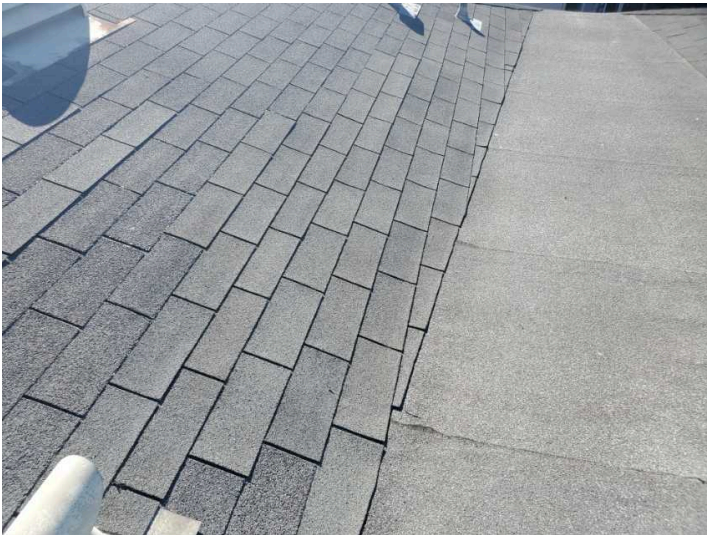
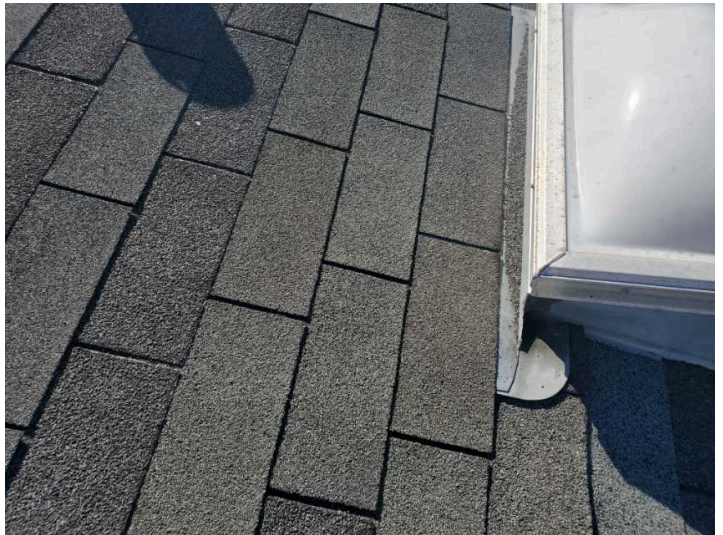
- Evidence of previous repairs were noted in one or more areas of this roof. This may be indicative of a past roof leak. Unable to determine if the current repairs are adequate. Recommend asking the sellers for documentation showing these repairs were completed by a licensed roof contractor. If documentation is not available, we recommend having the roof further evaluated by a licensed roof contractor before the end of your contingency period to determine if latent defects exist.
- Damaged shingle. Future leaking may occur. Recommend repair by a qualified roofing contractor.

Previous repairs

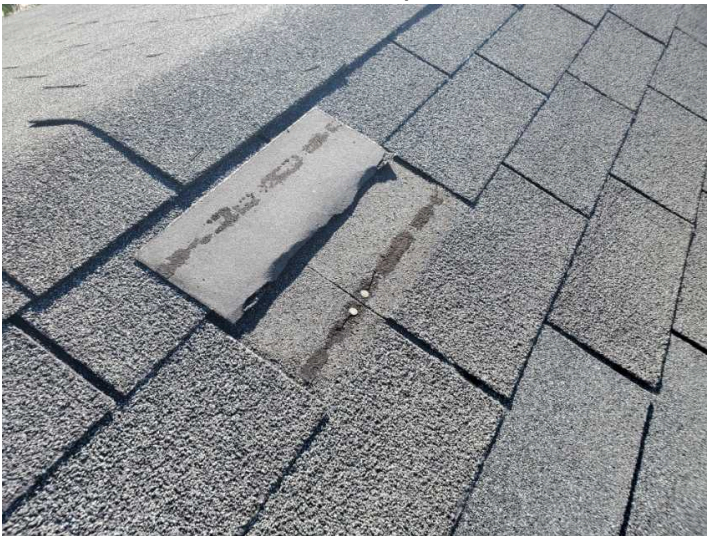
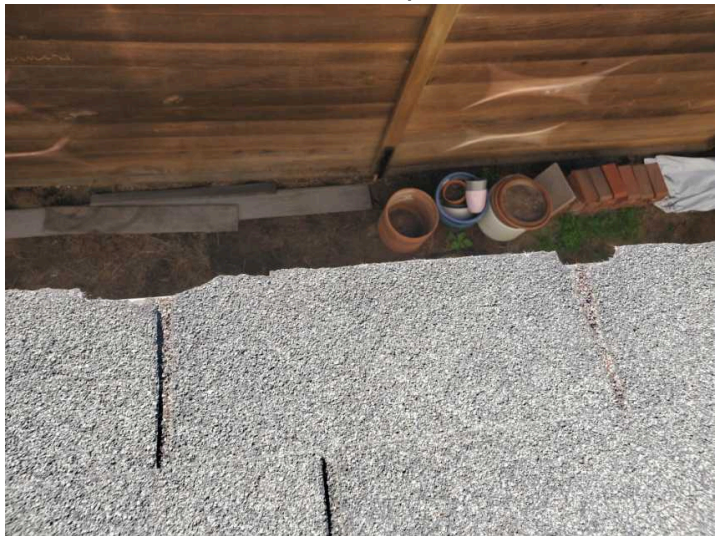
Damaged shingle

Damaged shingles

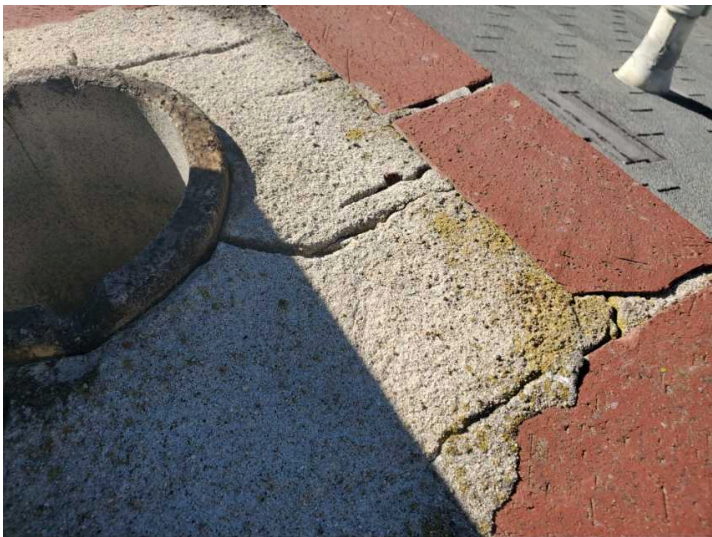
- The chimney crown is cracked or damaged. Further deterioration and expensive repairs may occur. Recommend a chimney mason/specialist repair or replace the damaged crown.

Cracked crown

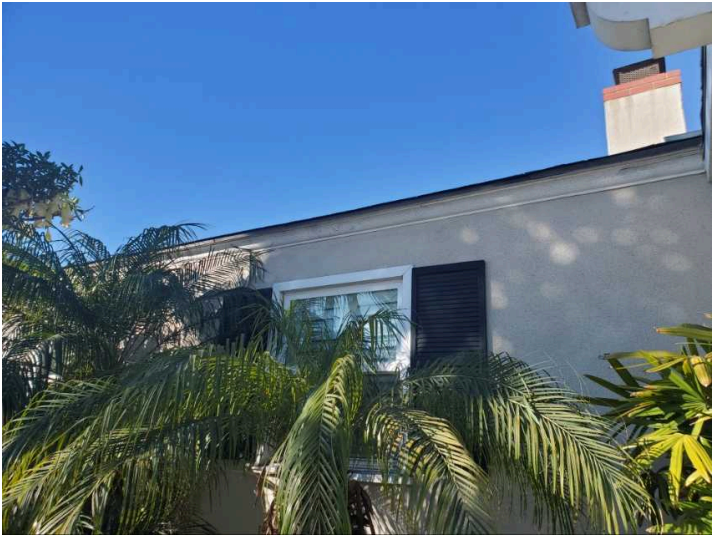
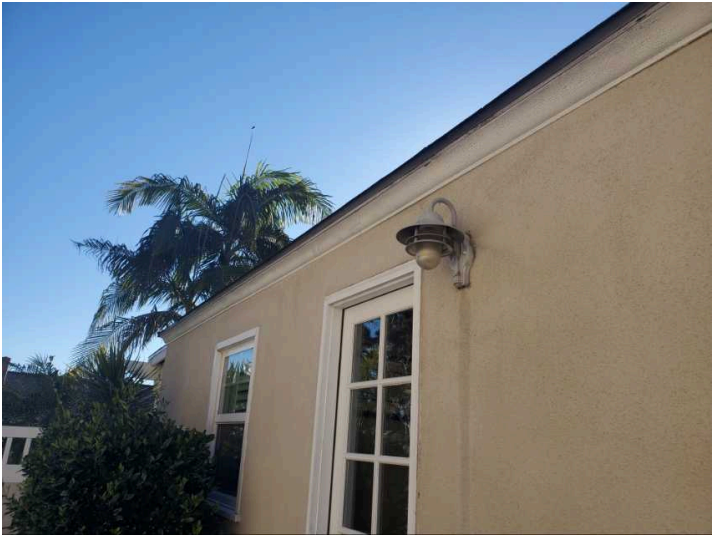
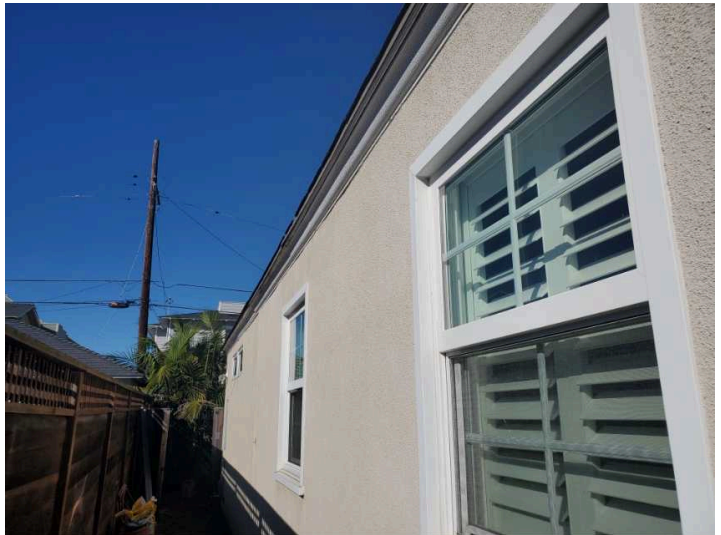
- There is no gutter/downspout installed at the roof drainage system. Location: Several sections. Potential water intrusion can occur and damage components. Recommend installing a gutter/downspout and properly extending away from the foundation to allow for proper drainage.

No gutter

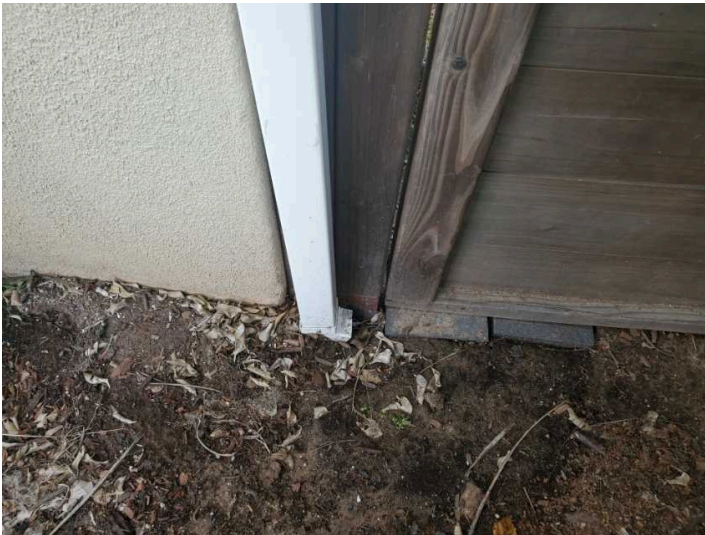
Downspout next to foundation

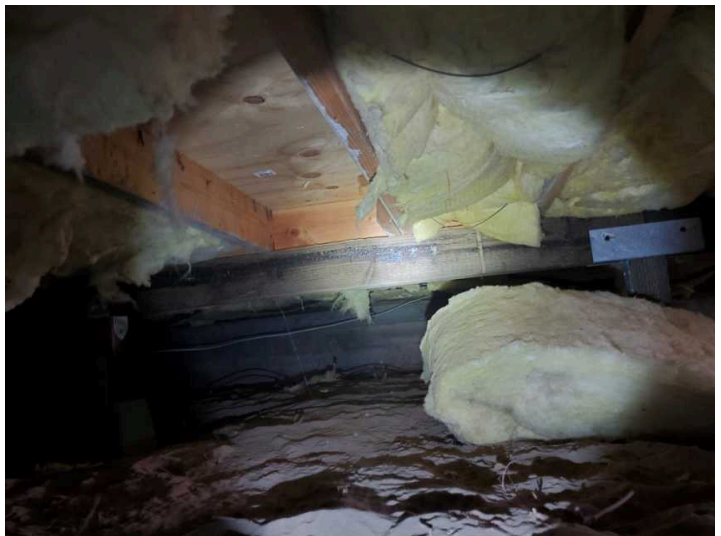
- **Insulation Support Failing.** The insulation at the underside of the house is not properly secured at some locations and has begun to fall. Improperly hung, missing or failing insulation can allow the house to inefficiently heat and cool. It is recommended that any displaced insulation be properly supported.

Insulation falling

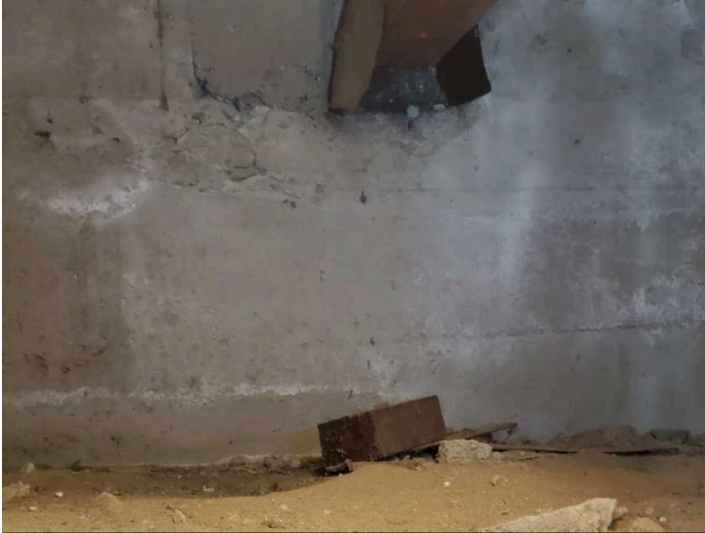
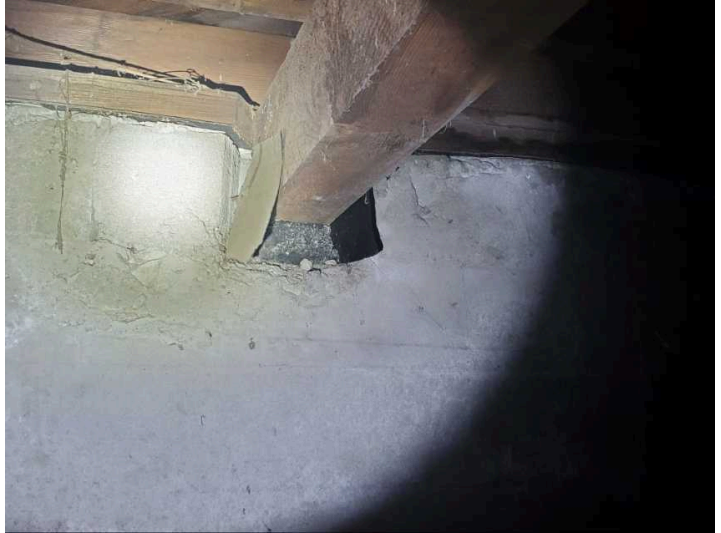
- Beam is not properly supported at foundation wall pocket. The wood shim/block has fallen out. Recommend corrections by a qualified contractor.

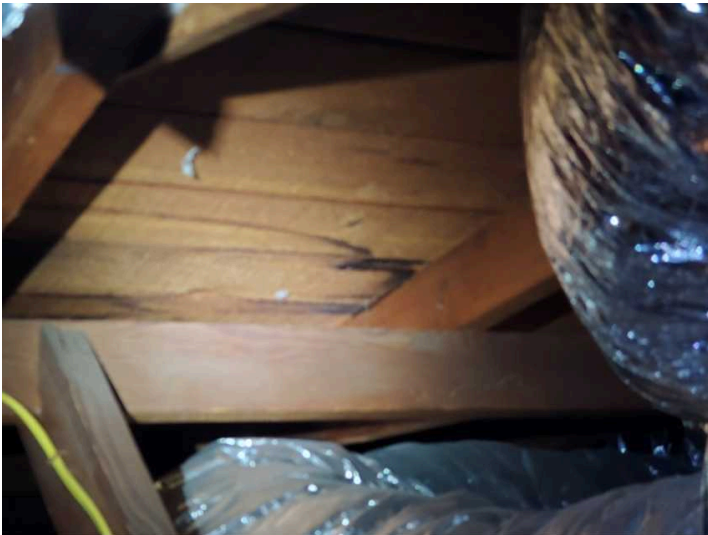
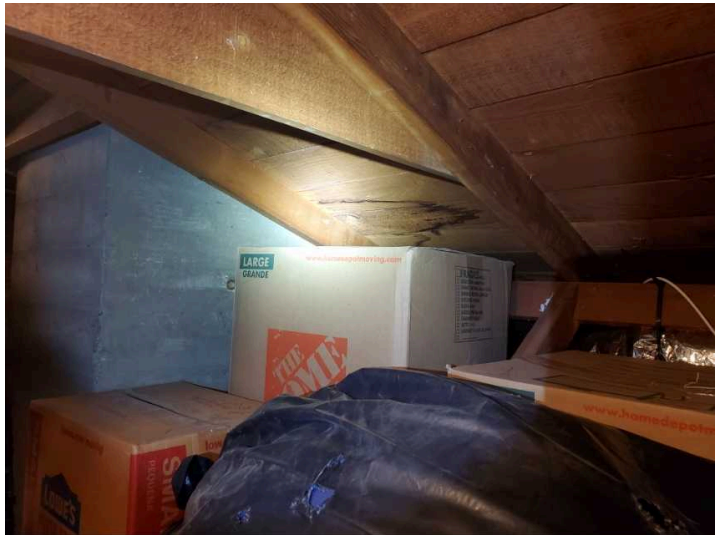
Moisture stains

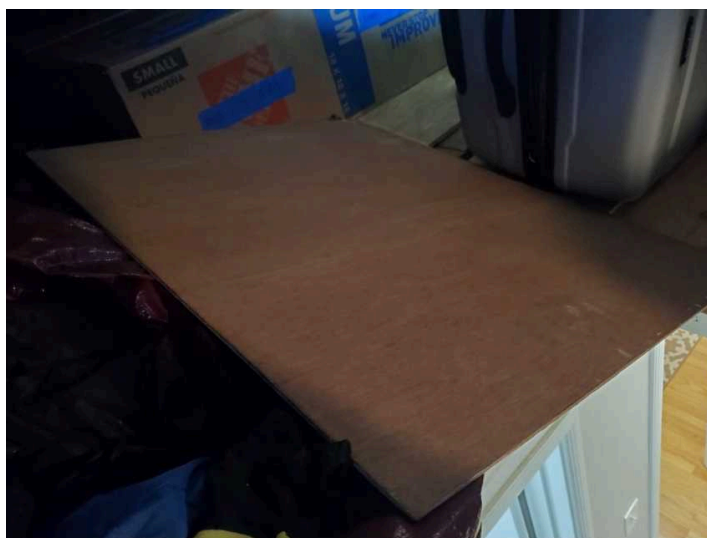
Observations: Missing insulation noted at the attic access panel at the time of the inspection. This condition will lead to heat loss and wasted energy. Recommend adding insulation to improve thermal efficiency of this home by a qualified professional.

Missing insulation

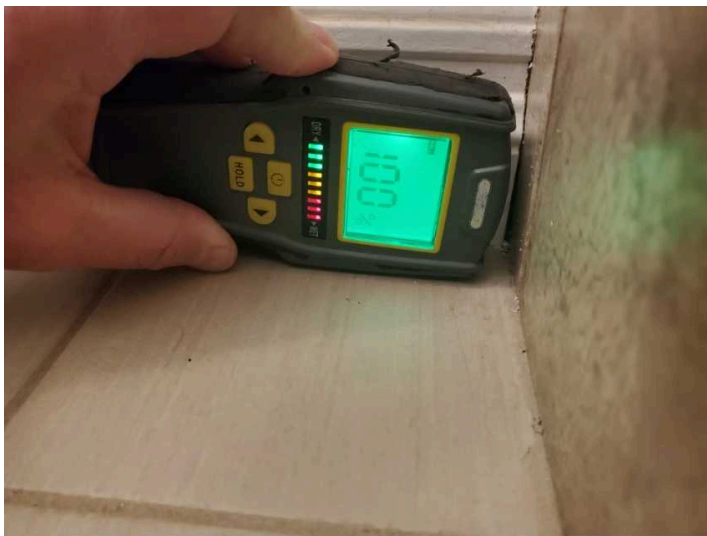
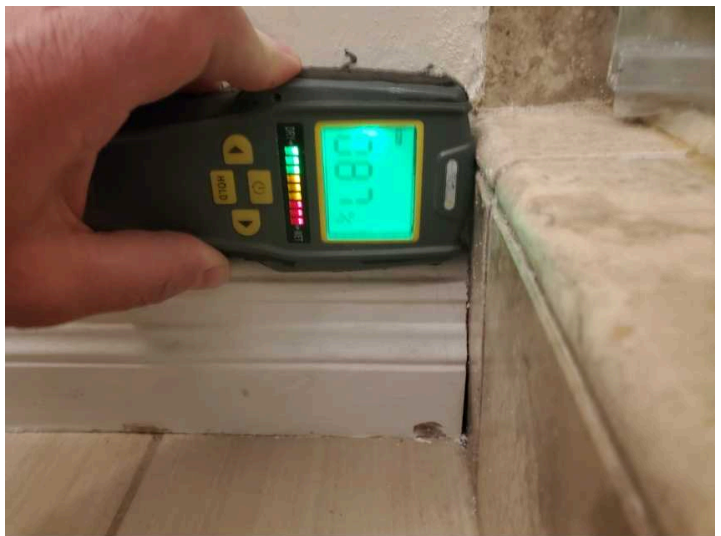
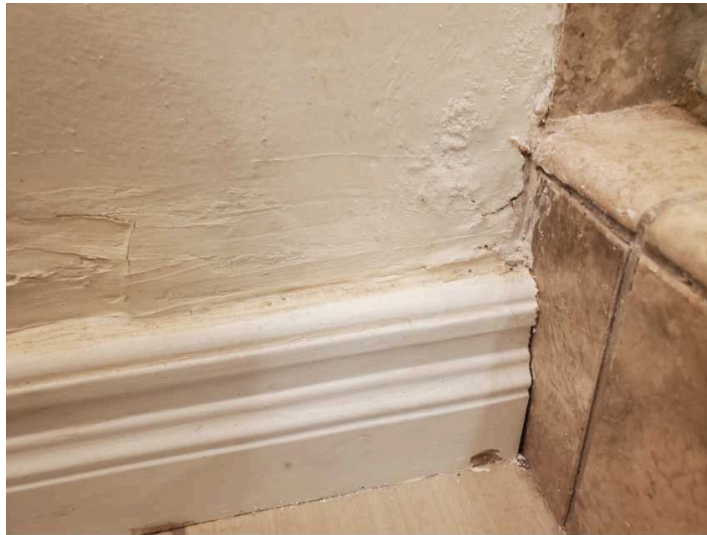
- Moisture damage noted at the wall and baseboard next to the master shower. The shower enclosure may be leaking. The affected areas are saturated at the time of the inspection. Recommend further evaluation by a licensed restoration contractor and termite inspector before the end of your contingency period to determine repairs necessary at this time.

Saturated

Elevated moisture

Moisture damage

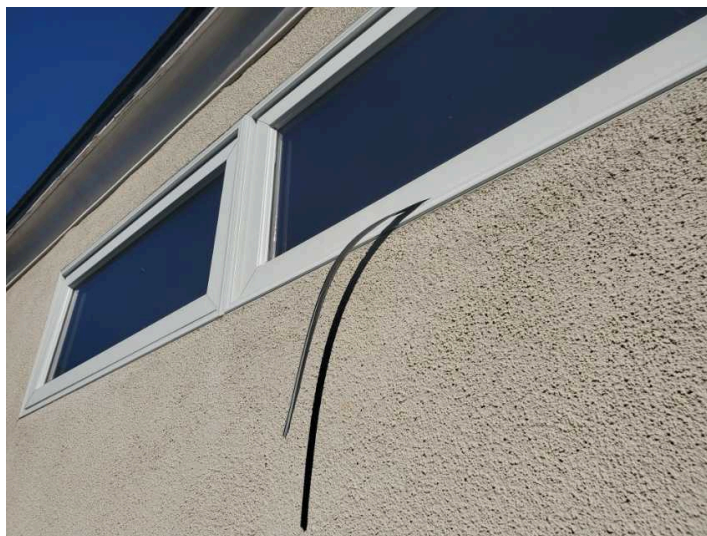
- In accordance with CREIA Standards, we do not test every window in the house, and particularly if it is furnished. We do test every unobstructed window in every bedroom to ensure that at least one provides and emergency exit.
- Operated windows appeared functional, at time of inspection
- Damaged weatherstripping observed. Recommend repair.

Weatherstripping damaged

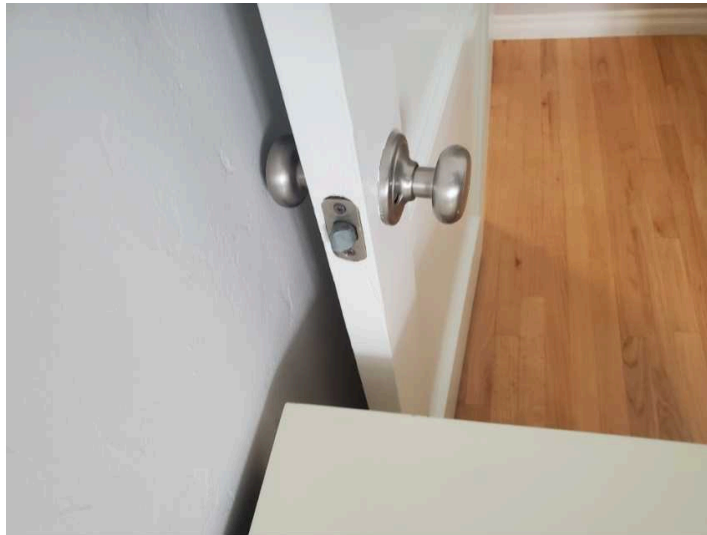
- The door stops are either damaged or missing. Damage could occur to the walls. Recommend installing protective door or wall protectors.

Missing doorstop

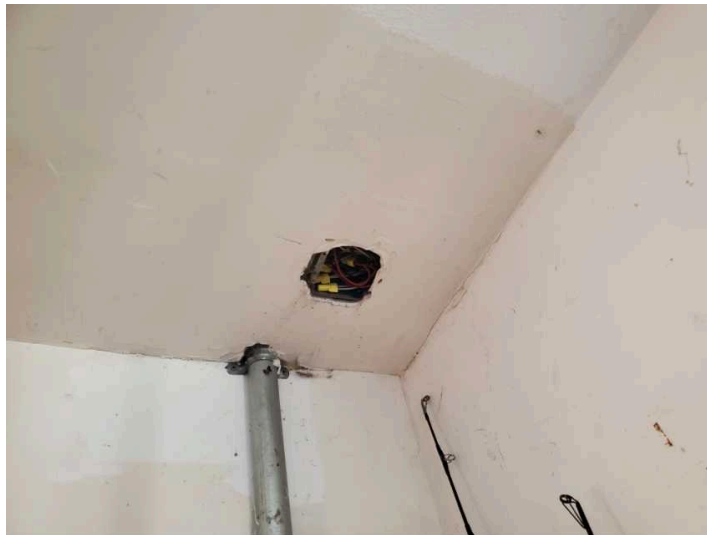
- Missing junction box cover in garage. Repair as needed.
- Visible wiring appeared functional, at time of inspection.

Junction box cover missing

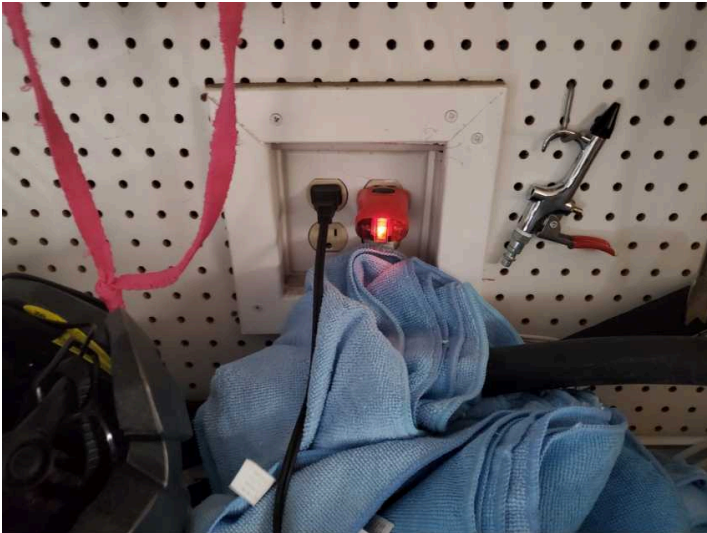
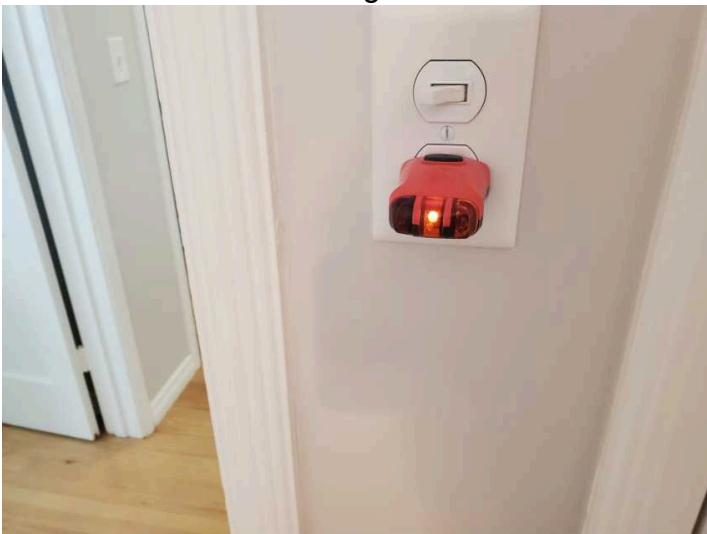
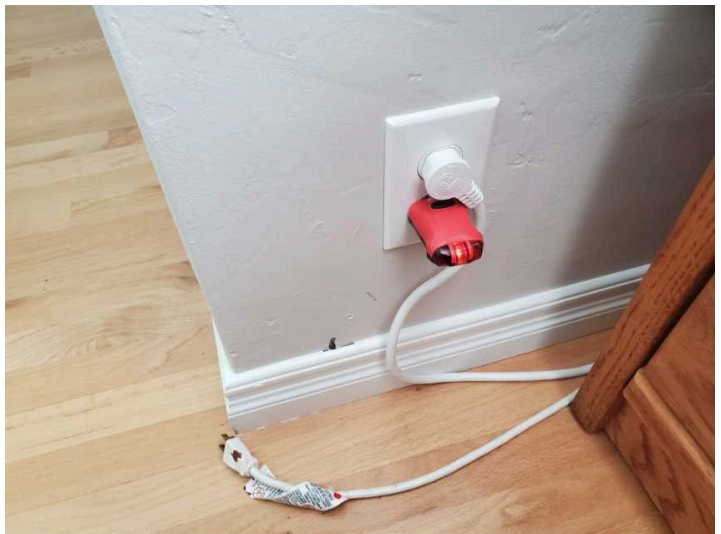
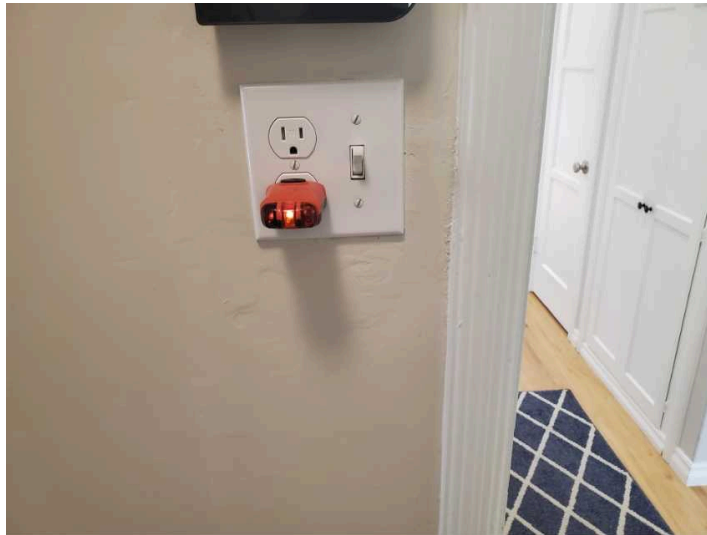
- **SAFETY CONCERN:** Several outlets have "open ground" fault. It is advised to have an electrician evaluate for adding grounded outlets for areas that would require ground protection. Areas would be for computers, appliances and tools.
- Receptacles located at the exterior of the home are without the benefit of In-use covers. In-use covers help protect the outlets from moisture while a plug or cord is in use. Installation of proper In-use covers are recommended to be installed at all exterior receptacles by a qualified electrician.

Outlet not grounded

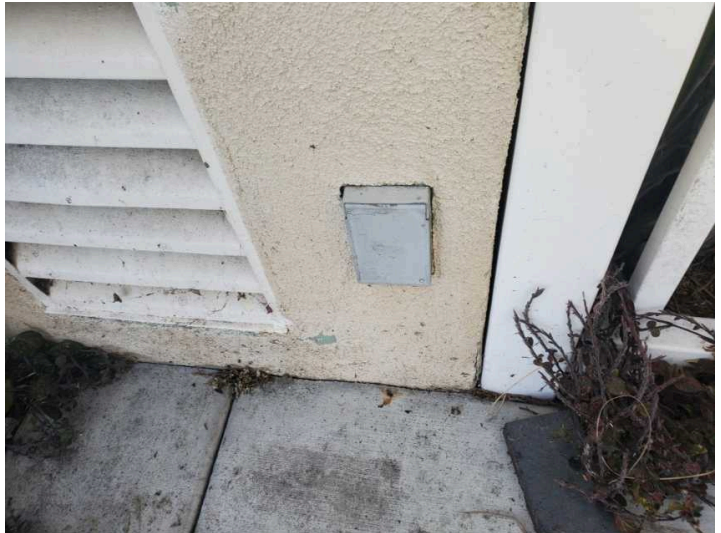
In-use cover not installed

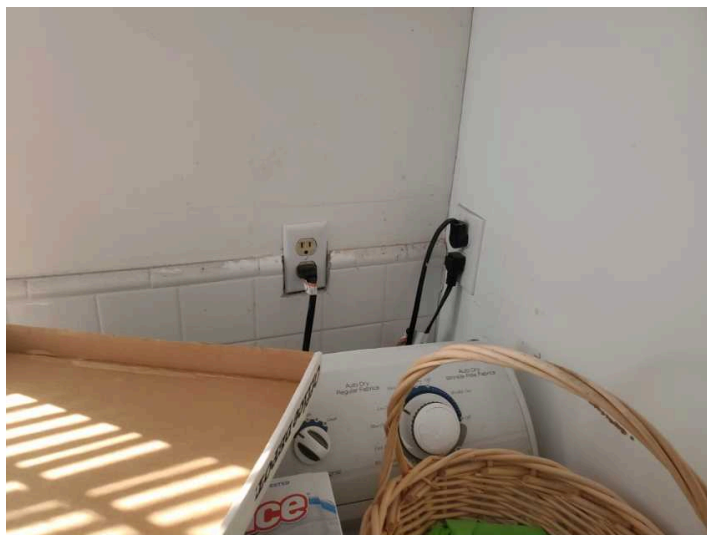
• This house was built prior to the requirement for the installation of GFCI receptacles in certain locations in the house. The locations where GFCI receptacles are required has increased, but it is not required to retrofit older homes unless a remodel takes place. For safety, it is advisable to upgrade all receptacles within 6 feet of a plumbing fixture, in garage, all kitchen counter top outlets, and at exterior, to GFCI protected outlets. A qualified electrician is recommended.

No GFCI present

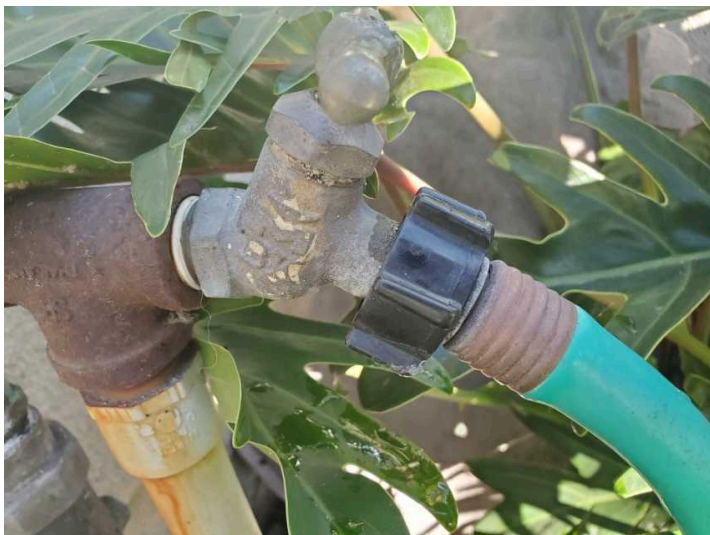
- IMPROVE: There are no anti siphon devices at some exterior faucets. Although this was not a requirement for when this house was constructed, it is recommended that these devices be installed at all exterior hose bibs. These are designed to prevent contamination should there be a pressure drop in the cities system. Anti-siphon devices will prevent water from being siphoned backwards potentially contaminating the public drinking water. Recommend installation of these devices.

Missing anti-siphon valve

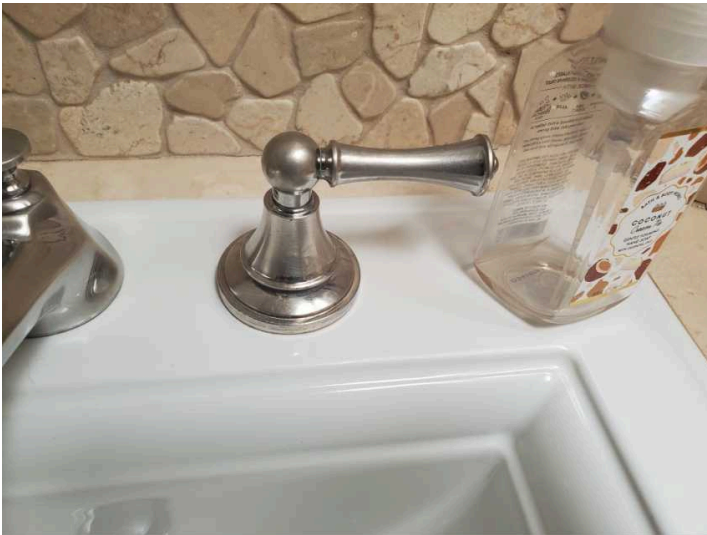
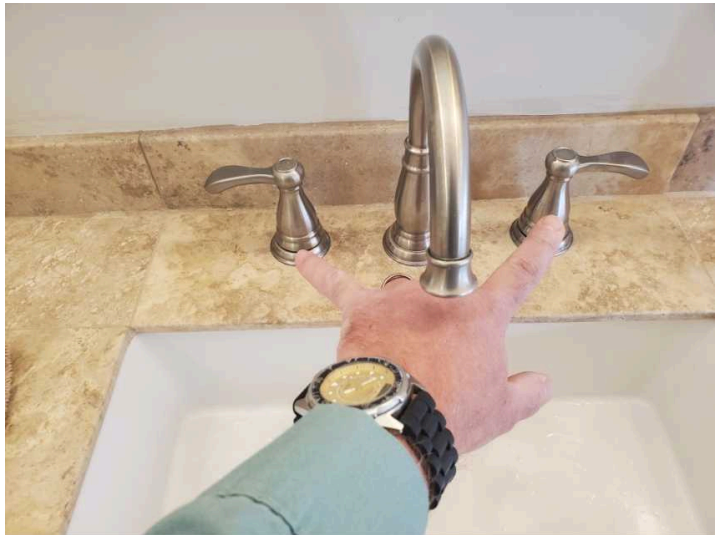
- Hot and cold faucet handles are loose at the master bathroom. Recommend review for repair.
- Faucet at guest bathroom is difficult to operate. Repair as needed.

Difficult to turn

Loose

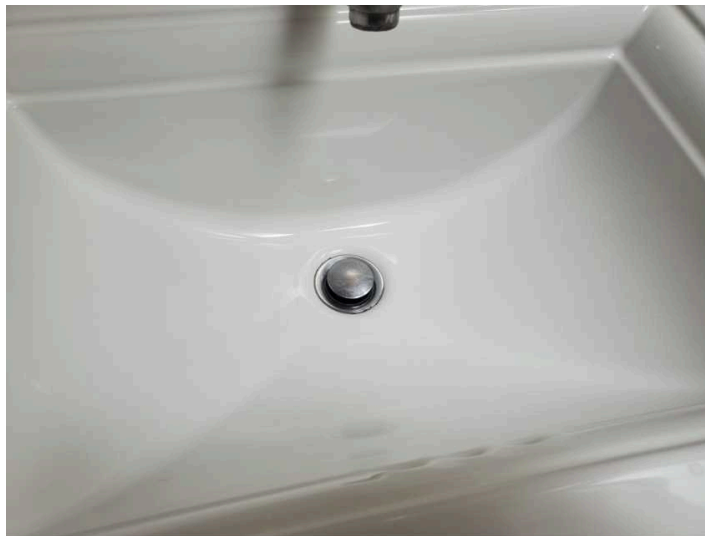
- Stopper is missing/inoperable at guest bathroom. Recommend review for repair or replacement as necessary.

Stopper inoperable

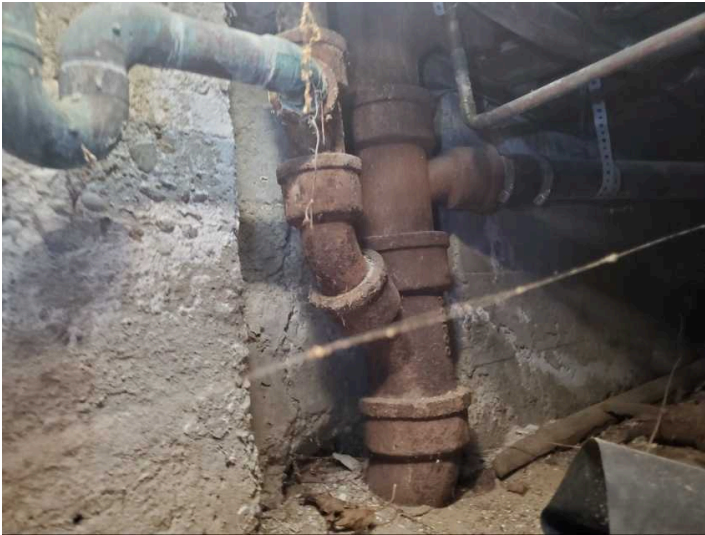
- Deferred Cost: There are portions of the plumbing system with older cast iron piping. Expect unexpected repairs in any older original plumbing.
- Towel found wrapped around drain and trap for master bathroom shower. No leaks were detected. Seller stated that it was installed as noise insulation. The seller was hearing water drop down into the drain and wanted to make it quieter. Recommend the towel be removed so that the plumbing lines can be monitored as part of routine homeowner maintenance.

Original cast iron piping passing underground

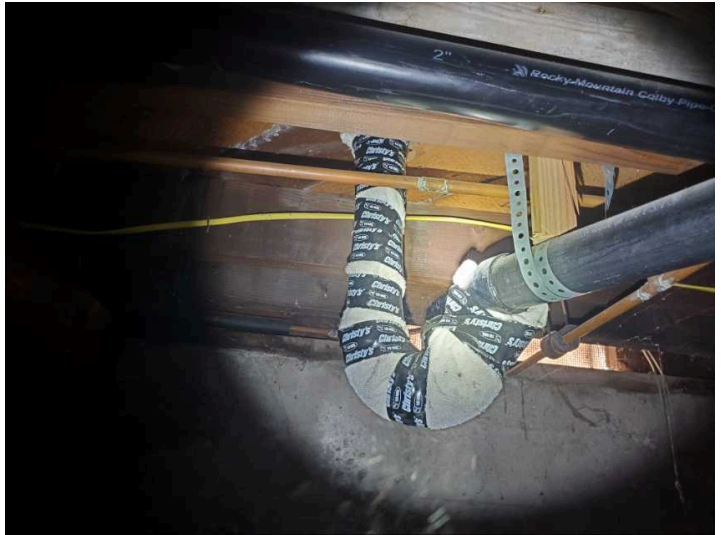
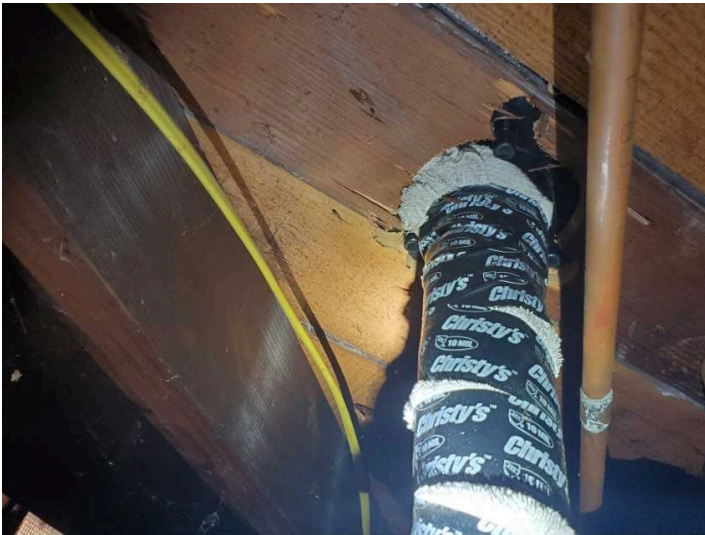
Insulation wrap

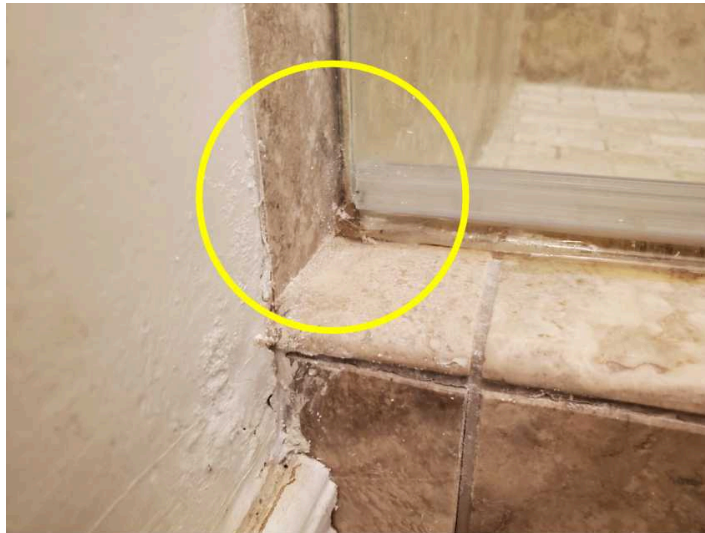
- Master shower enclosure is leaking. Recommend corrections to prevent leakage. A qualified contractor is needed.
- Failure to keep shower walls sealed can cause deterioration and extensive moisture damage to the interior walls and surrounding sub-flooring. This damage is not always visible or accessible to the inspector at the time of inspection.

Enclosure is leaking

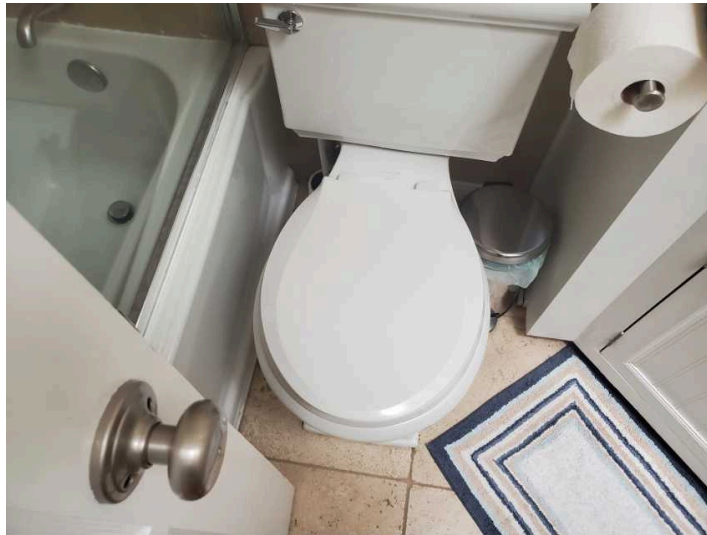
Improper clearance

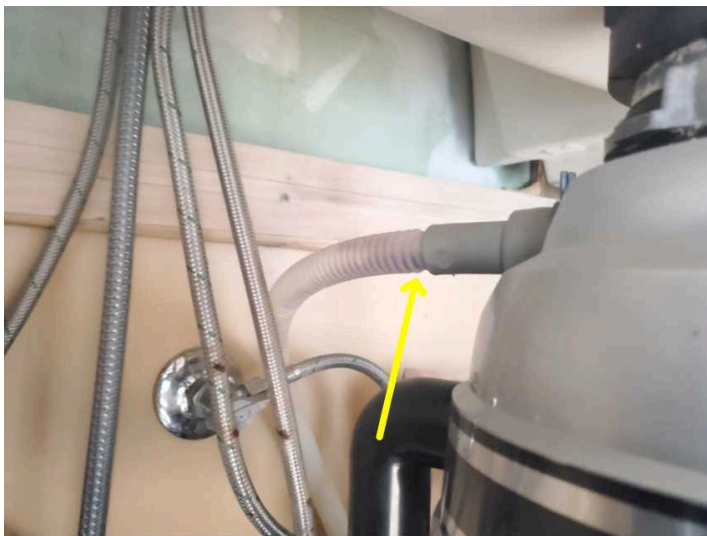
- Irregular drain line installation. Dishwasher drain line is connected directly to the garbage disposal. This is a safety hazard and a potential cross contamination. Recommend a proper **air gap** be installed by a qualified plumber. (See illustration)
- Loose handle. Recommend repair.

Improper drain connection

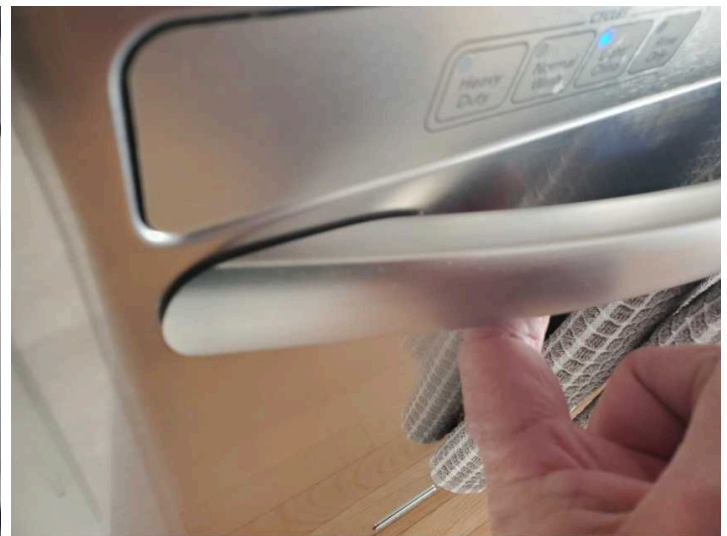
Loose handle
