Sunset Property Inspection

Confidential - Property Inspection Report - Confidential

3640 Promontory St
Inspection Prepared For: Robert Blumenshine
Agent: -

Date of Inspection: 2/18/2022
Year Built: 1983 Size: 1680

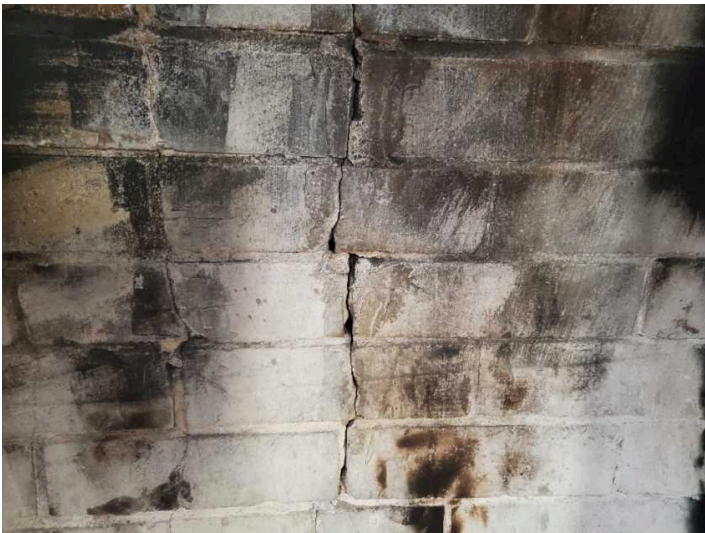
Damaged firebrick

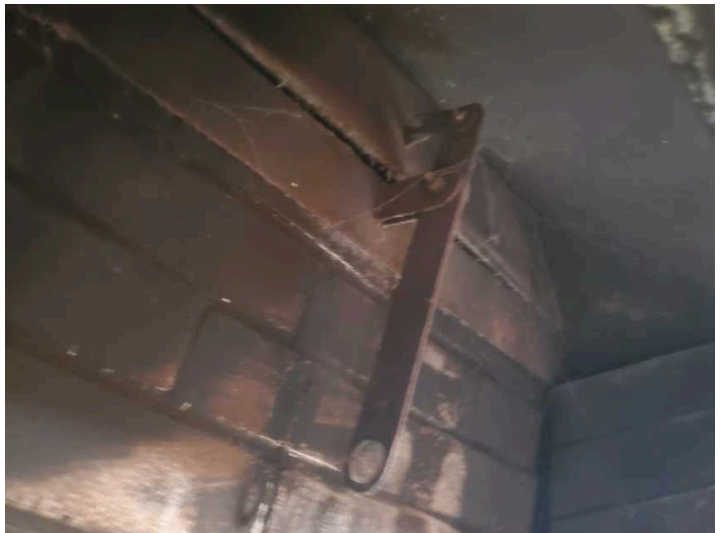
- The damper did not operate when tested. Recommend further evaluation by a qualified chimney sweep.
- Missing screen or enclosure at fireplace. Installation is needed by a qualified chimney sweep.
- Cracks in the fire brick or gaps in the mortar can result in house fires. Most small openings can be sealed using a temperature rated fireplace caulk. I recommend consulting a chimney sweep service company so a corrective course of action can be evaluated.

Damper inoperable

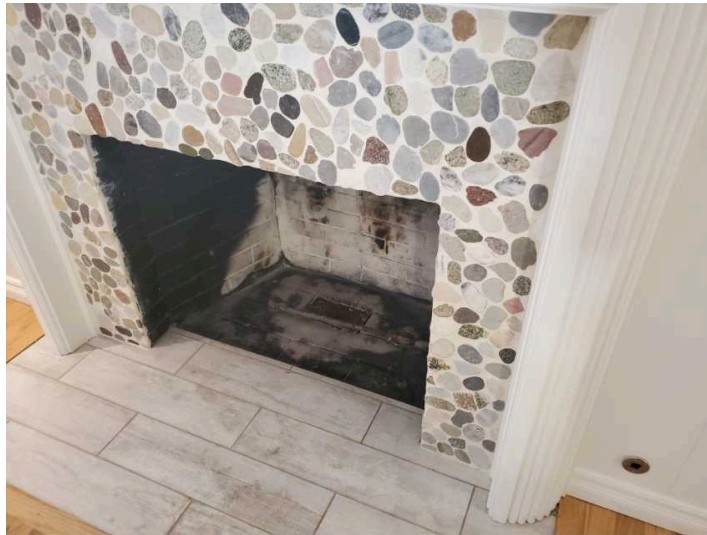
No screen or enclosure
