-			7:	Date of Inspection	Number of Pages
Building No.	Street	City	Zip		1 of 8
	Madison Avonus	La Mesa	91941	05/05/22	1010
9335	Madison Avenue	La Illicoa			
Ordered by: Coldwell Banker Wes Kelly Pavlick 620 First Avenue San Diego, CA 92101 kelly@thesavorygrou H: 619-913-9127		2206   Fax: 619-825-9743  @gmail.com	Coldw Kelly 620 F San E kelly@ H: 61	t sent to: vell Banker West Pavlick irst Avenue biego, CA 92101 othesavorygroup.com 9-913-9127	
COMPLETE REPO	RT X LIMITED REP	ORT SUPPLEMENT	, i.e. i.e. i.e. i.e. i.e. i.e. i.e. i.e	NSPECTION REPOR	~
Osmaral Description:	Control Contro		M 44"	ction Tag Posted:	
General Description:	will recidence unfur	nished and unoccupied,	detached		
2 Story single to	amily residence, unital	IIIOIIOA AIIA AII	Othe	r Tags Posted:	
garage			Non		d sorobos detached
An inequation has be	en made of the structure(s) s	shown on the diagram in accorda	ance with the Structural Pes	t Control Act. Detache	u porches, detached

Building No. Street	City	Zip	Date of Inspection	Report #	Page
9335 Madison Avenue	<b>La Mesa</b>	<b>91941</b>	05/05/22	6743	2 of 8

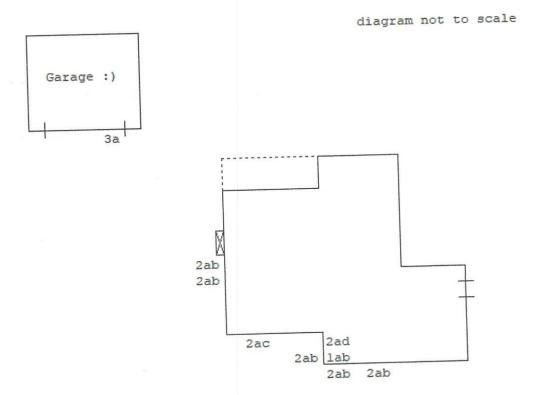
Evidence of subterranean termites noted in/at SUBAREA as diagrammed .

Subterranean termites have damaged wood members in/at the SUBAREA TOP PLATES AND

Evidence of drywood termites was noted in/at SUBAREA, EAVES AND EXTERIOR .

Infestation(s) appear to extend into inaccessible areas.

Drywood termites have damaged wood members in/at STARTERBOARDS, FASCIA AND

Drywood termites have damaged wood members in/at LOWER SIDING as diagrammed .

Drywood termites have damaged wood members in/at the SUBAREA TOP PLATES AND STUDS

Wood destroying fungus infection and damage was noted in/at GARAGE DOOR JAMB as

Locally treat the soil at noted area(s) with a state approved termiticide for the control of

Fumigate the full structure with a state approved fumigant (Vikane\* or Masterfume - Sulfuryl Fluoride) for the eradication of drywood termites. Requires the structure be vacated for 3-4 days. The owner or agent is to prepare for the fumigation as per the list of instructions provided by Lighthouse Termite Control. Remove or cover accessible drywood termite fecal pellets.

Remove and replace the damaged wood member(s) noted above, in currently available widths

Damage appears minor. The wood member is still capable of performing the function for which it was designed. Patch or fill the damaged wood member(s) as necessary. (SECTION I ITEM)

Remove and replace and/or repair the damaged wood member(s) as necessary in currently available widths and grades. Minor damage may be filled, or if removal appears impractical, reinforcement will be done. If any damage is found to extend into inaccessible areas we will issue a supplemental report with findings and recommendations with additional costs. (SECTION I

Replace the fungus infected and damaged component(s) noted above with new material, in
