BPG Inspection, LLC

**6364 Caminito Luisito
San Diego CA 92111**

Client(s): Flores
Inspection Date: 5/1/2022
Inspector: Mark Heckl ,

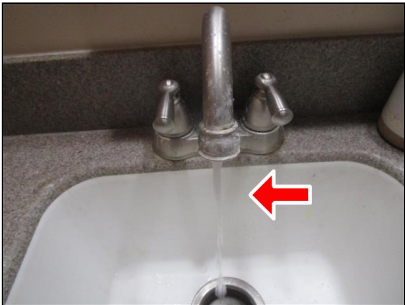
Item 2 - Item 1 (Picture)

The water volume at some of the fixtures drops noticeably when multiple fixtures are operated simultaneously at the bathroom. A technician should evaluate and repair as needed.

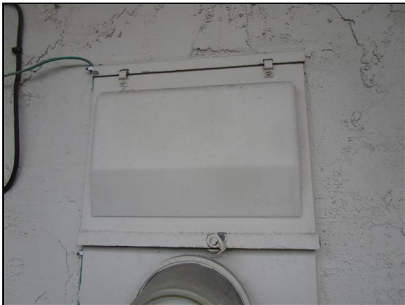
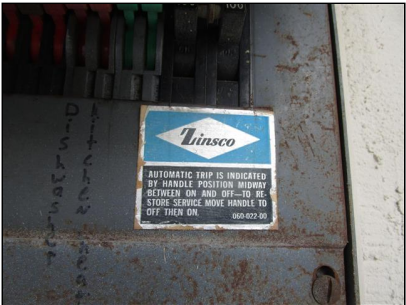
The main distribution panel was manufactured by Zinsco. Zinsco panels and circuit breakers have not been manufactured for some time, and some higher-rated Zinsco circuit breakers have been known to fail to trip at their rated amperage. Breakers that do not trip are a fire hazard. We recommend that the panel be evaluated by a qualified electrician to determine if upgrading the panel is warranted.

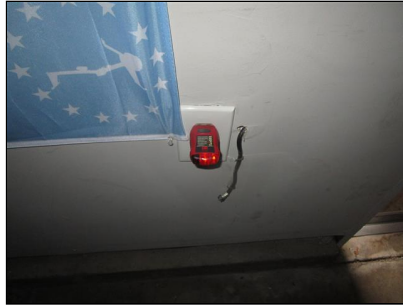
Item 4 - Item 1 (Picture)

- 4 We recommend upgrading by installing GFCI receptacles in all locations required by present standards. This includes ☒ locations in bathrooms, garages, exteriors, basements and crawl spaces, wet bars, kitchens and laundry. They are also commonly utilized for equipment such as sump pumps, whirlpools, spas and pool equipment. GFCI's have two different forms: receptacles with test/reset buttons, and panel breakers, and either form is effective in protecting appropriate outlets or fixtures. (garage)
Consider upgrading unprotected receptacles in areas where GFCI protection is presently required. A qualified electrician should do the work.

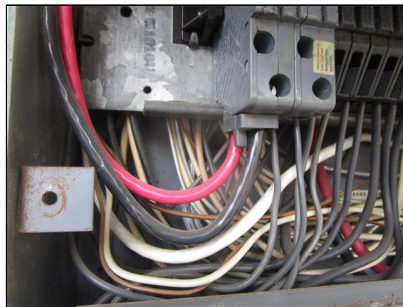
Item 5 - Item 1 (Picture)

- 5 Aluminum wire is installed on 120 VAC branch electrical circuits in the subject house. These single strand, branch circuit ☒ aluminum wires were used widely in houses during the mid 1960s and 1970s. According to the U.S. Consumer Product Safety Commission, problems due to expansion can cause overheating at connections between the wire and devices (switches and outlets) or at splices, which has resulted in fires. For further information on aluminum wiring contact the U.S. Consumer Product Safety Commission via the Internet at <http://www.cpsc.gov/> . It is recommended that the electrical system be evaluated by a licensed electrician.

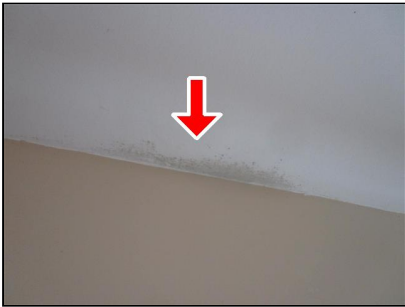
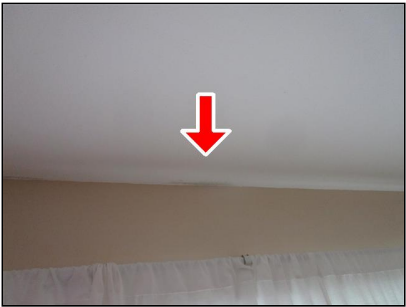
- 6 Water stain/damage is present in the master bedroom ceiling. The source of the leak should be identified and necessary ☒ repairs performed before any attempt is made to restore surface appearance. A technician should repair as needed.

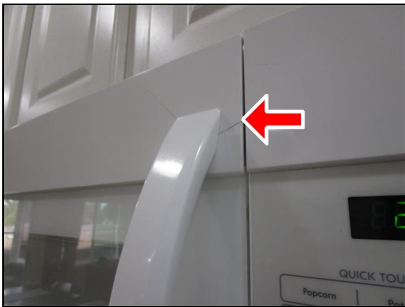
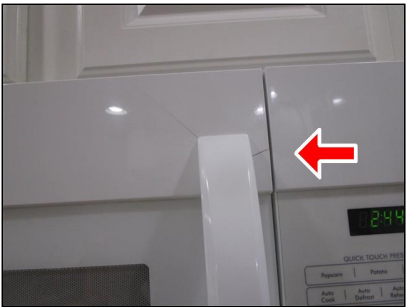
The microwave oven door is damaged. A qualified technician should repair or replace as needed.

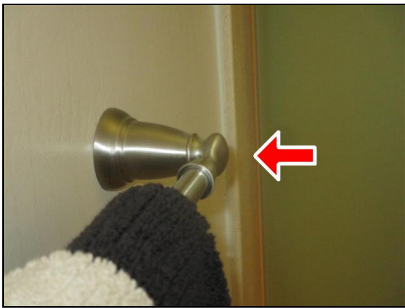
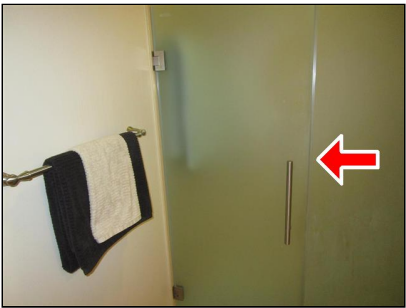
The shower enclosure door at the downstairs guest bathroom shower/tub hits the towel rack. The glass door could be broken. A qualified technician should repair or replace the enclosure as needed.

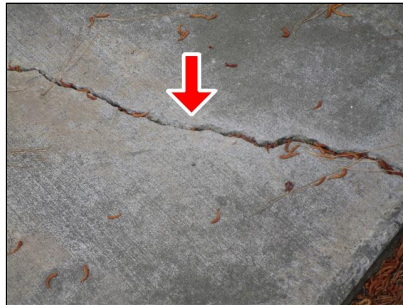
Item 4 - Item 1 (Picture)

- 4 The patio has cracks. The damaged areas should be evaluated and repaired as needed.

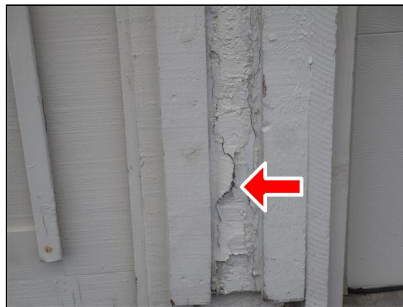
Item 5 - Item 1 (Picture)

- 5 Sections of the stucco at the front of the building are deteriorated.
- A qualified plastering technician should evaluate the stucco and make repairs or modifications as necessary.

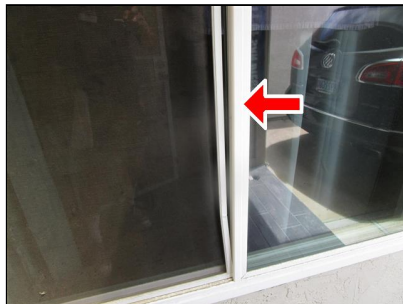
Item 6 - Item 1 (Picture)

- 6 A window screen is damaged at the front entry. All window screens should be repaired or replaced as necessary.

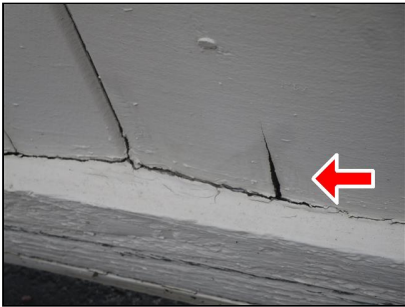
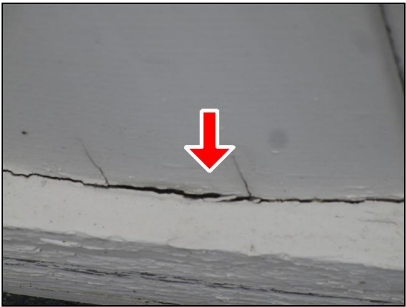
- 7 The sliding gate at the front of the property is damaged and deteriorated.
- The gate should be repaired or replaced as needed.

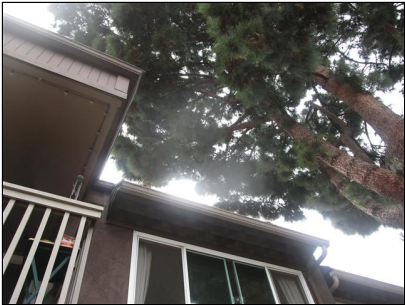
Item 8 - Item 1 (Picture)

Branches from the surrounding trees are overhanging the roof, or are in contact with the roof surface. This can provide a route onto the roof and into the attic for pests. Nearby trees should be kept pruned.

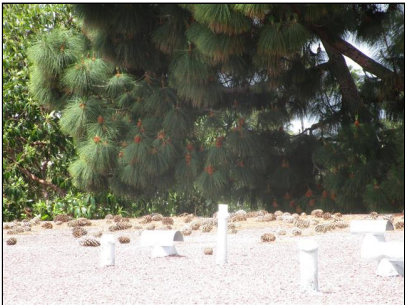
Item 9 - Item 1 (Picture)

There is an accumulation of vegetation on the roof. This can promote deterioration of the roofing materials. Removal of the vegetation is recommended.

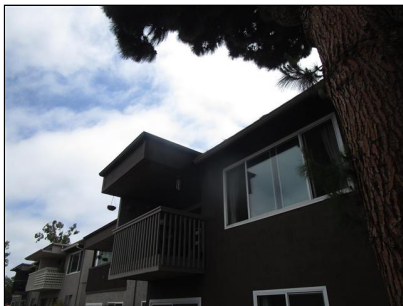
Item 10 - Item 1 (Picture)

The roof over this building is a common area element. It was not inspected.
- We strongly suggest that you consult with the Owner's Association regarding financial reserves and maintenance schedules for all common area elements.

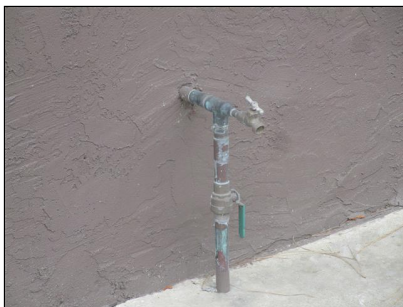
Item 13 - Item 1 (Picture)

- ☒ 13 The main water shutoff valve is located at the rear of the building. We note the type of shutoff valve (gate / ball valve) and its location only. Testing the valve to determine if it functions and shuts off all of the water to the house is outside the scope of an inspection.

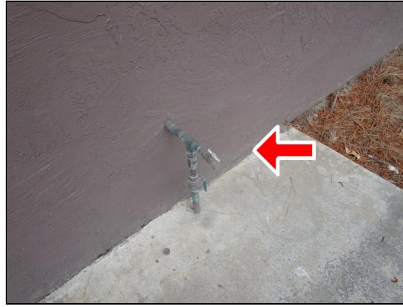
Item 15 - Item 1 (Picture)

- ☒ 15 Backflow prevention devices are now required on exterior hose bibbs to prevent contamination of the domestic water supply. These devices are inexpensive and available at most hardware stores. Consider upgrading the hose bibbs by installing backflow devices.

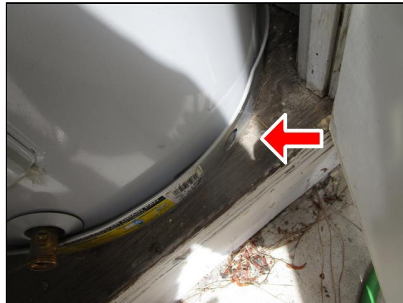
Item 18 - Item 1 (Picture)

- 18 There is no exterior routed catch pan drain installed at the water heater. A pan with an exterior routed drain is required by some jurisdictions when the appliance is located inside the foundation foot print of the structure. If the water heater leaks, the water will flood the floor or crawlspace. Consider installing a properly routed drain pipe.

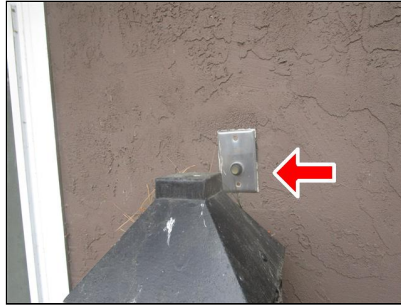
Item 20 - Item 1 (Picture)

- 20 One or more light fixtures on the exterior of the structure is controlled by a sensor. The sensors work by motion or photo cells that come on at darkness. Testing of these devices is not within the scope of this inspection. Verification of their function at night is recommended.

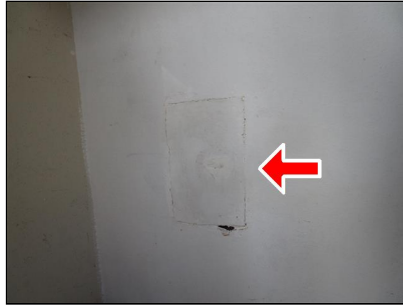
Item 26 - Item 1 (Picture)

- 26 There is evidence of previous patching and/or repairs to the finished ceiling at the water heater closet. Ask the owner what caused the damage and what repairs were done.

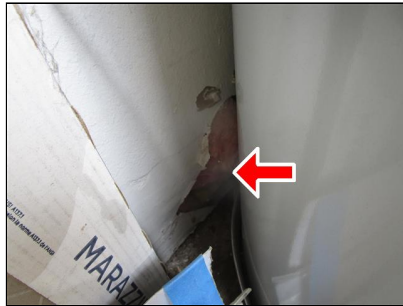
Item 27 - Item 1 (Picture)

- 27 The drywall is damaged at the water heater closet. A qualified technician should make any needed repairs.

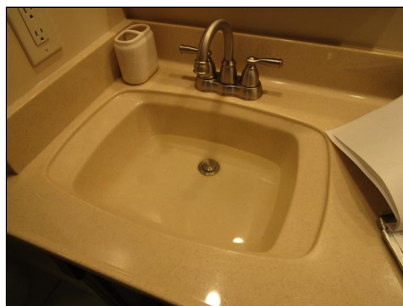
Item 30 - Item 1 (Picture) LEFT BASIN

- 30 The drain at the downstairs guest bathroom sink is slow. The trap on the wash basin should be cleaned or snaked. A qualified technician should do the work.

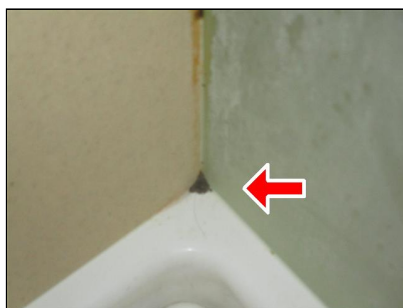
Item 31 - Item 1 (Picture)

Joint caulking in and around the tub/shower at the downstairs guest bathroom is mildewed. Mildewed joints should be scraped clean, treated to eliminate the mildew, and then re-caulked. This should reduce the potential for moisture penetration into the walls.

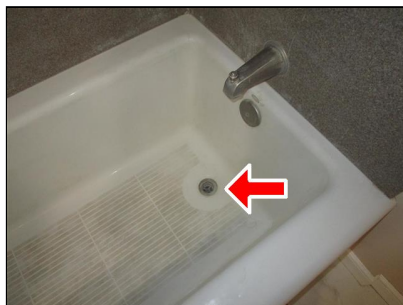
Item 32 - Item 1 (Picture)

The first floor guest bathroom bathtub drain stop and/or related parts are missing. A qualified technician should make repairs or modifications as necessary.

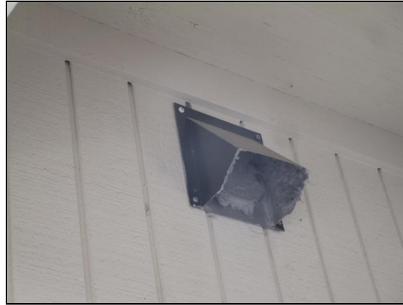
Item 35 - Item 1 (Picture)

- 35** The clothes dryer vent clogged with lint or debris. A qualified technician should make any needed repairs or modifications
