BUILDINGSPECSPRO'S LLC

RESIDENTIAL REPORT BY : JOHN BOWLEY, ACI,CRI, CRMI,

1325 Clove St
San Diego, CA 92106

SEPTEMBER 23, 2022

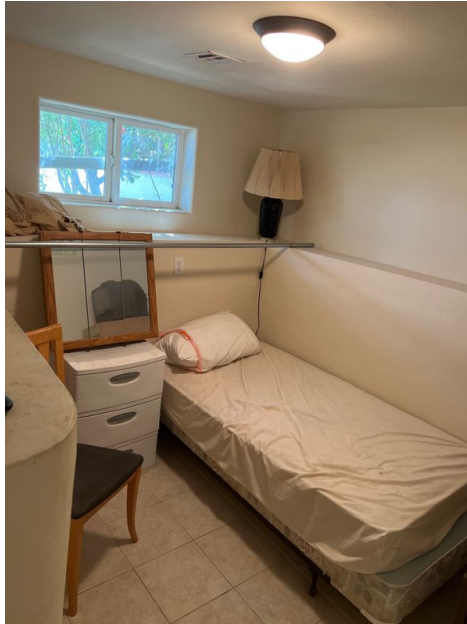
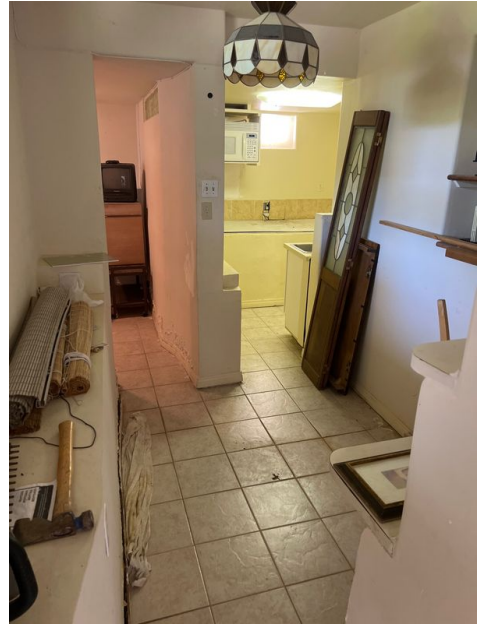
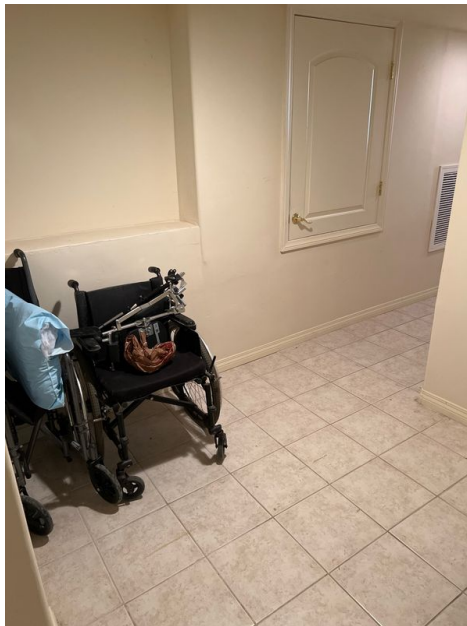
Lower Level Work Space *Crawlspace/ Basement

The lower level area has been modified into the living space that appears to be non-permitted. There are signs of prior moisture intrusion at interior walls. Refer to a licensed contractor for maintenance/ repairs prior to sale.

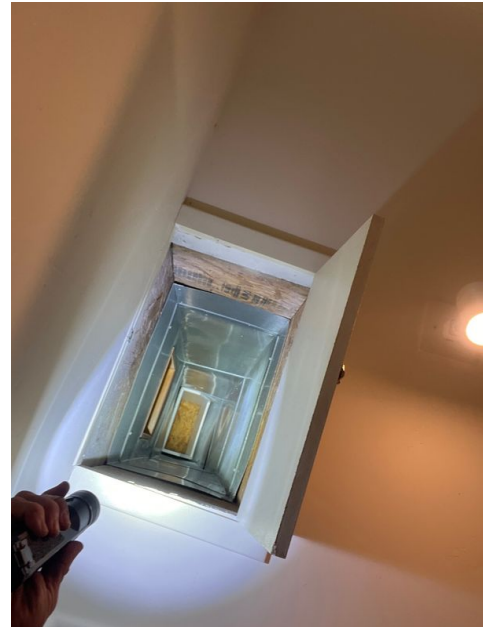
The hallway & Basement/ crawlspace ceiling appear to have unapproved laundry drop shoot which appears non-fire rated. Also the self closing door is missing. Caution fire-hazard. Refer to licensed contractor for repairs.

Recommendation
Contact your builder.

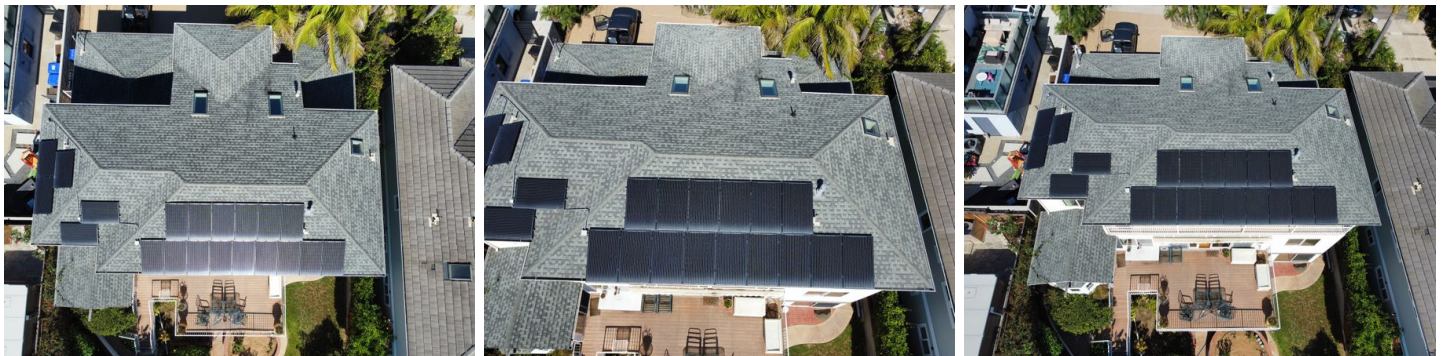
Solar Panels

The roof was not fully visible due to the solar system. Recommend that you have this area inspected by a licensed roof contractor if you are concerned about the condition of the roof beneath the system.

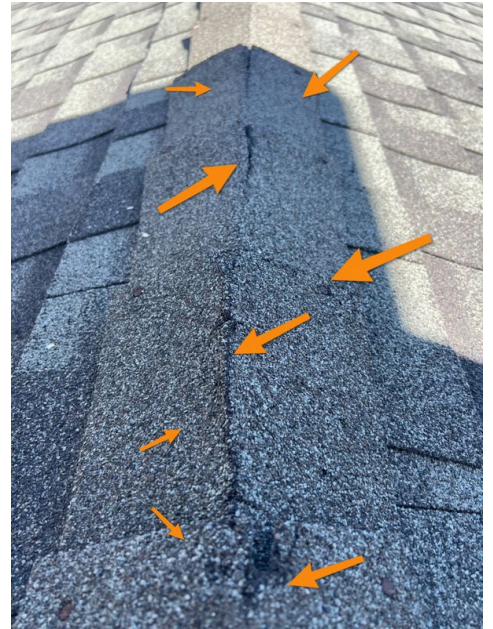
ROOF SHINGLES DAMAGED

Asphalt shingles at ridge line are improperly installed and deteriorating. Observed cracks and shingles on the ridge cap. There are exposed fasteners/ nails. The asphalt shingles are worn and deteriorating in various locations. Caution! Susceptible to moisture intrusion. Refer to licensed roofing contractor for further evaluation and maintenance/ repairs.

Contact a qualified roofing professional.

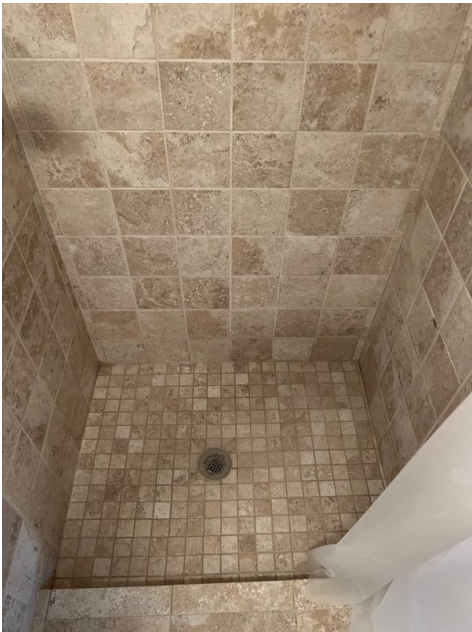
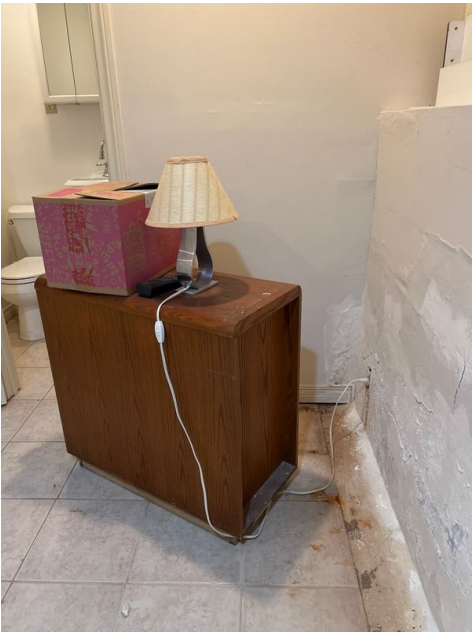
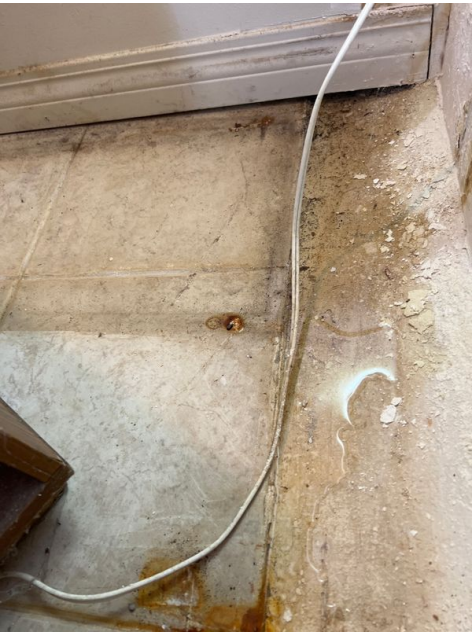
The shower stall and/or shower pan is leaking water into adjacent bedroom floor and side walls. Caution. Conditions are prone to further unforeseen moisture damages at rear wall cavity. Refer to a licensed contractor for further evaluations and cost of repairs.

Recommendation
Contact a qualified general contractor.

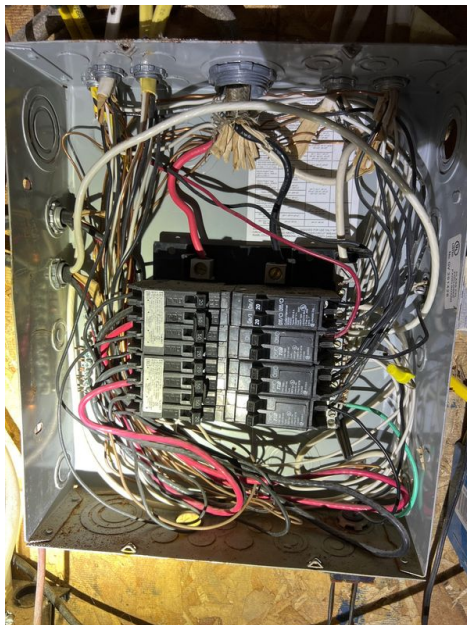
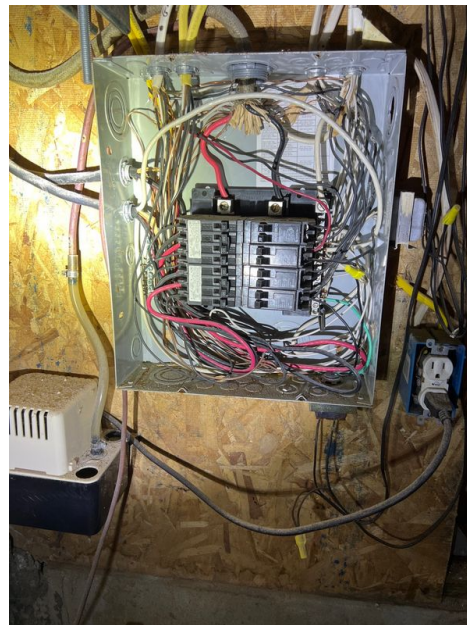
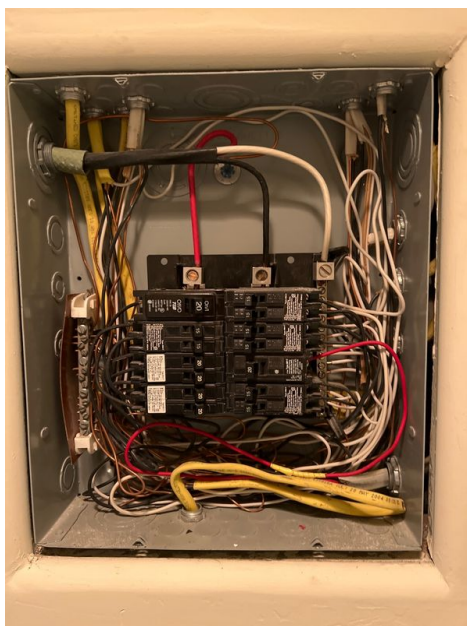
Basement / Crawlspace

View of the electrical sub panel and components" at the time of inspection. Circuit breakers are functional and no burn marks on screw heads or wiring. Monitor conditions.

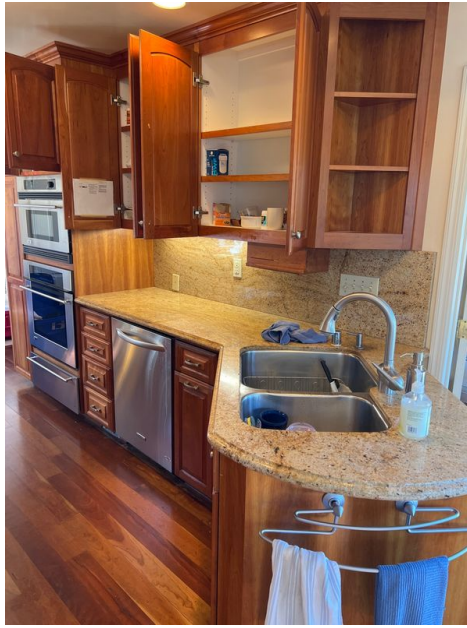
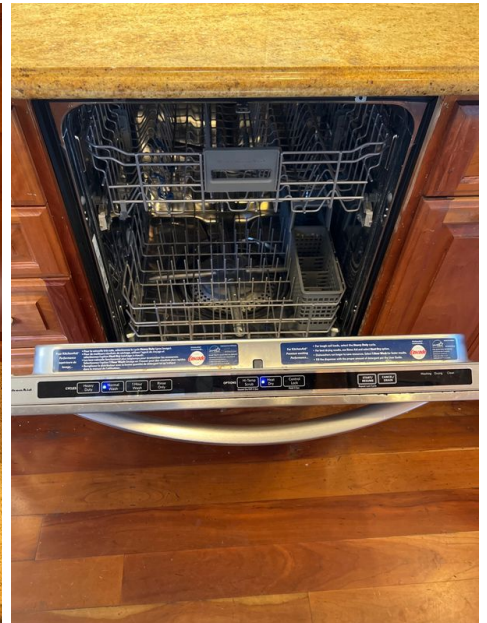
Kitchen

View of the kitchen and its components during the inspection. This kitchen appliance and cabinets are worn, dated and not fully functional. Caution. Seek further evaluations by a licensed contractor prior to sale for cost of replacement.

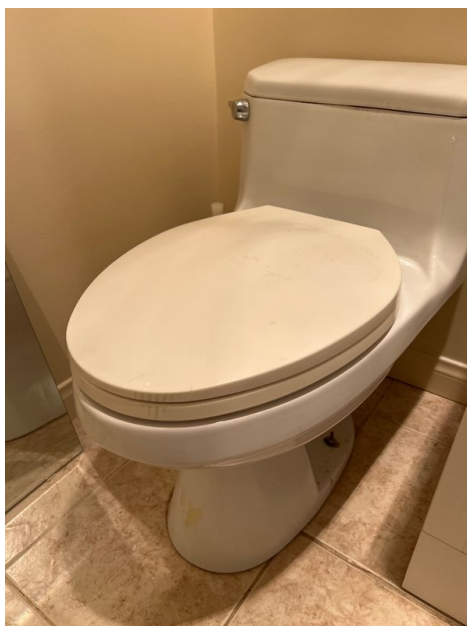
Lower Level Bathroom #1

The *bathroom has been remodeled and/or changed /altered. Therefore, you should request documentation that should include permits and any warranties or guarantees that might be applicable, because we do not approve of, or tacitly endorse, any work that was completed without permits, and latent defects could exist. To be determined by the buyer.

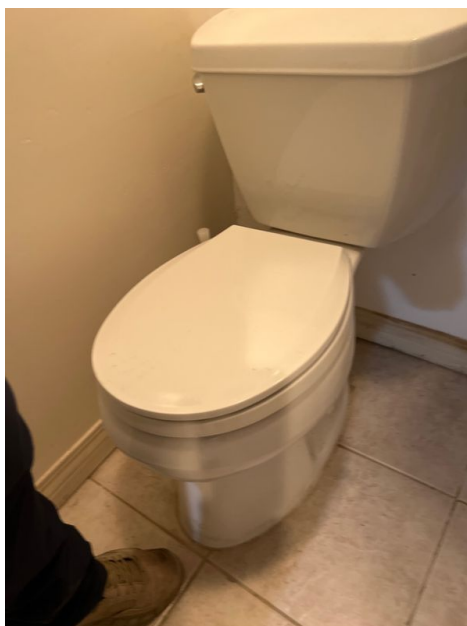
Lower Level Bathroom #2

The *bathroom has been remodeled and/or changed /altered. Therefore, you should request documentation that should include permits and any warranties or guarantees that might be applicable, because we do not approve of, or tacitly endorse, any work that was completed without permits, and latent defects could exist. To be determined by the buyer.

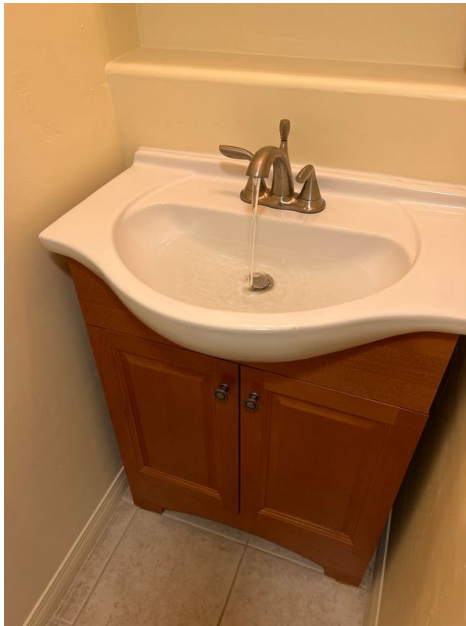
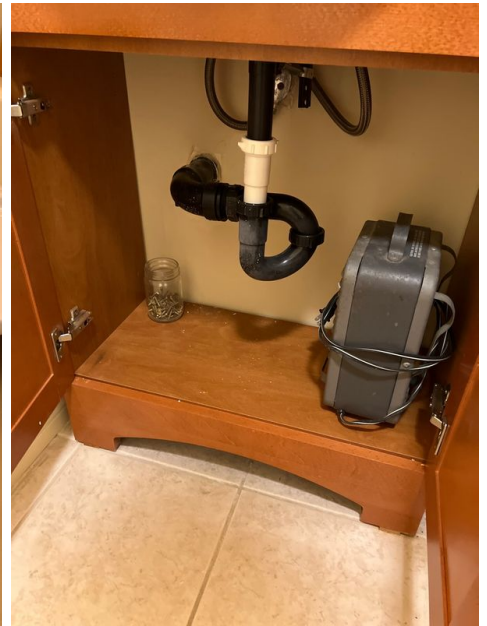
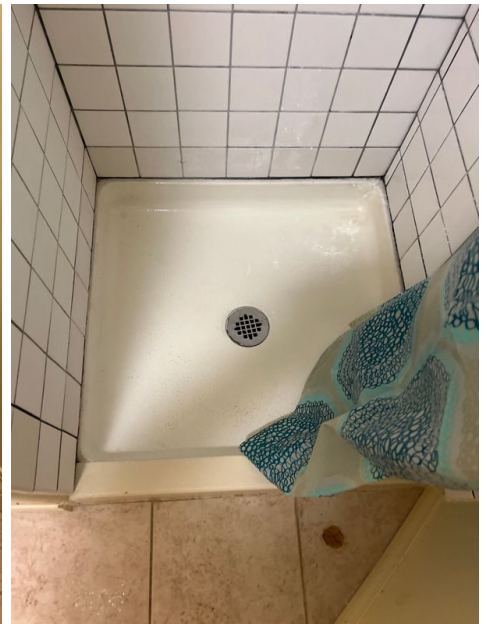
The *bathroom has been remodeled and/or changed /altered. Therefore, you should request documentation that should include permits and any warranties or guarantees that might be applicable, because we do not approve of, or tacitly endorse, any work that was completed without permits, and latent defects could exist. To be determined by the buyer.
