CONFIDENTIAL INSPECTION REPORT

5875 Highplace Drive, San Diego, CA 92120

4/6/2023 1:00 pm

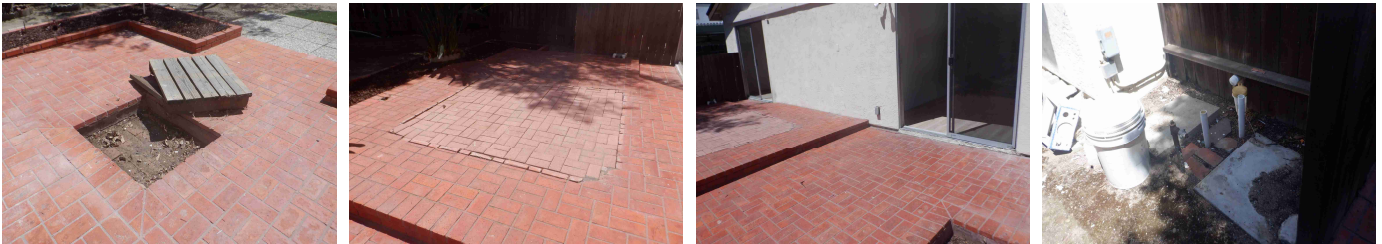
The brick patio needs servicing, i.e.; built-up too high against the house wall, too low by the bedroom slider, uneven surface, some broken bricks, possibly an opening for a fire pit, etc...

It appears there may have been a spa on the patio that should be explained or investigated and the old gas line, timer, and electrical components should be removed by a licensed specialist.

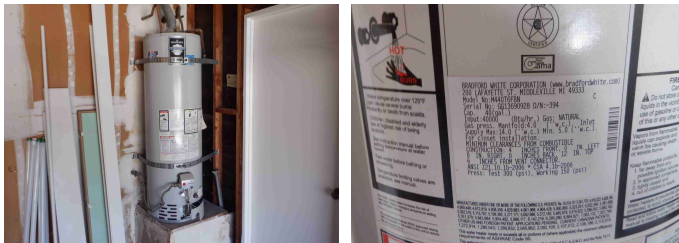
Hot water is provided by a 40 year old, 13 gallon water heater that is located in the garage.

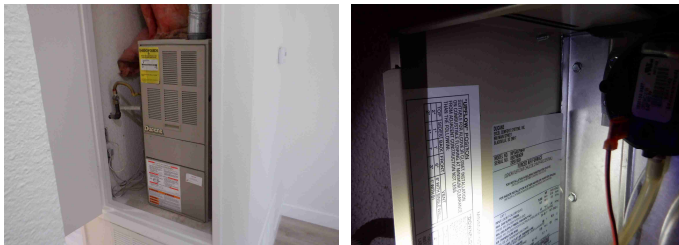
Central heat is provided by a 17 year-old forced-air furnace that is located in a hallway closet.

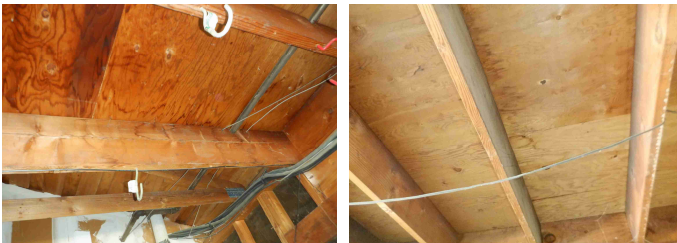
There are moisture stains on the ceiling that should be explained or investigated because they could be evidence of a leak.

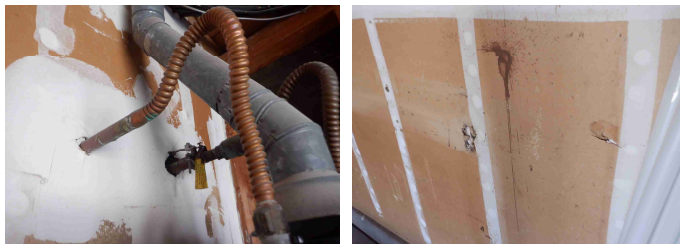
The voids in the garage firewall must be repaired, in order to maintain the necessary firewall separation between the garage and the residence.

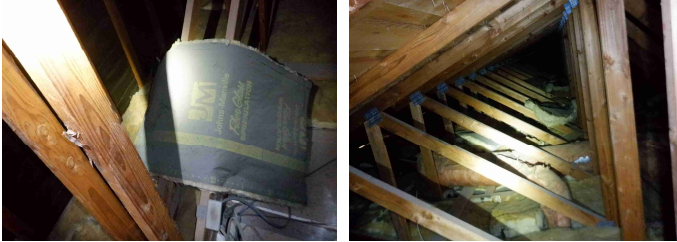
Some of the attic insulation has been displaced and it should be re-installed.
