Inspection Report
1745 South Harvard Boulevard, Los Angeles 90006

Report ID
NXT-229-001696

Inspection Date
June 17, 2021 at 10:00 AM

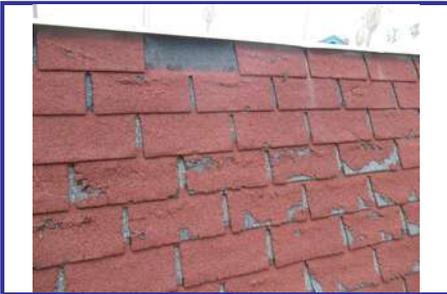
Location: ROOF

2.6.1 Roof with multiple defects (Repair and cert)

The roof had shingles that were damaged or had exposed roofing nails, unsealed nails or other defects in various locations at the time of the inspection. The Inspector recommends sealing of any exposed nails and replacement of any damaged shingles by a qualified roofing contractor to industry standard in order to avoid damage from moisture related issues. After these repairs are made the roof should be certified for five years.

1.1 Damaged shingles

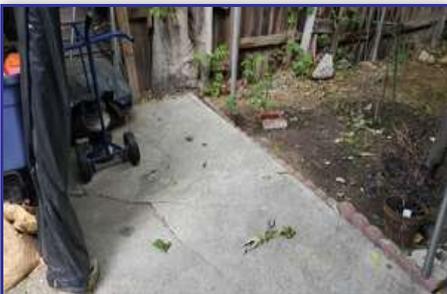
Location: EXT GROUNDS /REAR PATIO

3.1.1 Tree root damage (Walkway/Driveway)

Tree roots have caused movement and damage to area(s) of the walkway/driveway. Removal of the tree or root should be considered and repairs made to the driveway/walkway. The Inspector recommends that the affected area(s) be evaluated, replaced or repaired, as needed, by a professional concrete contractor.

1.1 Heaving (roots)

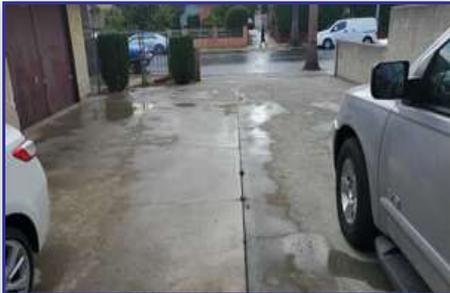
Location: EXT GROUNDS

3.1.2 Cracked Walkway/driveway (Minor Repair)

Minor cracks were noted in the sidewalk/driveway at the time of the inspection. These cracks were less than 1/4 inch. The inspector recommends that a professional contractor seal the cracks with concrete grade sealant periodically to keep moisture from collecting under the slab and cause further damage. If you are considering doing the repair yourself, see the DIY linked video, to assist you in your decision.

2.1 Typical concrete cracks

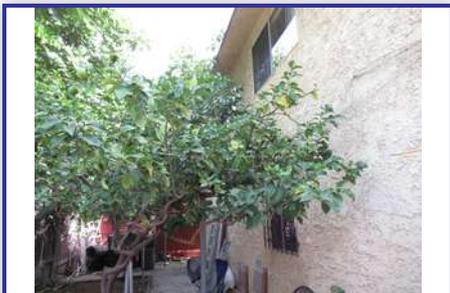
Location: ROOF

There are tree limbs that are in contact with roof, or hanging near roof and should be trimmed back. The inspector recommends that the trees be trimmed, by a professional tree trimming contractor.

1.1 Vegetation near or in contact with structure

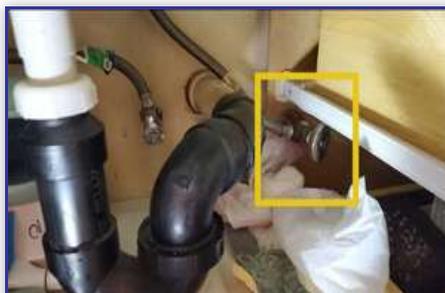
Location: 1745/ BEDROOM 3

10.4.1 WATER SHUT-OFF VALVES INOPERATIVE/RUST/LEAKS/BROKEN

Water shut-off valves under the sink were inoperative/rust/leaking/broken which makes plumbing repairs for the sink difficult to work on. Recommend that water shut-off valves replaced for both cold and hot water lines by a professional plumbing contractor.

1.2 Ceased shutoff

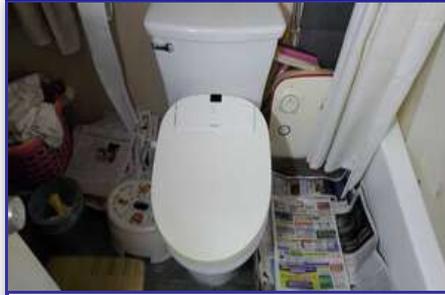
Location: 2ND FLOOR UNIT 1749/HALLWAY BATHROOM

The toilet seat was loose. There are small bolts on the side of the seat that can be tightened or in other cases may need to be replaced.

2.2 Loose toilet

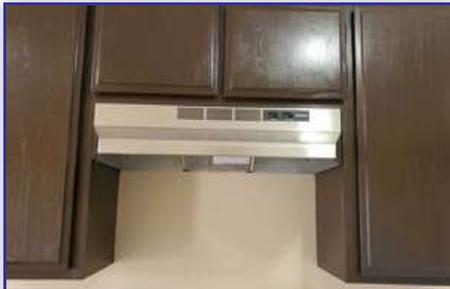
Location: 2ND FLOOR UNIT 1747 /KITCHEN

The range hood light and fan were inoperable at the time of the inspection. We recommend replacing the bulb and then retesting the unit. If it does not respond the both problems will need to be repaired by a professional appliance repair contractor.

1.1 Not responding

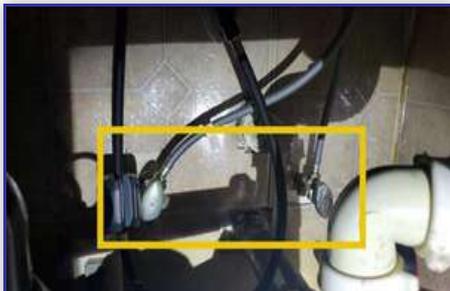
Location: KITCHEN 1745

11.9.1 WATER SHUT-OFF VALVES INOPERATIVE/RUST/LEAKS/BROKEN

Water shut-off valves under the sink were inoperative/rust/leaking/broken which makes plumbing repairs for the sink difficult to work on. Recommend that water shut-off valves be replaced for both cold and hot water lines by a professional plumbing contractor.

1.1 Ceased shutoff valve

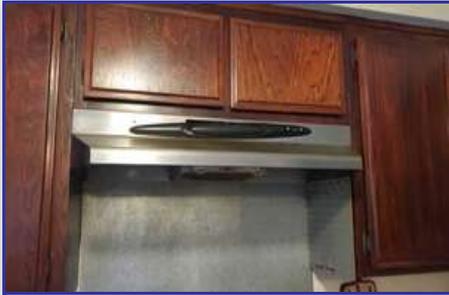
Location: KITCHEN 1745

At the time of inspection, the filters for the kitchen range hood were dirty and needed to be cleaned.

1.1 Needs maintenance (range)

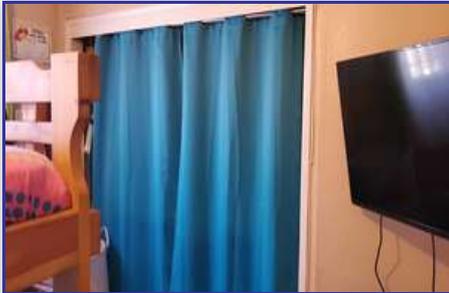
Location: 1745/ BEDROOM 2

12.7.1 Closet Doors Missing

Closet doors were missing/not installed in one or more locations. Recommend installing as necessary.

1.1 Missing closet door

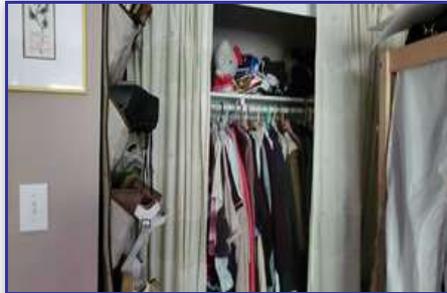
Location: 2ND FLOOR UNIT 1749 /BEDROOM 1

1.2 Missing closet door

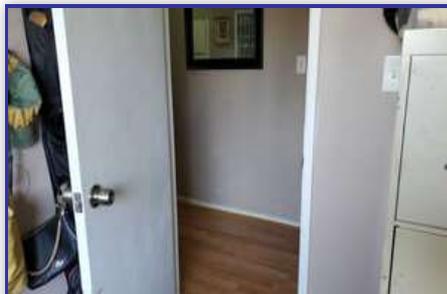
Location: 2ND FLOOR UNIT 1749 /BEDROOM 2

One or more doors wouldn't latch or were difficult to latch. Currently the door handle does not need to be turned for the door to be opened. Recommend that a qualified person repair as necessary. For example, by adjusting latch plates or locksets.

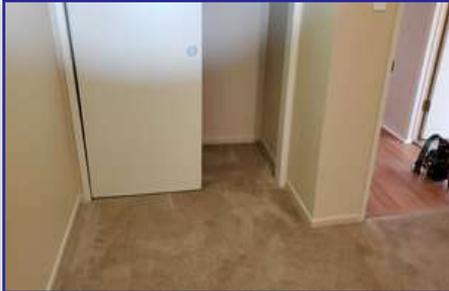
Location: 2ND FLOOR UNIT 1747 /BEDROOMS

The door guides servicing the closet in one or more rooms were damaged, missing, or installed incorrectly at the time of the inspection. This leaves the doors where they swing in and out and can fall off of the track. The inspector recommends that they are repaired or replaced as needed.

3.1 Missing lower guides

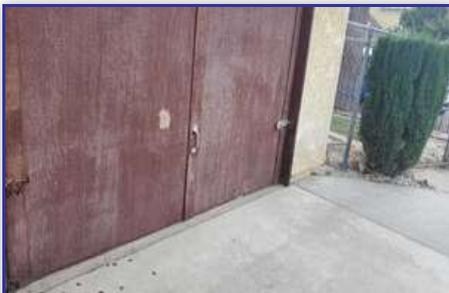
Location: GARAGES

2. NO PHOTO SENSOR INSTALLED

No photo sensors were installed servicing the garage door. We recommend that they be installed.

1.1 One locked

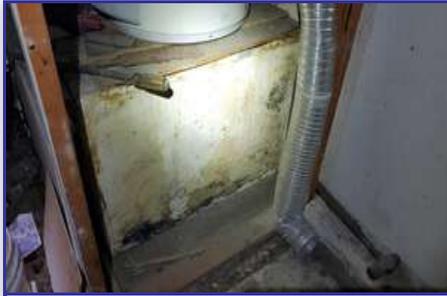
Location: GARAGES

1.2 Microbial growth

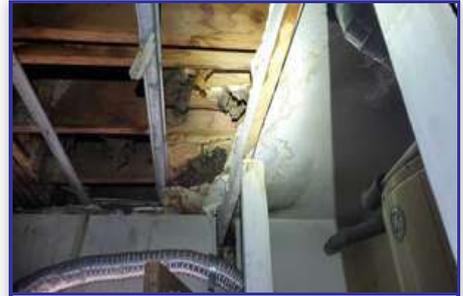
Location: GARAGES

1.3 Microbial growth

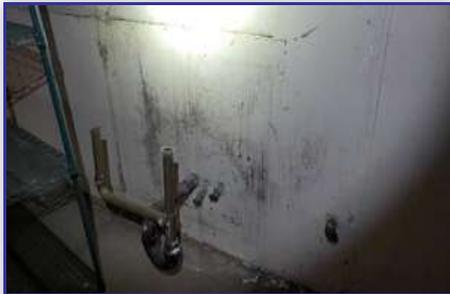
Location: GARAGES

1.4 Microbial growth

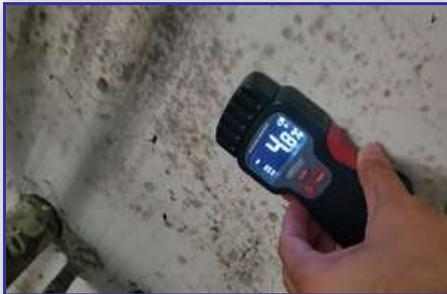
Location: GARAGES

1.5 Microbial growth

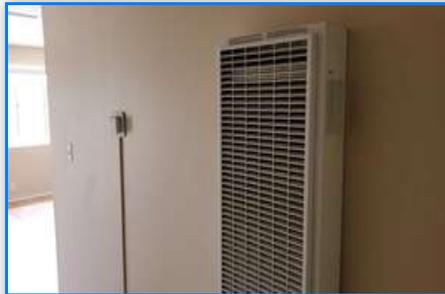
Location: 2ND FLOOR UNIT 1747 /FURNACE

1.2 Service all units

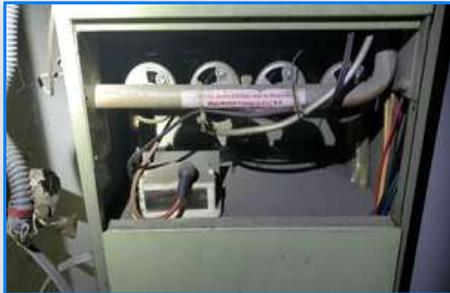
Location: 1745/ FURNACE

The furnace was at or past its recommended lifespan. It was visibly old and dirty and should be serviced at the least. The Inspector recommends that the furnace is evaluated, serviced or replaced, as needed, by a professional HVAC contractor, to ensure the best possible working condition.

4.1 Service and certify unit (past life expectancy)

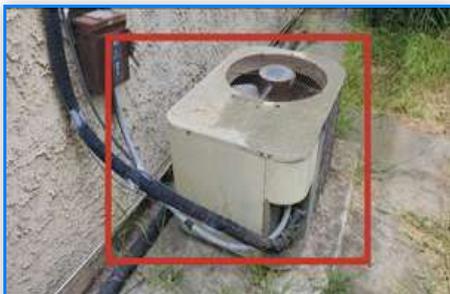
Location: EXT BUILDING/ AC

2. INOPERABLE A/C

At the time of inspection, the air-conditioning system was old and inoperable. The Inspector recommends that the affected area(s) be evaluated, replaced or repaired, as needed, by a professional contractor.

1.1 Not operating

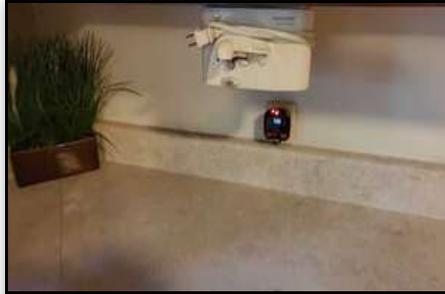
Location: KITCHEN

Kitchen electrical outlets were operable at the time of the inspection but no Ground Fault Circuit Interrupter (GFCI) protection were installed. GFCI protection should be installed for outlets within 6 feet of plumbing fixtures or on kitchen counters, as they were required in kitchens starting in 1987 by the NEC. Recommended this be done by a professional electrical contractor.

1.2 Missing gfci (update)

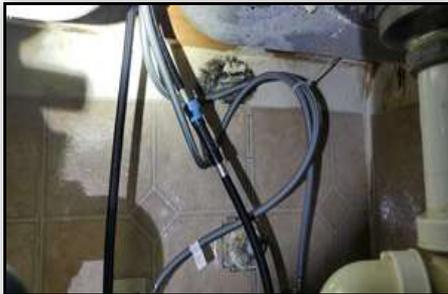
Location: KITCHEN 1745

Microbial Growth Matter is a type of fungus that consists of small organisms found almost everywhere. ... In small amounts, mold spores are usually harmless, but when they land on a damp spot in your home, they can start to grow. When mold is growing on a surface, spores can be released into the air where they can be easily inhaled. We recommend samples taken for any type of active contamination.

1.1 Microbial growth

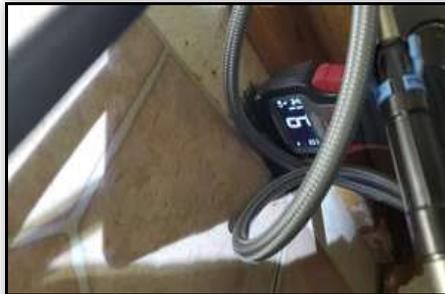
Location: KITCHEN 1745

1.2 Moisture present

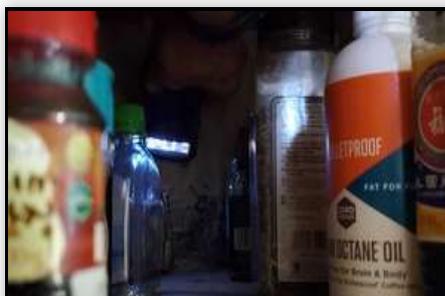
Location: 2ND FLOOR UNIT 1749 KITCHEN

1.5 Moisture present over 17%

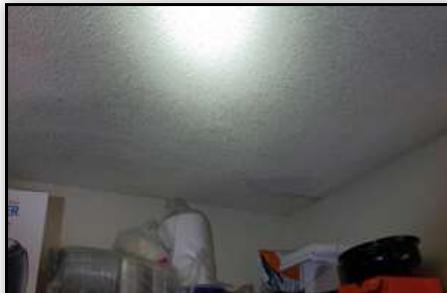
Location: 2ND FLOOR UNIT
1749/LIVINGROOM

1.2 Microbial growth /roof water stains

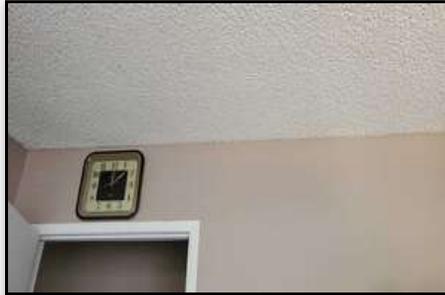
Location: 2ND FLOOR UNIT 1749 /BEDROOM 2

2.2 Missing smoke detector

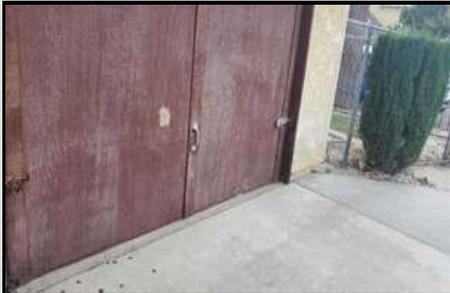
Location: GARAGES

2. NO PHOTO SENSOR INSTALLED

No photo sensors were installed servicing the garage door. We recommend that they be installed.

1.1 One locked

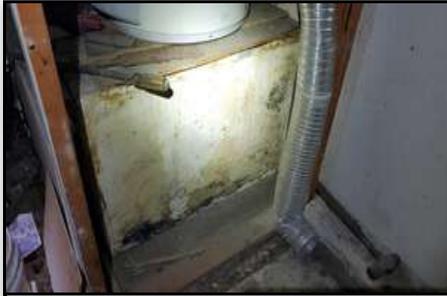
Location: GARAGES

1.2 Microbial growth

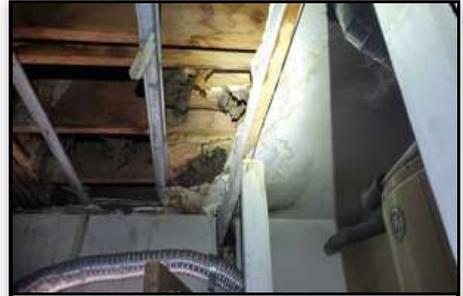
Location: GARAGES

1.3 Microbial growth

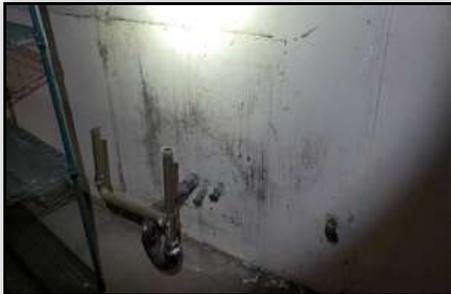
Location: GARAGES

1.4 Microbial growth

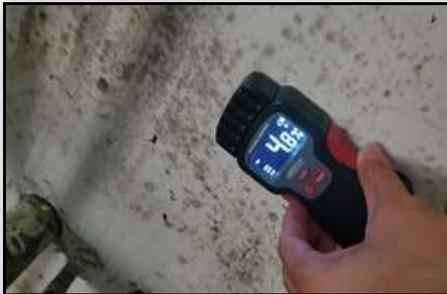
Location: GARAGES

1.5 Microbial growth

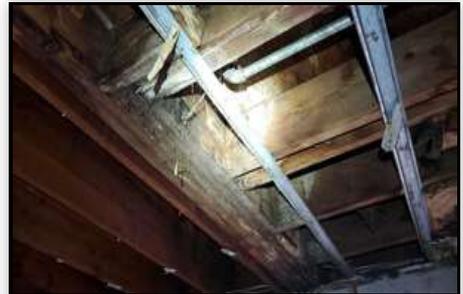
Location: GARAGES

1.6 Wood damage

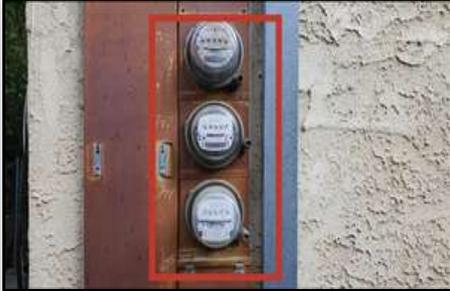
Location: EXT BUILDING

The seal for the metal ring securing the electric meter to its base is missing or broken. The utility company installs these seals. Recommend consulting with the property owner(s) about this and/or contacting the utility company to have one reinstalled.

1.1 Missing seal lock

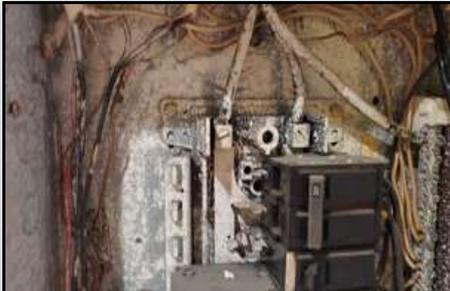
Location: 1745/ HALLWAY/ DISTRIBUTION PANEL

There was paint and other materials in the panel. We recommend that the panel be cleaned and and repaired as needed.

1.1 Overspray in panel

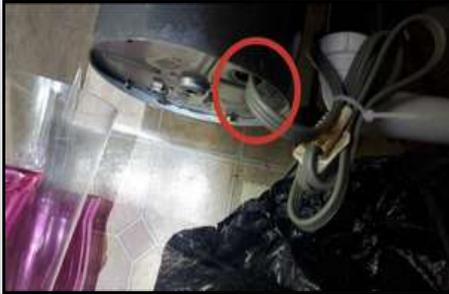
Location: KITCHEN 1745

The opening for the electric power cord to exit the bottom or side of a garbage disposal housing has sharp edges. The concern is that these sharp edges, due to use, vibration, reaching for items under the sink, or over time, may cut into the electric cord and cause a short or spark.

1.1 Missing clamp

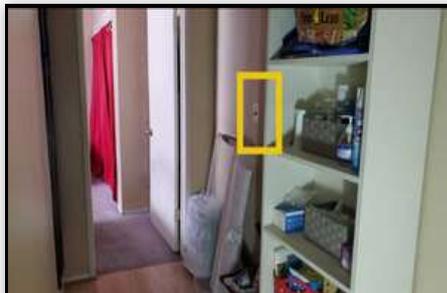
Location: 1745/ FURNACE

The light fixture in one or more long hallways or room that can be entered from two locations was controlled by a single switch at one end. This is a safety hazard due to inadequate lighting. The light should be controlled by 3-way switches at each end of the hallway / room so it can be easily operated at both ends. Recommend that a qualified electrician repair per standard building practices.

1.2 Improper connection 3 way

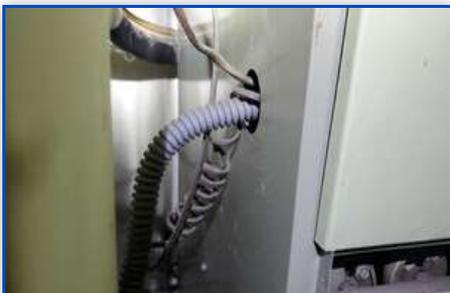
Location: 1745/ FURNACE

The gas-fired furnace flex connector was installed through the cabinet. This should be replaced with an approved hard pipe connection extended outside of the furnace cabinet that the flex connector connects to, and cannot be damaged sharp edges of the unit. All work should be performed by a professional plumbing contractor.

3.1 Flex line through cabinet

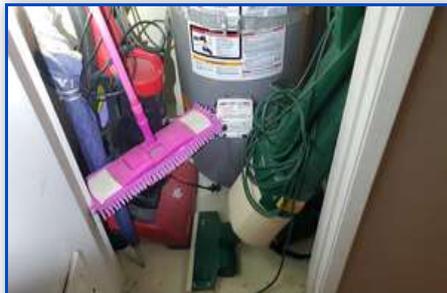
Location: 2ND FLOOR UNIT 1749/WATER HEATER

A water heater is installed with no drip pan or drain. We recommend having corrections made by a professional plumbing contractor.

2.2 No drip pan

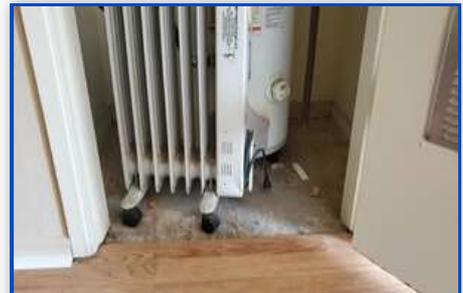
Location: 2ND FLOOR UNIT 1747 /WATER HEATER

2.3 No pan

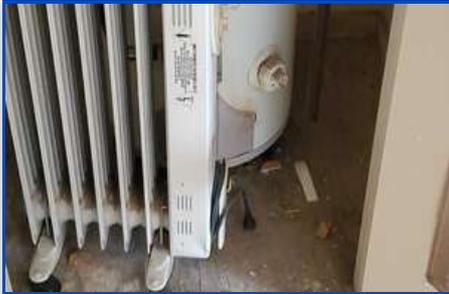
Location: 2ND FLOOR UNIT 1747 /WATER HEATER

There were scorch marks above the burner chamber indicating flame roll out. This unit needs to be serviced as soon as possible.

3.1 Scorched marks

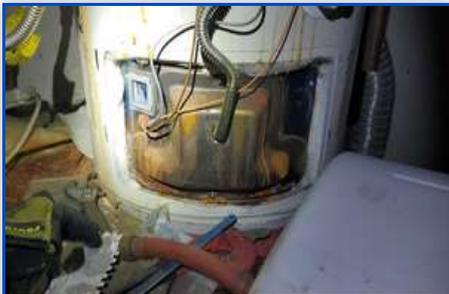
Location: 1745 WATER HEATER/GARAGE

Corrosion was found in one or more areas on the water heater. The water heater may be failing. A qualified plumbing contractor should evaluate and replace or repair water heater if necessary.

5.1 Corrosion on tank

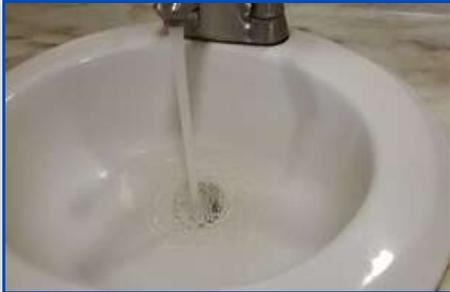
Location: 1745/ BEDROOM 1/BATHROOM

The water in the toilet tanks, sinks and/or tub were noted to have water discoloration. The discoloration may indicate a possible defect in the water supply system, distribution piping or water source. Have a licensed plumbing contractor further evaluate the entire system and make any additional repairs as needed. If the home is not or has not been tested for bacteria or contamination it is also recommended.

1.1 Discolored water

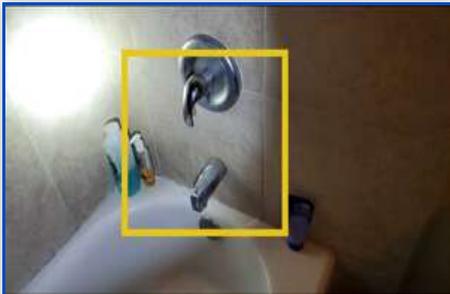
Location: 1745/ HALLWAY BATHROOM

The faucet handles are stripped (spin all the way around). If the handles are not placed in the exact location the water will continue to drip. Contact a licensed plumber for review and make any additional repairs as needed.

1.1 Stripped/ won't fully shut

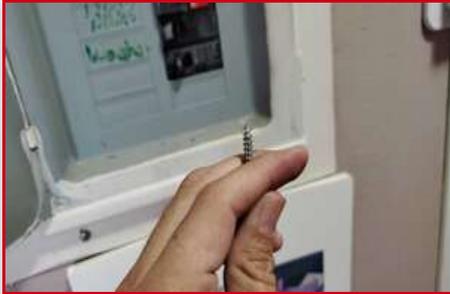
Location: 2ND FLOOR UNIT
1749/DISTRIBUTION PANEL

The service panel used one or more pointed and/or too-long screws which can come into contact with wiring inside the panel than stock screws from the manufacturer and damage wiring insulation. These screws should be replaced with non-pointed screws.

2.1 Pointed screws

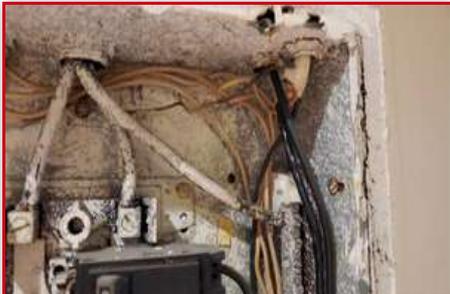
Location: 1745/ HALLWAY/ DISTRIBUTION
PANEL

There were red or black wires in the service panel that were connected to the neutral bus bar, that were not re-identified with red or black tape. We recommend that the affected wires be evaluated and traced as needed to identify if the wire is hot or not. Either re-identify or properly terminate the wire as needed by a professional electrical contractor.

1.1 Re identify wiring

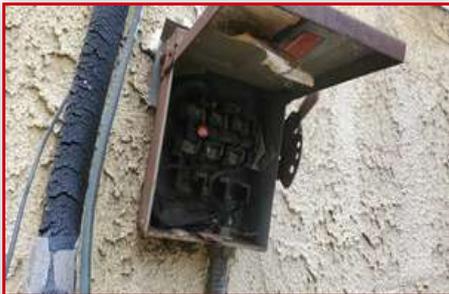
Location: EXT BUILDING

One or more cover plates for junction box(es) were loose, missing and/or broken. These plates are intended to contain fire and prevent electric shock from occurring due to exposed wires. Recommend that a qualified person install cover plates where necessary.

1.1 Missing front cover

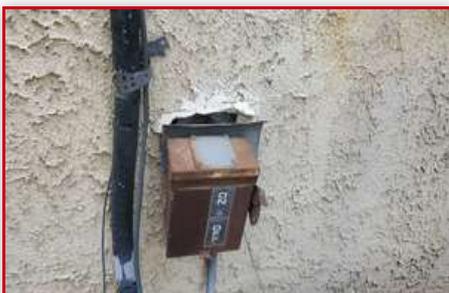
Location: EXT BUILDING

One or more electric receptacles and/or the boxes in which they were installed were loose and/or not securely anchored. Wire conductors can be damaged due to repeated movement and/or tension on wires, or insulation can be damaged. This is a shock and fire hazard. Recommend that a qualified electrician repair as necessary.

2.1 Loose fuse box

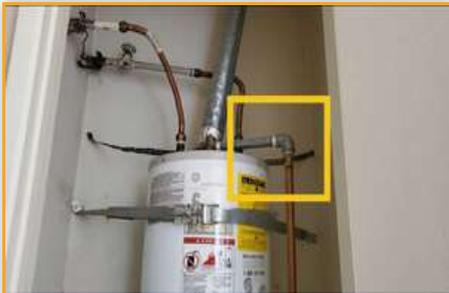
Location: 2ND FLOOR UNIT 1747 /WATER HEATER

The TPR discharge pipe was threaded on the end leaving it easy to connect other lines to it such as a hose or other fittings. This is not to industry standard and can be unsafe. The inspector recommend that the discharge pipe be repaired to industry standard with the proper material by a professional plumbing contractor.

4.1 Threaded parts

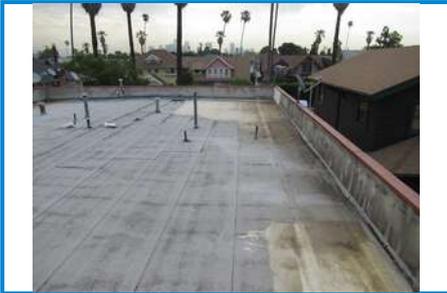
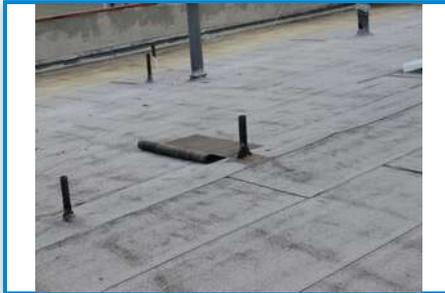
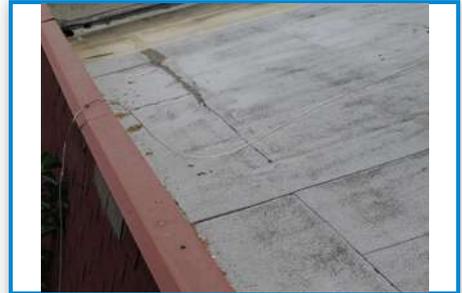
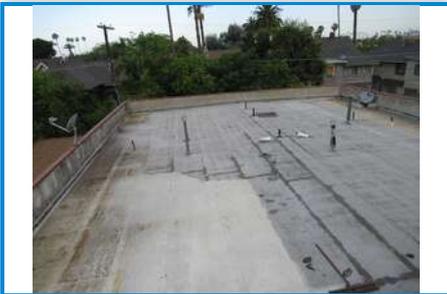
Evidence of ponding were noted on the roof. This creates Chance of water damage to structure, further evaluation and repair by a licensed roofing contractor.

1.1 Ponding /temporary patch work

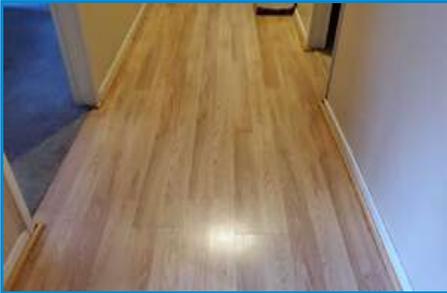
Location: 1745/ HALLWAY BATHROOM

one or more areas of the home's living space has floors with significant slope . Floors should not slope more than 1/2" at 20' feet, we recommend that the area be evaluated and repaired by a licensed contractor.

3.1 Sloped floors

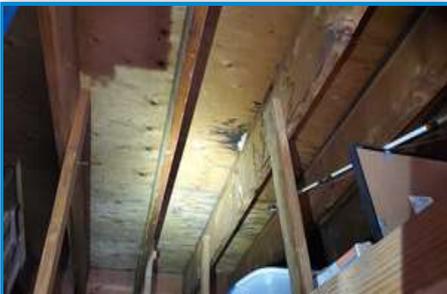
Location: GARAGES

Microbial like growth or musty odor was found at one or more locations. We did not test the substance through a lab so proper verification was not made. Growth is normally cause by moist conditions, plumbing or Roof/exterior moisture issues, and issues with improper ventilation. We recommend that after the areas are verified as mould, mitigation, for mold/moisture should be done by a professional contractor.

1.1 Water stains roof sheathing

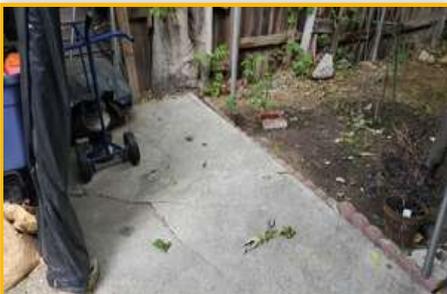
Location: EXT GROUNDS /REAR PATIO

Tree roots have caused movement and damage to area(s) of the walkway/driveway. Removal of the tree or root should be considered and repairs made to the driveway/walkway. The Inspector recommends that the affected area(s) be evaluated, replaced or repaired, as needed, by a professional concrete contractor.

1.1 Heaving (roots)

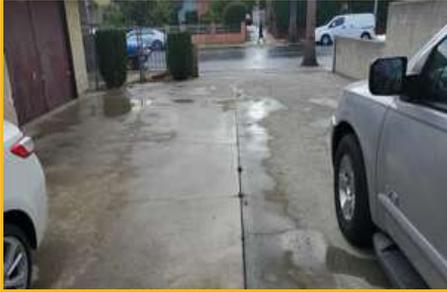
Location: EXT GROUNDS

Minor cracks were noted in the sidewalk/driveway at the time of the inspection. These cracks were less than 1/4 inch. The inspector recommends that a professional contractor seal the cracks with concrete grade sealant periodically to keep moisture from collecting under the slab and cause further damage. If you are considering doing the repair yourself, see the DIY linked video, to assist you in your decision.

2.1 Typical concrete cracks

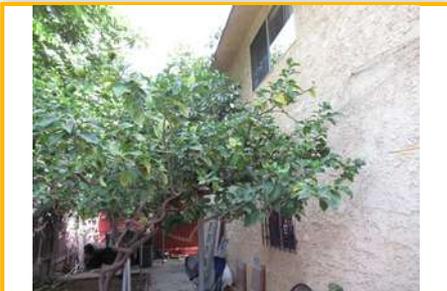
Location: ROOF

There are tree limbs that are in contact with roof, or hanging near roof and should be trimmed back. The inspector recommends that the trees be trimmed, by a professional tree trimming contractor.

1.1 Vegetation near or in contact with structure

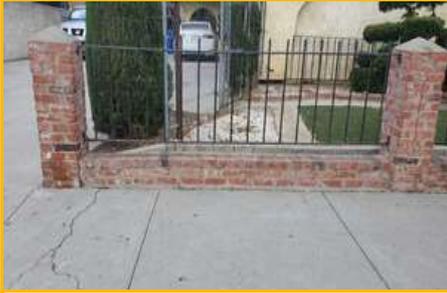
Location: FRONT FENCE

Areas of the fencing are deteriorated and damaged. Fencing should be repaired as needed.

1.1 Damaged

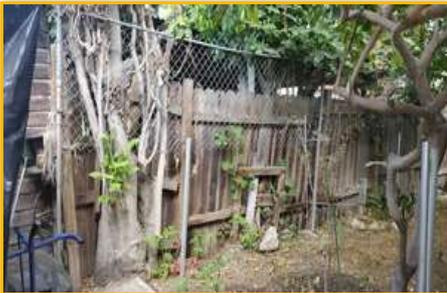
Location: EXT GROUNDS /REAR PATIO

The chain link fence was disconnect, loose or damaged in areas. The inspector recommends repair or replacement of the fence as needed by a professional fence repair company.

2.1 Damaged fencing

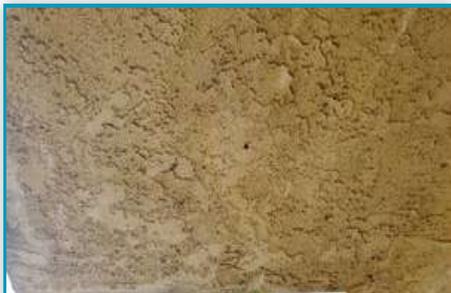
Location: EXT BUILDING

One or more minor hairline cracks were found in the stucco or wall areas. It is unknown the age of these cracks. At the time of inspection nothing out of the ordinary of normalized cracking was noticed. Recommend caulking and painting these areas, along with monitoring for future movement/widening. Stucco cracks over framing can allow moisture penetration behind wall areas and can potentially damage sheathing/framing. Note that areas concealed behind walls are not able to be evaluated without invasive testing and cannot be evaluated.

1.1 Typical stucco cracks

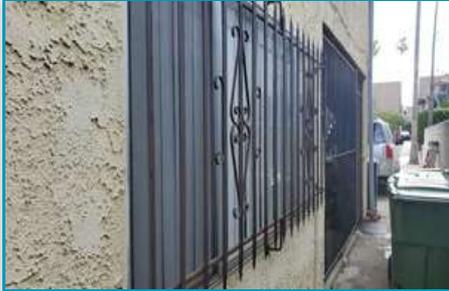
Location: EXT BUILDING

Fixed security bars around windows, does not allow security bars to open. This poses a fire safety concern as it prevents exit from the home in case of fire. The Inspector recommends that the security bars be evaluated, replaced or repaired, as needed, by a professional contractor, to allow opening bars without special tools or keys.

1.1 Security bars (no quick release)

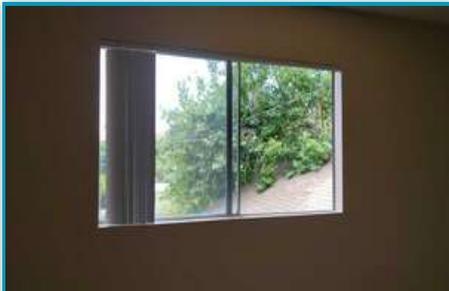
Location: 2ND FLOOR UNIT 1747 /BEDROOM 1

At the time of inspection, one or more exterior window screens were missing or damaged. The Inspector recommends that the damaged screens be evaluated, replaced or repaired, as needed, by a professional contractor, and missing screens replaced. Should you consider doing the repair yourself, see the DIY linked video, to assist you in your decision.

2.1 Missing screen

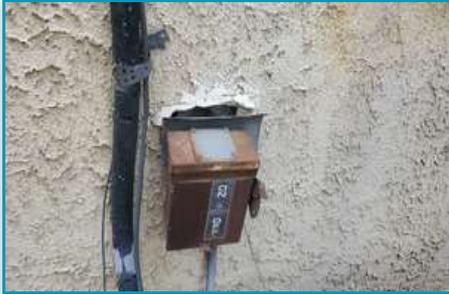
Location: EXT BUILDING

One or more electric receptacles and/or the boxes in which they were installed were loose and/or not securely anchored. Wire conductors can be damaged due to repeated movement and/or tension on wires, or insulation can be damaged. This is a shock and fire hazard. Recommend that a qualified electrician repair as necessary.

2.1 Loose fuse box

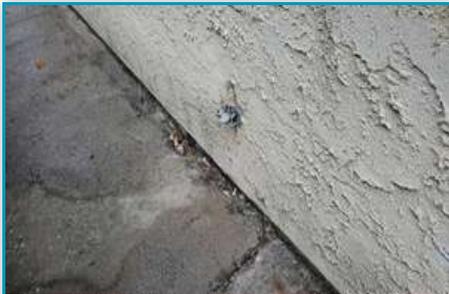
Location: EXT BUILDING

At the time of inspection, the hose bib handles are broken and/or missing. The Inspector recommends that the affected area(s) be evaluated, replaced or repaired, as needed, by a professional contractor.

2.1 Broken faucet

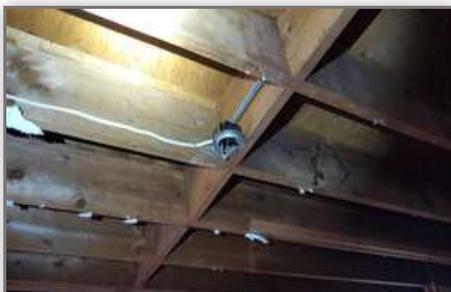
Location: GARAGES

Cover plate(s) are missing from electric boxes, in the garage. They are intended to contain fire and prevent electric shock from exposed wires. This is a safety concern due to the risk of fire and shock. Cover plates should be installed where missing.

1.1 Missing light fixture

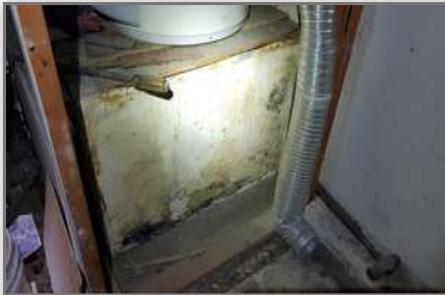
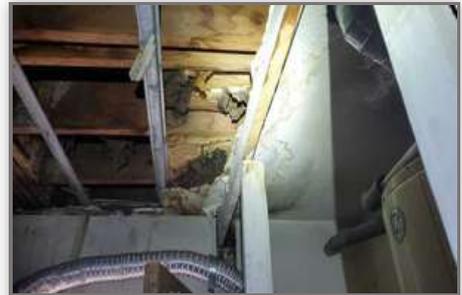
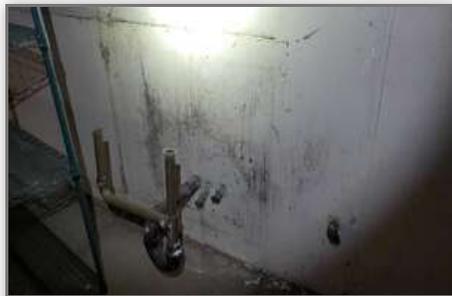
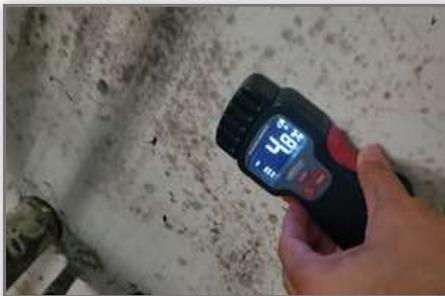
Microbial like growth or musty odor was found at one or more locations. We did not test the substance through a lab so proper verification was not made. Growth is normally cause by moist conditions, plumbing or Roof/exterior moisture issues, and issues with improper ventilation. We recommend that after the areas are verified as mould, mitigation, for mold/moisture should be done by a professional contractor.

1.2 Microbial growth

1.3 Microbial growth

1.4 Microbial growth

1.5 Microbial growth

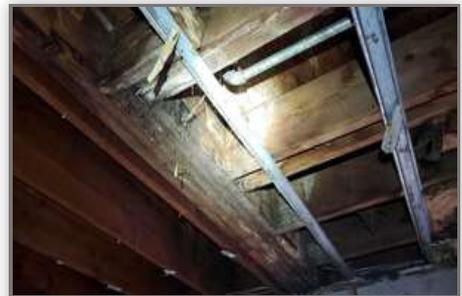
Location: GARAGES

1.6 Wood damage

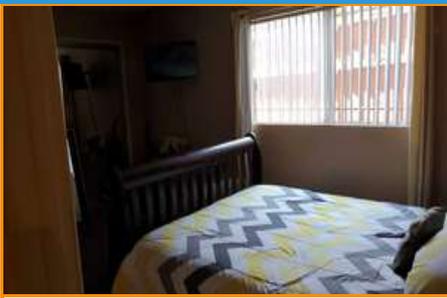
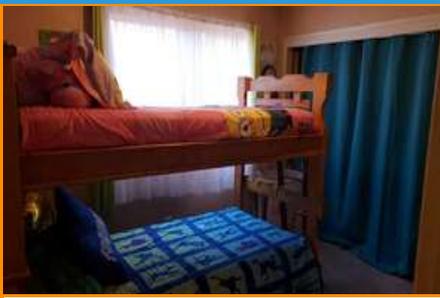
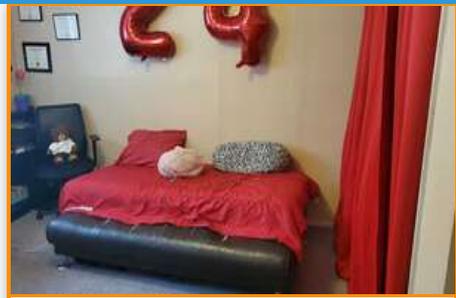
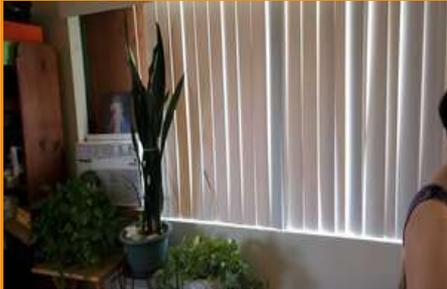
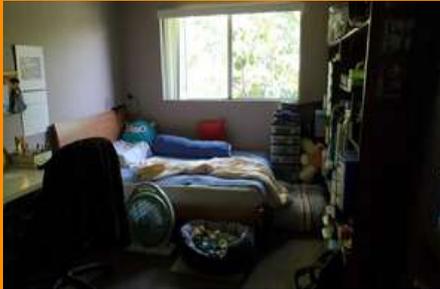
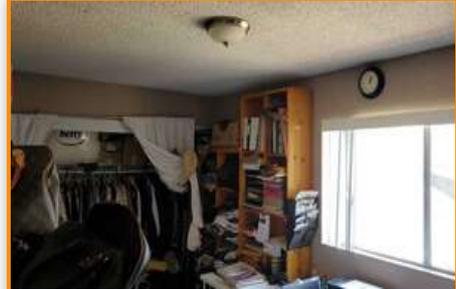
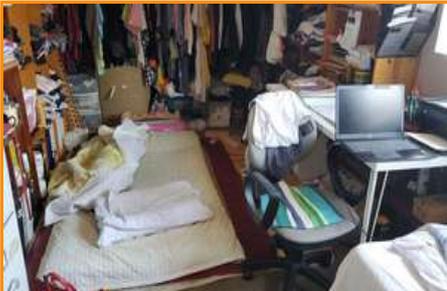
Note: Unable to test the following windows due to stored items blocking the windows at the time of inspection:

1.4 Blocked window

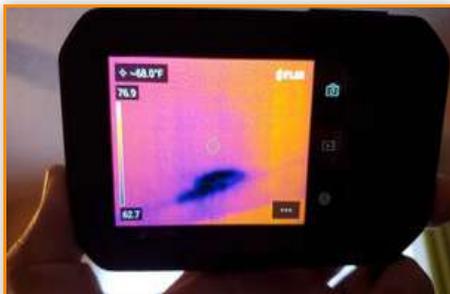
Location: 1745/ BEDROOM 2

We found one or more areas with thermal signatures that appear to moisture related issues. Verification of moisture should always be followed up with further testing with a moisture meter. All affected leaks should be found and repaired as well as any other areas that were damaged from this occurrence. All work should be performed by a professional contractor.

1.1 Ceiling moisture noted

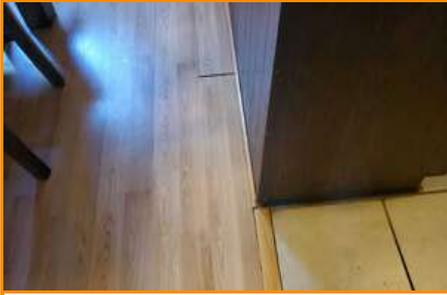
Location: UNIT 1745/ DINNING AREA

One or more gaps were found in laminate flooring joints/seams. This is indicative of improper installation or a thin, lower quality laminate that is prone to movement. Recommend consulting with a qualified flooring contractor for repair/replacement options.

1.1 Poor flooring installation

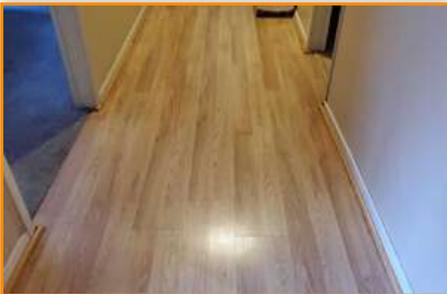
Location: 1745/ HALLWAY BATHROOM

one or more areas of the home's living space has floors with significant slope . Floors should not slope more than 1/2" at 20' feet, we recommend that the area be evaluated and repaired by a licensed contractor.

3.1 Sloped floors

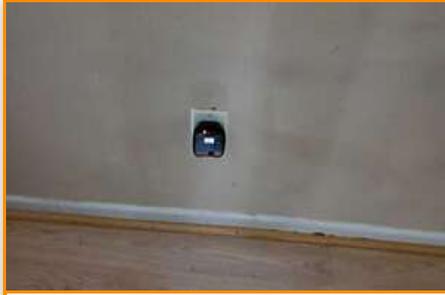
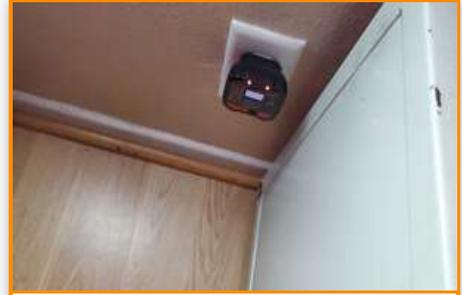
1.2 Improper wire connection

1.3 Improper wire connection

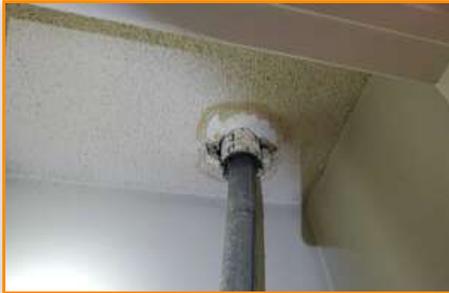
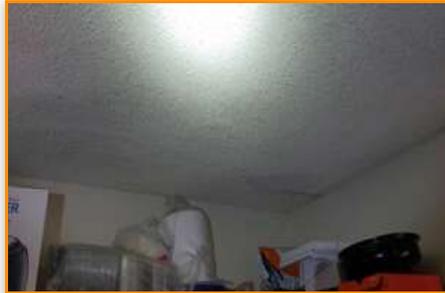
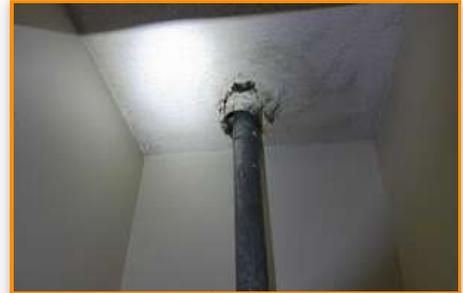
Stains and/or elevated levels of moisture were found in one or more ceiling areas. The stains appear to be due to an active roof leak. Recommend that a qualified contractor evaluate and repair as necessary.

4.1 Stains

4.2 Microbial growth /roof water stains

4.3 roof water stains

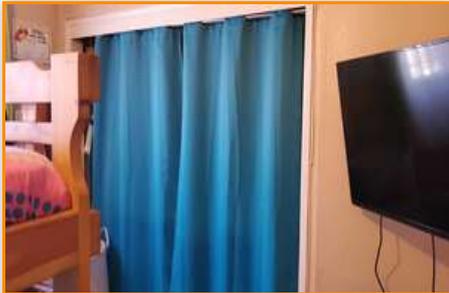
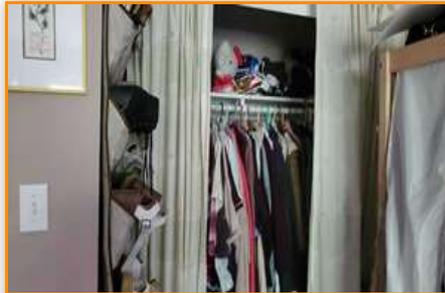
Closet doors were missing/not installed in one or more locations. Recommend installing as necessary.

1.1 Missing closet door

1.2 Missing closet door

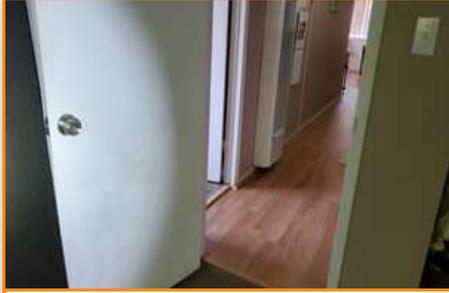
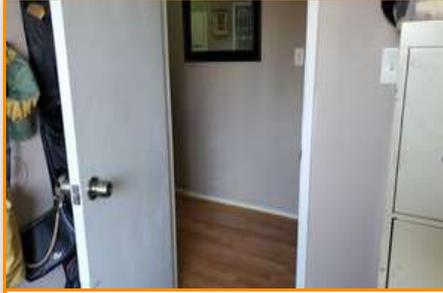
One or more doors wouldn't latch or were difficult to latch. Currently the door handle does not need to be turned for the door to be opened. Recommend that a qualified person repair as necessary. For example, by adjusting latch plates or locksets.

2.1 Door not latching

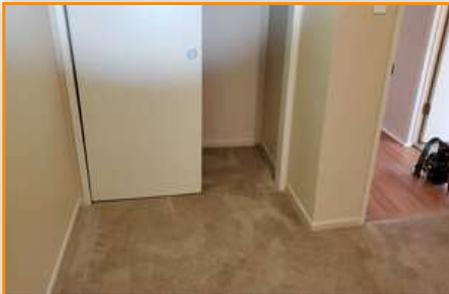
Location: 2ND FLOOR UNIT 1747 /BEDROOMS

The door guides servicing the closet in one or more rooms were damaged, missing, or installed incorrectly at the time of the inspection. This leaves the doors where they swing in and out and can fall off of the track. The inspector recommends that they are repaired or replaced as needed.

3.1 Missing lower guides

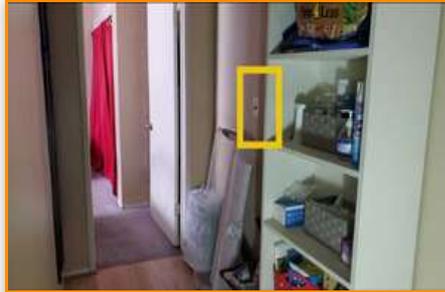
Location: 1745/ FURNACE

The light fixture in one or more long hallways or room that can be entered from two locations was controlled by a single switch at one end. This is a safety hazard due to inadequate lighting. The light should be controlled by 3-way switches at each end of the hallway / room so it can be easily operated at both ends. Recommend that a qualified electrician repair per standard building practices.

1.2 Improper connection 3 way

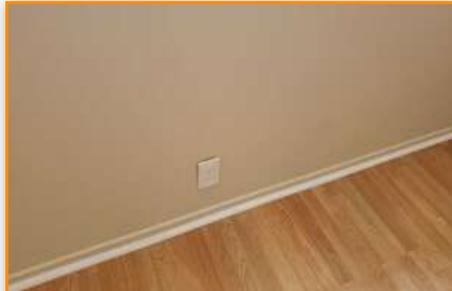
Location: 2ND FLOOR UNIT 1747
/LIVINGROOM

One or more cover plates servicing outlets were missing, loose and/or damaged. We recommend that the affected cover plates be replaced.

1.1 Loose outlet

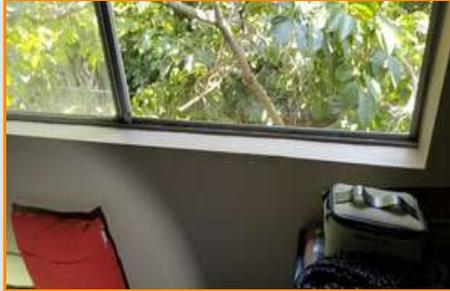
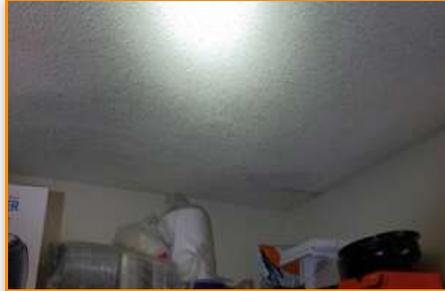
Microbial like growth or a musty odor was found at one or more locations. We did not test the substance through a lab so proper verification was not made. Growth is normally caused by moist conditions, plumbing or roof/exterior moisture issues, and issues with improper ventilation. We recommend that after the areas are verified as mould, mitigation, for mold/moisture should be done by a professional contractor.

1.1 Microbial growth around windows

1.2 Microbial growth /roof water stains

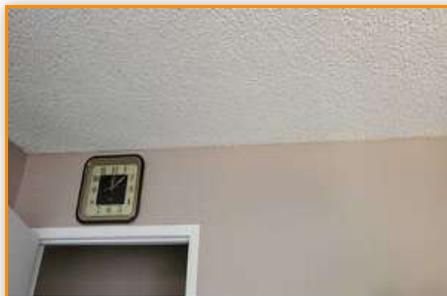
Location: 2ND FLOOR UNIT 1749 /BEDROOM 2

No smoke detectors were present in the structure. Smoke detectors should be installed in bedrooms, hallways leading to sleeping areas and on each floor. Client should add additional smoke detectors as needed. We recommend installing photoelectric type smoke detectors / alarms. Note: Homes built prior to 1992 were not required to have smoke detectors installed in each bedroom, only hallways. Regardless, calfire.ca.gov recommends installing smoke detectors in each bedroom for increased safety. Click here for more information.

2.2 Missing smoke detector

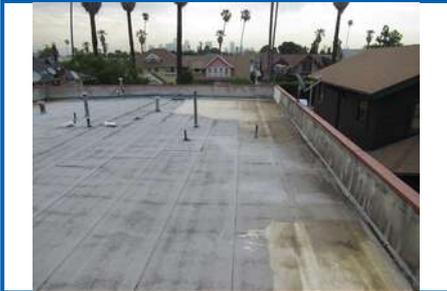
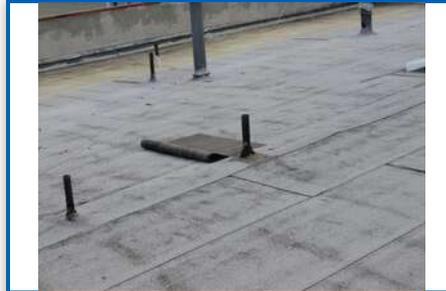
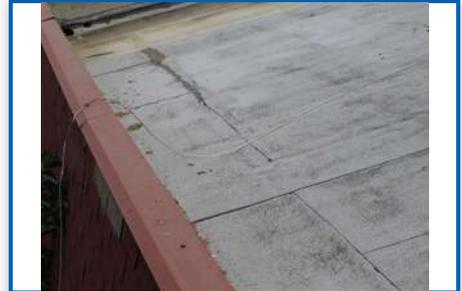
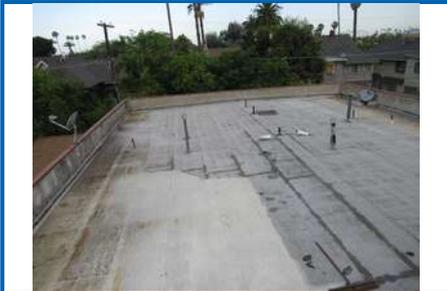
Evidence of ponding were noted on the roof. This creates Chance of water damage to structure, further evaluation and repair by a licensed roofing contractor.

1.1 Ponding /temporary patch work

1.2 Ponding /temporary patch work

1.3 Ponding /temporary patch work

1.4 Ponding /temporary patch work

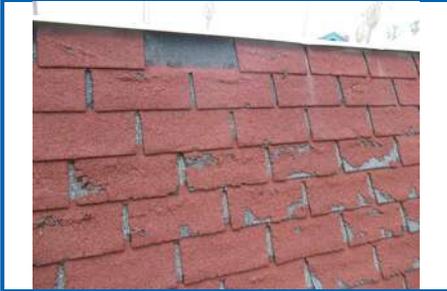
Location: ROOF

The roof had shingles that were damaged or had exposed roofing nails, unsealed nails or other defects in various locations at the time of the inspection. The Inspector recommends sealing of any exposed nails and replacement of any damaged shingles by a qualified roofing contractor to industry standard in order to avoid damage from moisture related issues. After these repairs are made the roof should be certified for five years.

1.1 Damaged shingles

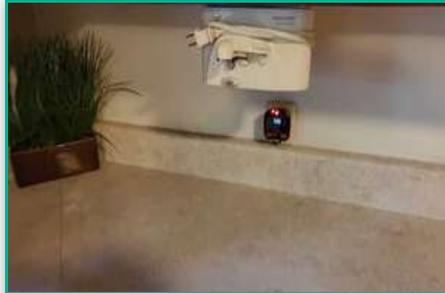
Location: KITCHEN

Kitchen electrical outlets were operable at the time of the inspection but no Ground Fault Circuit Interrupter (GFCI) protection were installed. GFCI protection should be installed for outlets within 6 feet of plumbing fixtures or on kitchen counters, as they were required in kitchens starting in 1987 by the NEC. Recommended this be done by a professional electrical contractor.

1.2 Missing gfci (update)

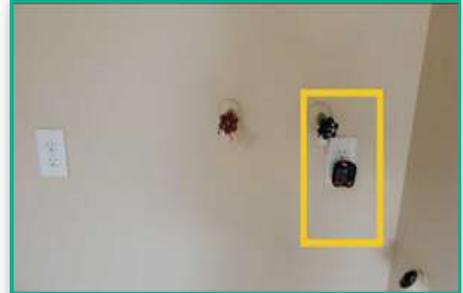
Location: 2ND FLOOR UNIT 1747 /KITCHEN

1.3 Not gfci

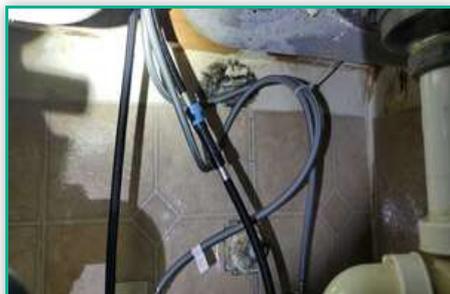
Location: KITCHEN 1745

Microbial Growth Matter is a type of fungus that consists of small organisms found almost everywhere. ... In small amounts, mold spores are usually harmless, but when they land on a damp spot in your home, they can start to grow. When mold is growing on a surface, spores can be released into the air where they can be easily inhaled. We recommend samples taken for any type of active contamination.

1.1 Microbial growth

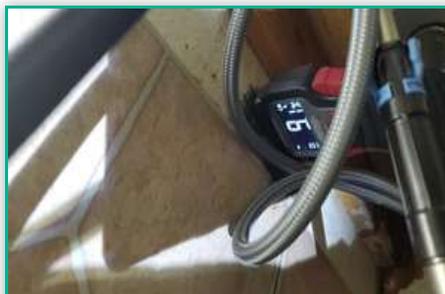
Location: KITCHEN 1745

1.2 Moisture present

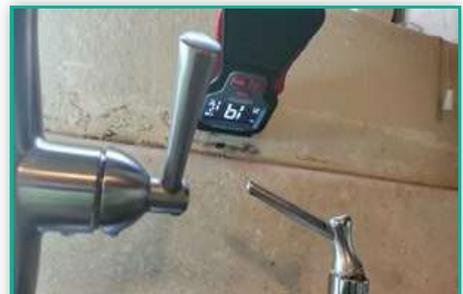
Location: KITCHEN 1745

1.3 Moisture present

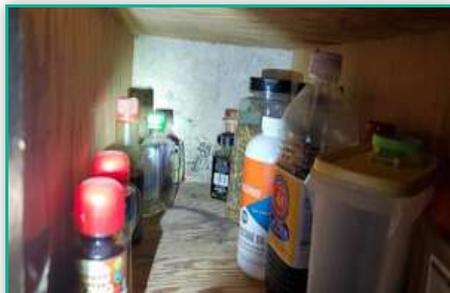
Location: 2ND FLOOR UNIT 1749 KITCHEN

1.4 Microbial growth

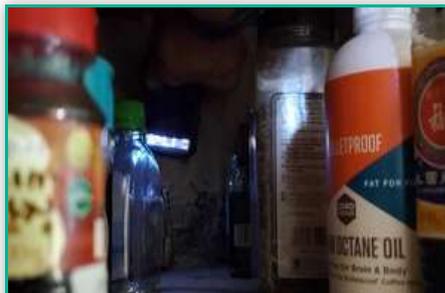
Location: 2ND FLOOR UNIT 1749 KITCHEN

1.5 Moisture present over 17%

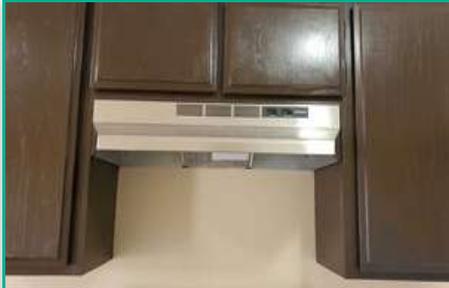
Location: 2ND FLOOR UNIT 1747 /KITCHEN

The range hood light and fan were inoperable at the time of the inspection. We recommend replacing the bulb and then retesting the unit. If it does not respond the both problems will need to be repaired by a professional appliance repair contractor.

1.1 Not responding

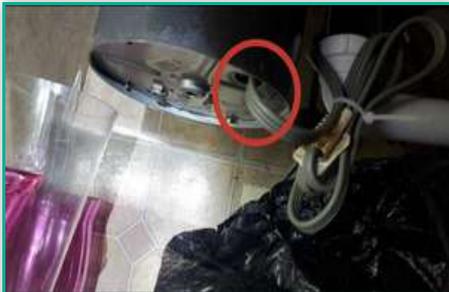
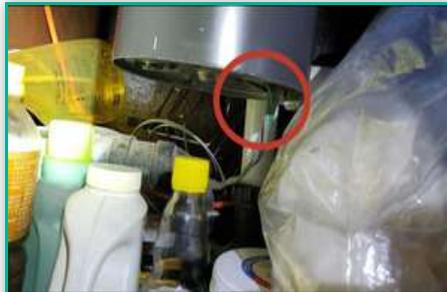
The opening for the electric power cord to exit the bottom or side of a garbage disposal housing has sharp edges. The concern is that these sharp edges, due to use, vibration, reaching for items under the sink, or over time, may cut into the electric cord and cause a short or spark.

1.1 Missing clamp

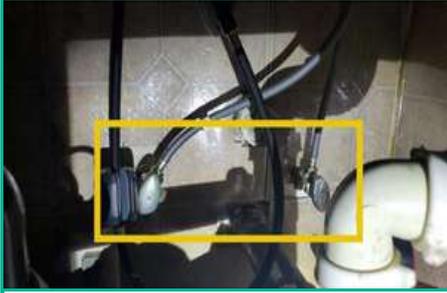
Location: KITCHEN 1745

Water shut-off valves under the sink were inoperative/rust/leaking/broken which makes plumbing repairs for the sink difficult to work on. Recommend that water shut-off valves replaced for both cold and hot water lines by a professional plumbing contractor.

1.1 Ceased shutoff valve

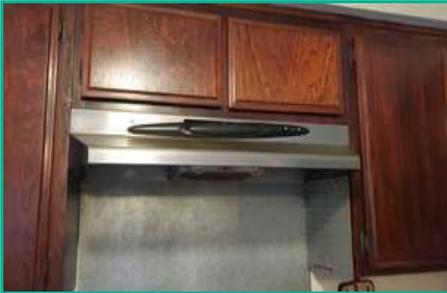
Location: KITCHEN 1745

At the time of inspection, the filters for the kitchen range hood were dirty and needed to be cleaned.

1.1 Needs maintenance (range)

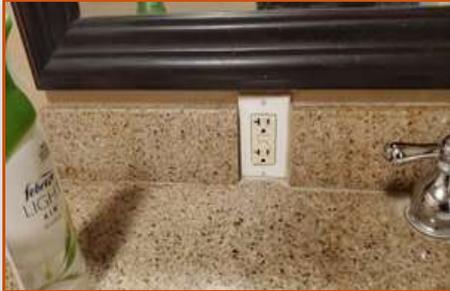
Location: 1745/ HALLWAY BATHROOM

At the time of inspection, one or more bathroom GFCI electrical outlet made a buzzing sound when the reset button was tested. Recommended these GFCI receptacles are evaluated, repaired or replaced by a professional electrical contractor.

1.1 Buzzing gfc

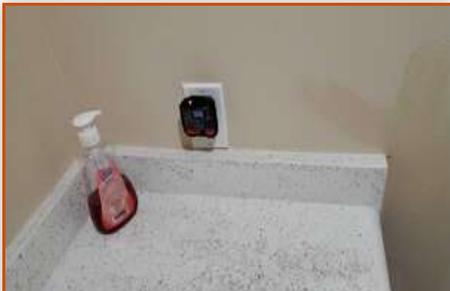
Location: 2ND FLOOR UNIT 1747 /HALLWAY BATHROOM

One or more electrical outlets were broken or damaged in the bathroom. Recommend that a professional electrician evaluate, repair or replace these electrical outlets as necessary. If replacing, consider installing GFCI outlets for safety reasons.

2.1 Improper wire connection

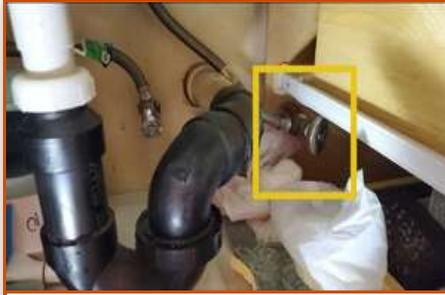
Location: 1745/ BEDROOM 3

Water shut-off valves under the sink were inoperative/rust/leaking/broken which makes plumbing repairs for the sink difficult to work on. Recommend that water shut-off valves replaced for both cold and hot water lines by a professional plumbing contractor.

1.2 Ceased shutoff

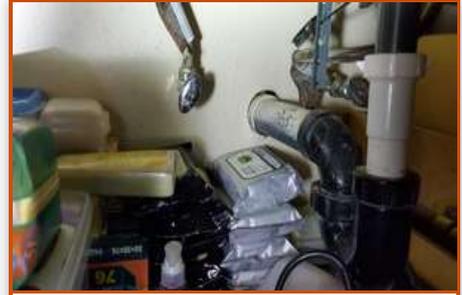
Location: 2ND FLOOR UNIT 1749/HALLWAY BATHROOM

1.3 Replace shutoff valve

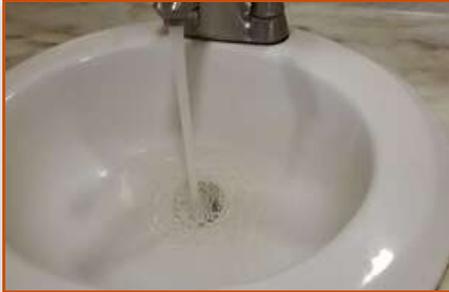
Location: 1745/ BEDROOM 1/BATHROOM

The water in the toilet tanks, sinks and/or tub were noted to have water discoloration. The discoloration may indicate a possible defect in the water supply system, distribution piping or water source. Have a licensed plumbing contractor further evaluate the entire system and make any additional repairs as needed. If the home is not or has not been tested for bacteria or contamination it is also recommended.

1.1 Discolored water
