Inspection Report
1745 South Harvard Boulevard, Los Angeles 90006

Report ID
NXT-229-001696

Inspection Date
June 17, 2021 at 10:00 AM

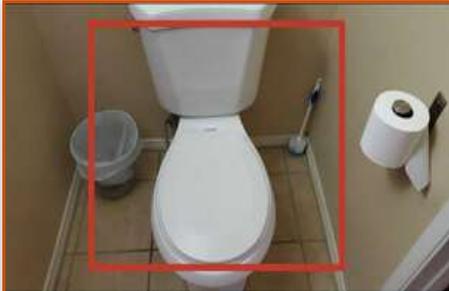
Location: 1745/ BEDROOM 1/BATHROOM

The toilet seat was loose. There are small bolts on the side of the seat that can be tightened or in other cases may need to be replaced.

2.1 Loose toilet

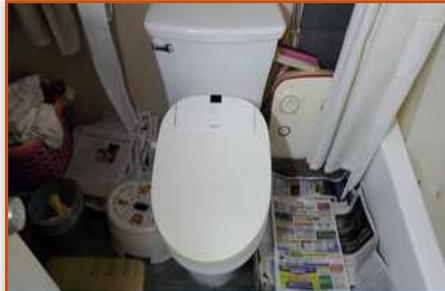
Location: 2ND FLOOR UNIT 1749/HALLWAY BATHROOM

2.2 Loose toilet

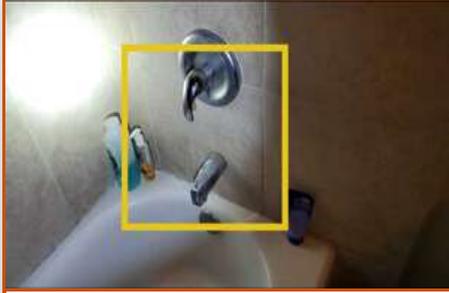
Location: 1745/ HALLWAY BATHROOM

The faucet handles are stripped (spin all the way around). If the handles are not placed in the exact location the water will continue to drip. Contact a licensed plumber for review and make any additional repairs as needed.

1.1 Stripped/ won't fully shut

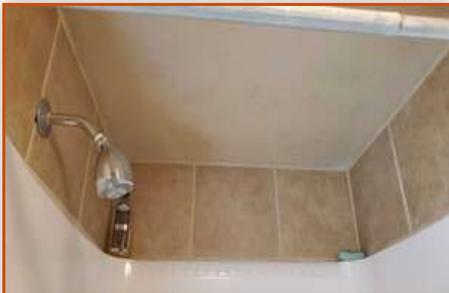
Location: 1745/ BEDROOM 1/BATHROOM

Microbial like growth or a musty odor was found at one or more locations. We did not test the substance through a lab so proper verification was not made. Growth is normally caused by moist conditions, plumbing or roof/exterior moisture issues, and issues with improper ventilation. We recommend that after the areas are verified as mould, mitigation, for mold/moisture should be done by a professional contractor.

1.1 Microbial growth

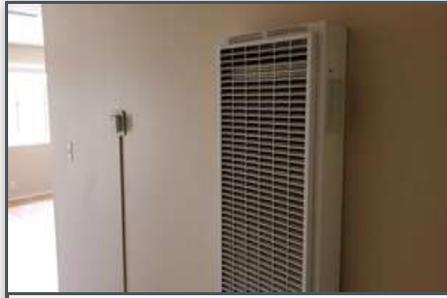
Location: 2ND FLOOR UNIT 1747 /FURNACE

1.2 Service all units

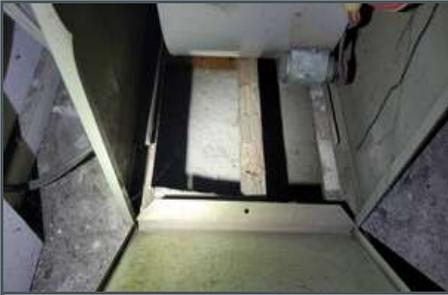
Location: 1745/ FURNACE

The fastener(s) at one or more return air / filter registers was missing, damaged and/or faulty. Recommend repairs be made.

1.1 Missing filter

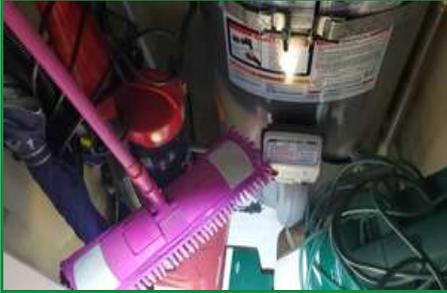
Location: 2ND FLOOR UNIT 1749/WATER HEATER

No drip leg is installed on the water heater gas supply line. Drip legs are intended to trap oil, scale, water condensation and/or debris from the gas supply lines before they reach and damage the water heater components. A qualified contractor should install a drip leg as per standard building practices.

1.1 No drip leg

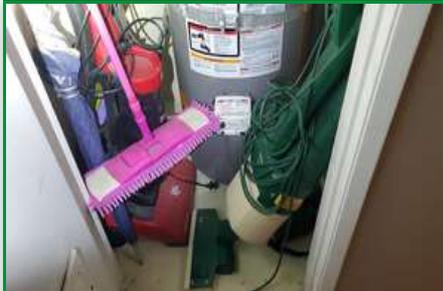
Location: 2ND FLOOR UNIT 1749/WATER HEATER

A water heater is installed with no drip pan or drain. We recommend having corrections made by a professional plumbing contractor.

2.2 No drip pan

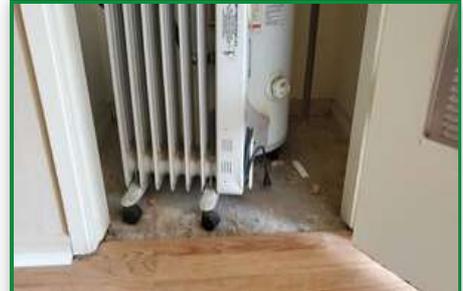
Location: 2ND FLOOR UNIT 1747 /WATER HEATER

2.3 No pan

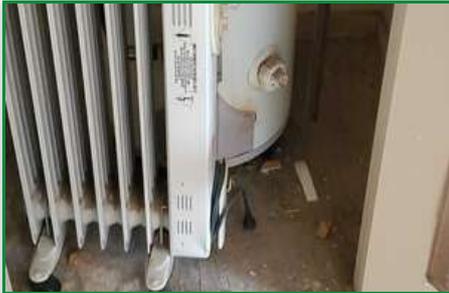
Location: 2ND FLOOR UNIT 1747 /WATER HEATER

There were scorch marks above the burner chamber indicating flame roll out. This unit needs to be serviced as soon as possible.

3.1 Scorched marks

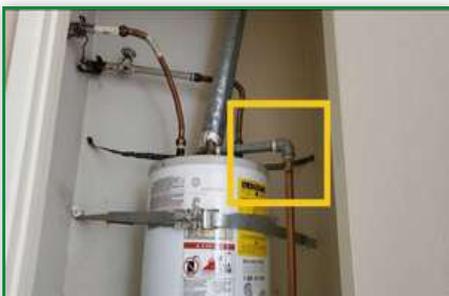
Location: 2ND FLOOR UNIT 1747 /WATER HEATER

The TPR discharge pipe was threaded on the end leaving it easy to connect other lines to it such as a hose or other fittings. This is not to industry standard and can be unsafe. The inspector recommend that the discharge pipe be repaired to industry standard with the proper materiel by a professional plumbing contractor.

4.1 Threaded parts

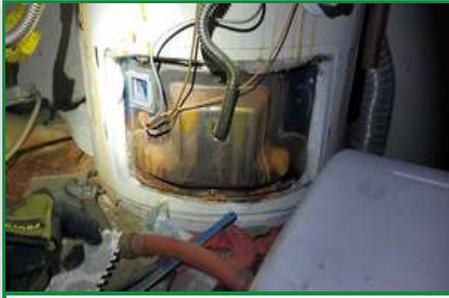
Location: 1745 WATER HEATER/GARAGE

Corrosion was found in one or more areas on the water heater. The water heater may be failing. A qualified plumbing contractor should evaluate and replace or repair water heater if necessary.

5.1 Corrosion on tank

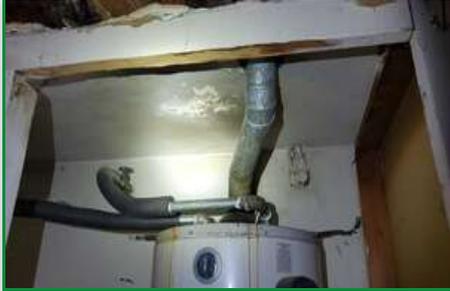
Location: 1745 WATER HEATER/GARAGE

Some or all of the water supply pipes were made of galvanized steel. Based on the age of this structure and the 40-60 year useful life of this piping, it will likely need replacing in the future. Leaks can develop, flow can be restricted due to scale accumulating inside the piping, and water may be rusty. Note that it is beyond the scope of this inspection to determine what percentage of the piping is older, galvanized steel, as much of it is concealed in wall, floor and/or ceiling cavities. Some insurance companies in the state do not insure galvanized plumbing. Recommend the following: ~ Budget for replacement in the future ~ Monitor these pipes for leaks and decreased flow in the future ~ Consider replacing old, galvanized steel piping proactively as client sees fit

2.1 Corroded galvanized water lines

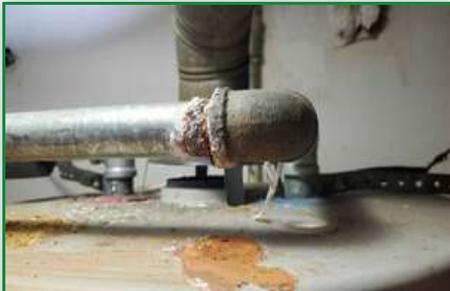
Location: 1745 WATER HEATER/GARAGE

Corrosion was found at water supply pipes, water shut offs, and/or fittings. This can indicate past leaks, or that leaks are likely to occur in the future. Recommend that a qualified plumber evaluate and replace components as necessary.

3.1 Corroded galvanized water lines

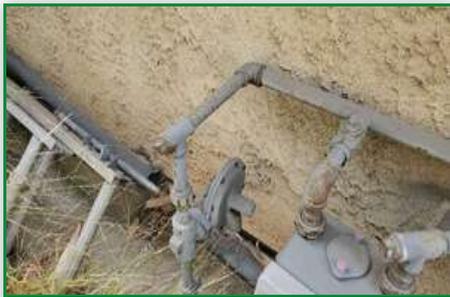
2.1 Disconnected/ damaged

One or more drain or waste pipes or fittings were damaged. Repairs needed.

Location: EXT BUILDING /DRAIN LINE

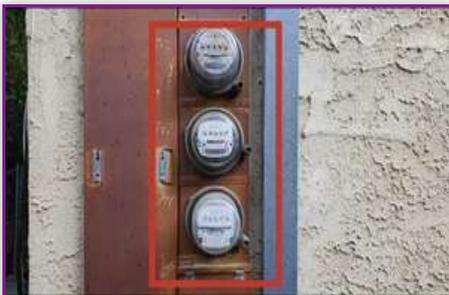
1.1 Missing seal lock

The seal for the metal ring securing the electric meter to its base is missing or broken. The utility company installs these seals. Recommend consulting with the property owner(s) about this and/or contacting the utility company to have one reinstalled.

Location: EXT BUILDING

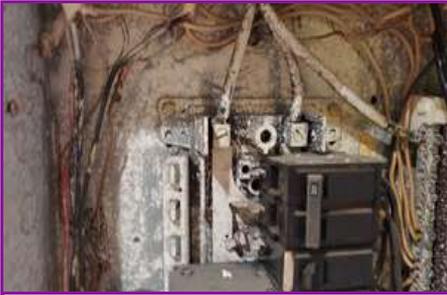
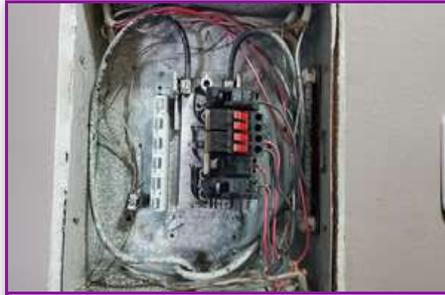
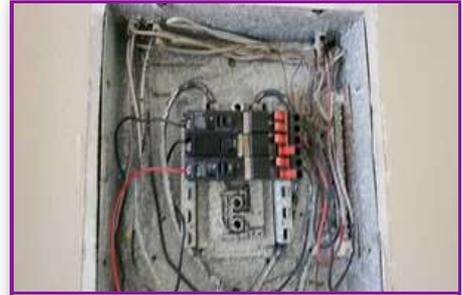
1.1 Overspray in panel

There was paint and other materials in the panel. We recommend that the panel be cleaned and repaired as needed.

Location: 1745/ HALLWAY/ DISTRIBUTION PANEL

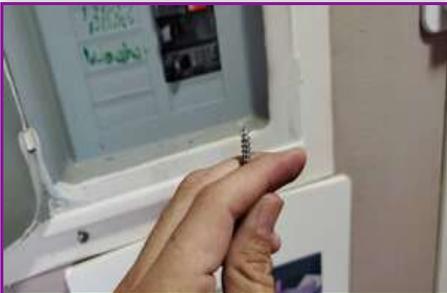
2.1 Pointed screws

The service panel used one or more pointed and/or too-long screws which can come into contact with wiring inside the panel than stock screws from the manufacturer and damage wiring insulation. These screws should be replaced with non-pointed screws.

Location: 2ND FLOOR UNIT 1749/DISTRIBUTION PANEL

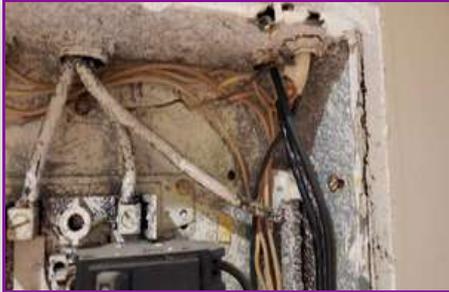
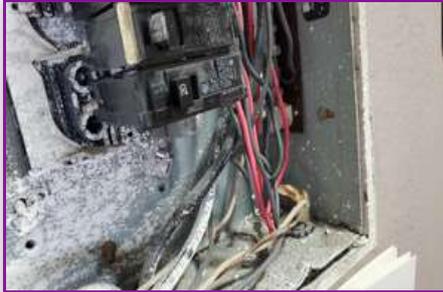
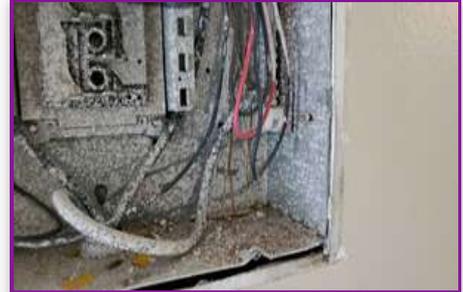
1.1 Re identify wiring

There were red or black wires in the service panel that were connected to the neutral bus bar, that were not re-identified with red or black tape. We recommend that the affected wires be evaluated and traced as needed to identify if the wire is hot or not. Either re-identify or properly terminate the wire as needed by a professional electrical contractor.

Location: 1745/ HALLWAY/ DISTRIBUTION PANEL

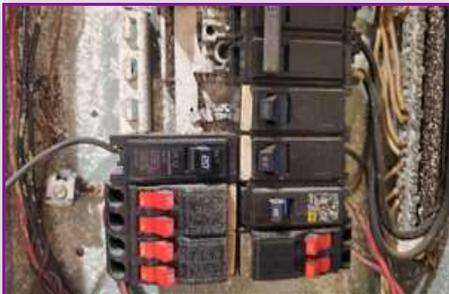
1.1 Mismatched breakers

The home's electrical panel breaker was manufactured by a company other than the panel manufacturer, as this may void the panel's warranty and could be a safety concern. The inspector recommends an evaluation by a professional electrical contractor.

Location: 1745/ HALLWAY/ DISTRIBUTION PANEL

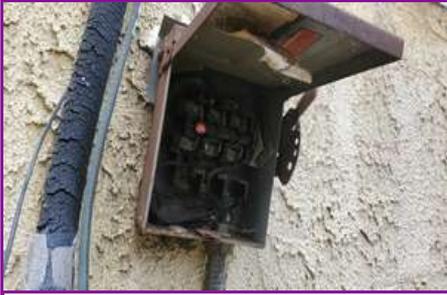
1.1 Missing front cover

One or more cover plates for junction box(es) were loose, missing and/or broken. These plates are intended to contain fire and prevent electric shock from occurring due to exposed wires. Recommend that a qualified person install cover plates where necessary.

Location: EXT BUILDING
