BUILDINGSPECSPRO'S LLC

RESIDENTIAL REPORT BY : JOHN BOWLEY, ACI,CRI, CRMI,

1325 Clove St
San Diego, CA 92106

SEPTEMBER 23, 2022

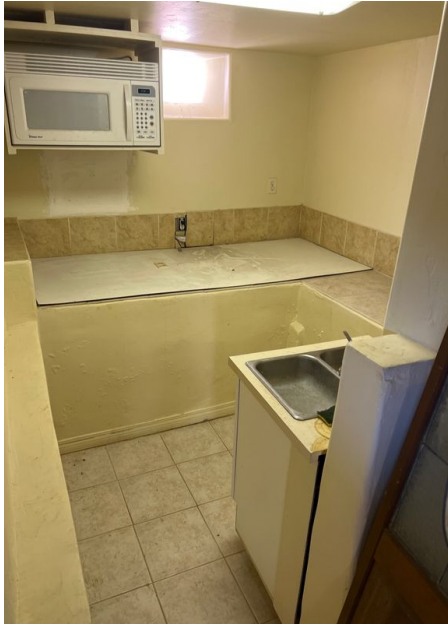
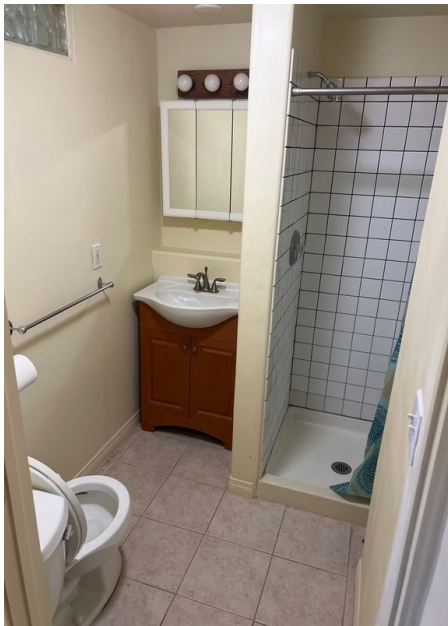
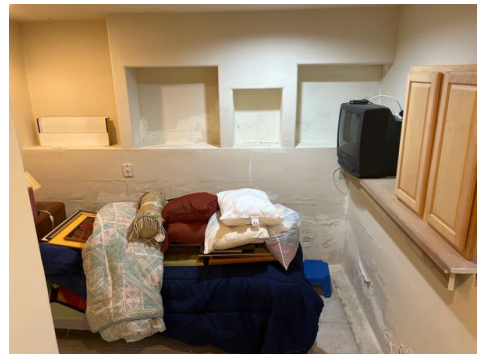
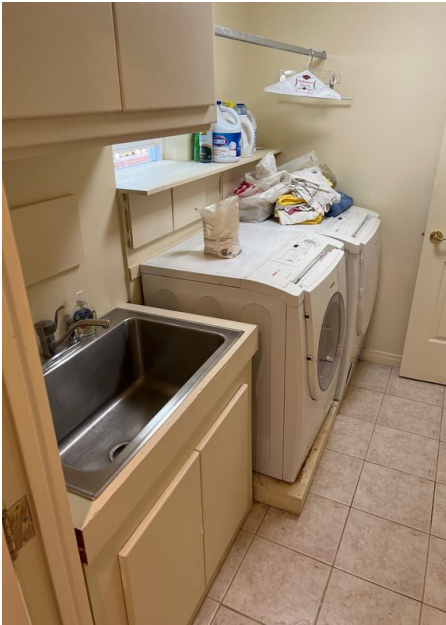
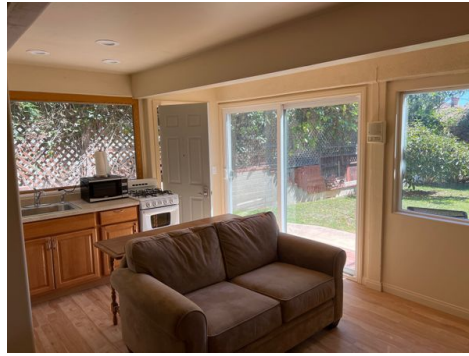
Lower Level Work Space *Crawlspace/ Basement

The lower level area has been modified into the living space that appears to be non-permitted. There are signs of prior moisture intrusion at interior walls. Refer to a licensed contractor for maintenance/ repairs prior to sale.

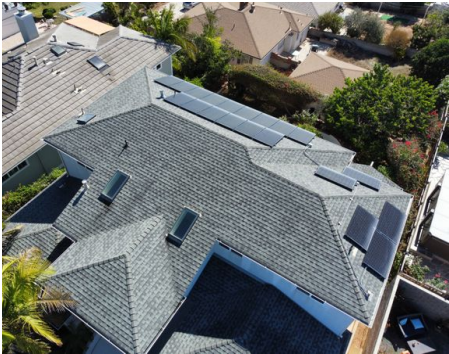
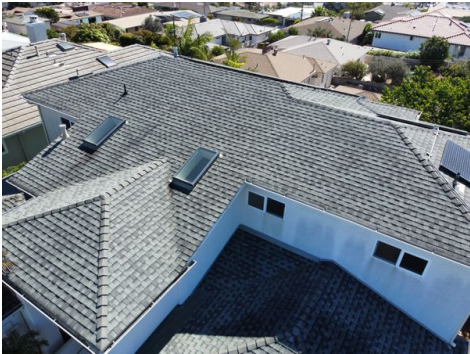
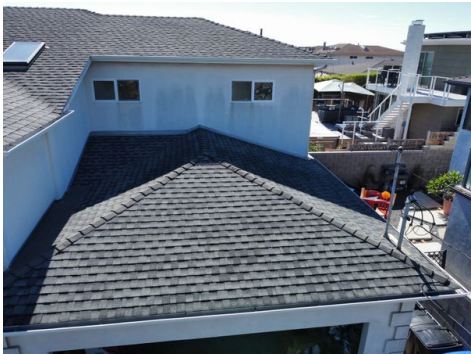
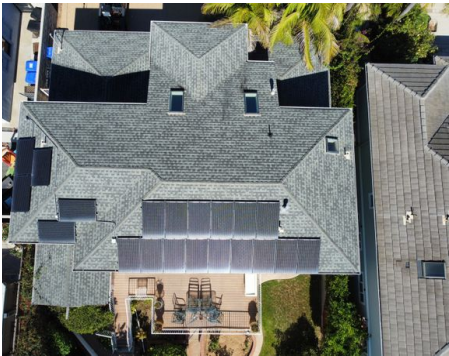
Coverings: Roof Views

Roof covering requires periodic repairs and sealant, especially around roof penetrations. Suggest periodic evaluation and repairs as needed to aide in preventing water penetration into structure. Roof covering are subject to unpredictable change. i.e. leaks may develop with out warning.

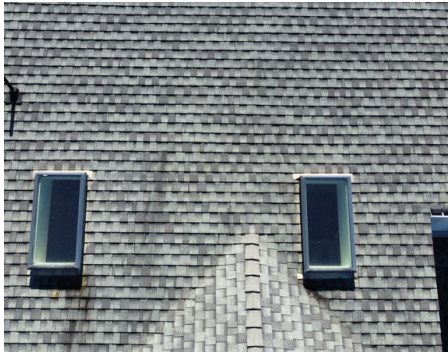
Skylights, Chimneys & Other Roof Penetrations: Skylight

Skylight(s) are installed in the home. As manufacturers differ in design and installation methods, improper or non-standard sealing methods are impossible to detect without an intrusive roof inspection. The roof covering precludes us from evaluating the installation and flashings. Skylights may leak at any time. Recommend obtaining a roof certification before the close of escrow if the client is concerned.

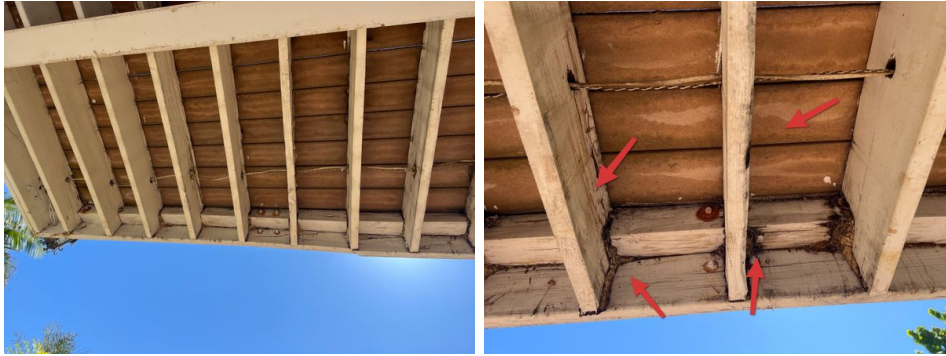
5.6.2 Decks/Stairs

DECK, BALCONY, PORCH UNSTABLE / WOBBLY

Contact a qualified deck contractor.

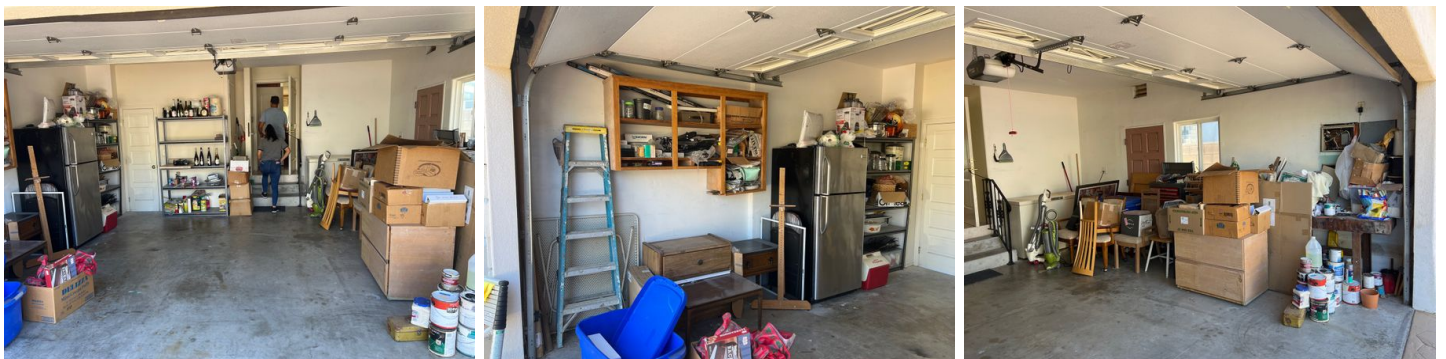
8.6.1 Floor, Walls, Ceiling

FLOORS / WALLS OBSCURED

Floor and / or wall areas were obscured by stored items and couldn't be fully evaluated.

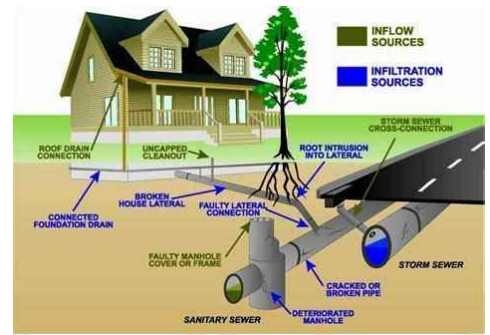
DRAIN LINE SCOPE RECOMMENDED

Our inspection of the drain waste lines is limited to running water down each sink, tub and shower drain and look for slow or clogged drains at each fixture. This test is very limited and does not ensure that the main drain line is not blocked or clogged and truly functional. Only a sewer line video scope can provide an accurate and detailed inspection of the main sewer line. Problems with the main sewer line can be very expensive to repair and should be identified during your contingency period. This service can be provided by our company at request and is highly recommended.

Contact a qualified professional.

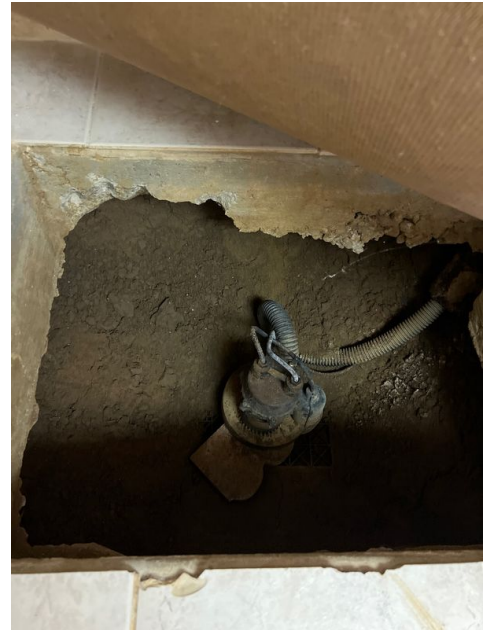
9.3.1 Supply Lines

MIXED METALS / ELECTROLYSIS

The copper water pipe have galvanized hangers, straps or mixed metals. Caution unlike metals and/or mixed metals in contact with one another cause rust, oxidation, and/or electrolysis which are prone to causing pinhole water leaks in copper pipes. Refer to licensed plumbing contractor for repairs as needed.

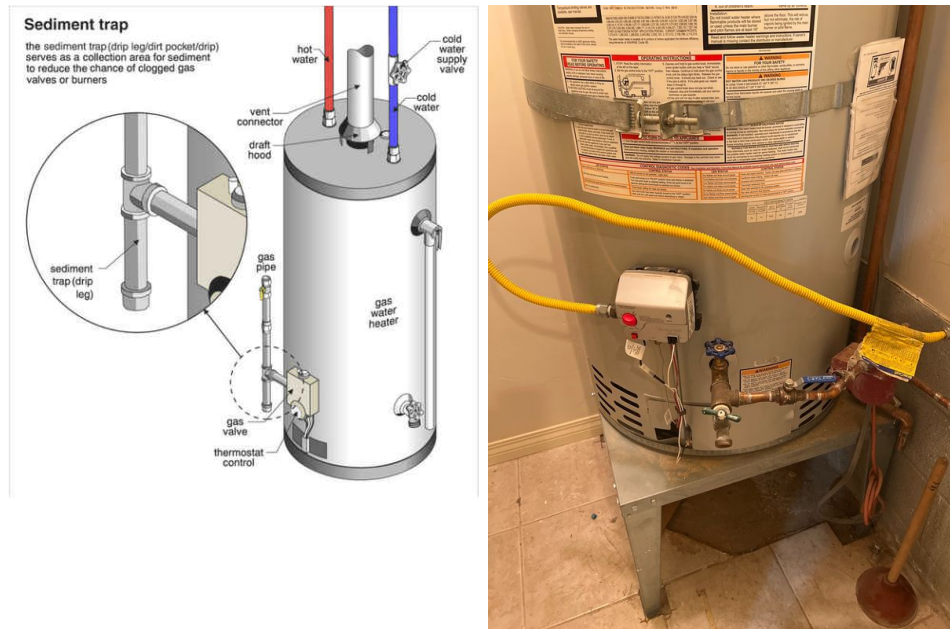
The gas supply pipe at the water heater did not contained a drip leg/ sediment trap. This may have been standard at the time of installation but now is highly recommended. The purpose of a drip leg is to prevent sediment/ debris from entering and clogging the water heater gas valve which could cause the water heater to shut down. Recommend having a drip leg installed by a qualified licensed plumber.

Contact a qualified professional.

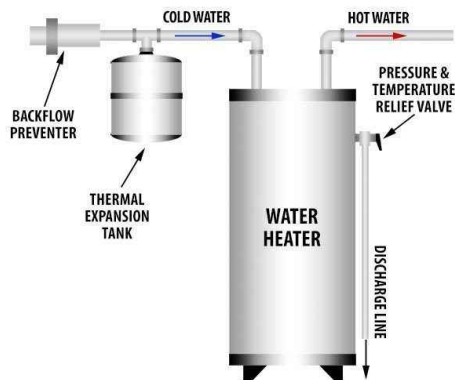
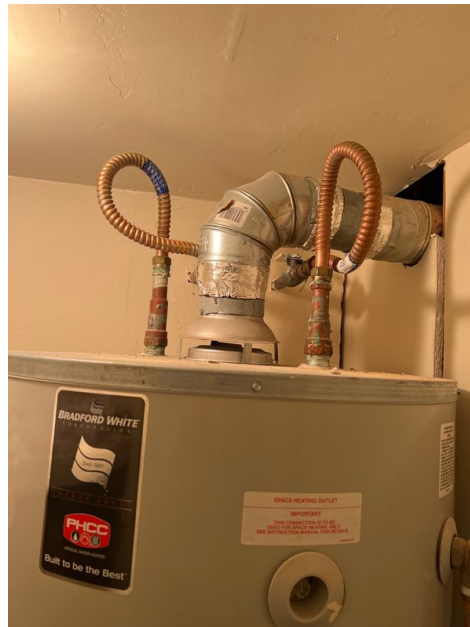
9.5.3 Water Heater

FLUE / DRAFT HOOD IMPROPERLY INSTALLED / SUBSTANDARD

The water heater vent flue and/or draft hood was improperly installed. This is a potential safety hazard due to the risk of exhaust gases entering living spaces. A qualified person should install the draft hood / vent flue per standard building practices.

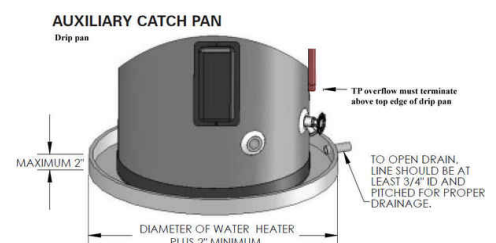
9.5.5 Water Heater

NO DRAIN INSTALLED FOR CATCH PAN / DRAIN DAMAGED / INCOMPLETE

A catch pan was installed below the water heater, but no drain line was visible or the drain was damaged or incomplete. Typically such catch pans hold only a gallon or two of water. If the water heater fails and leaks significantly, nearby flooring and wall materials, or finished spaces below (if any) may get water-damaged. Normally, a drain line is installed at the catch pan to route any accumulated water outside the structure. Consider having a qualified contractor install a drain line per standard building practices.

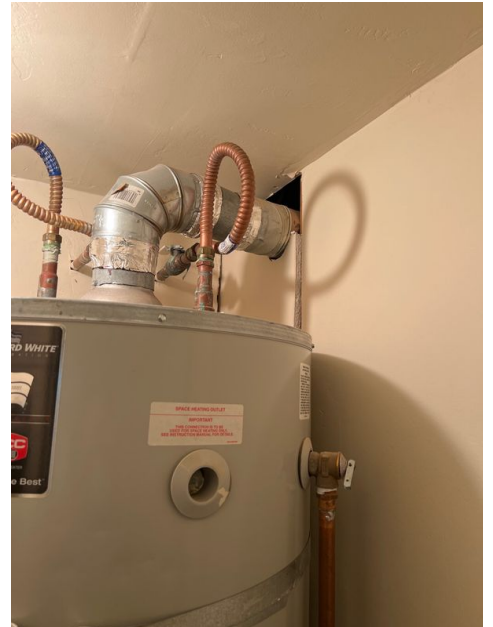
9.5.7 Water Heater

**FLUE - INADEQUATE CLEARANCE**

There appeared to be inadequate clearance between the water heater flue pipe and combustible materials at one or more areas. This condition can prove to be a safety concern. Recommend further evaluation by a licensed plumbing contractor before the removal of contingencies to determine repairs possible at this time for safety.

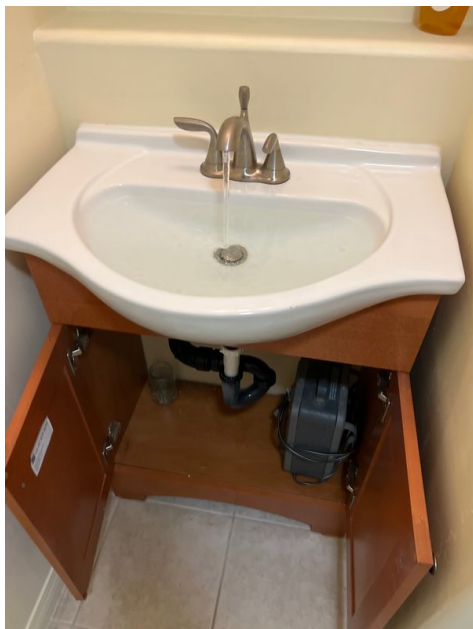
9.6.2 Sinks / Fixtures

FAUCET FAULTY

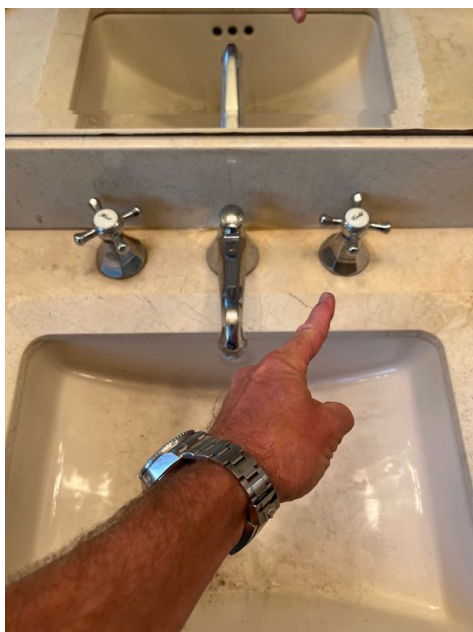
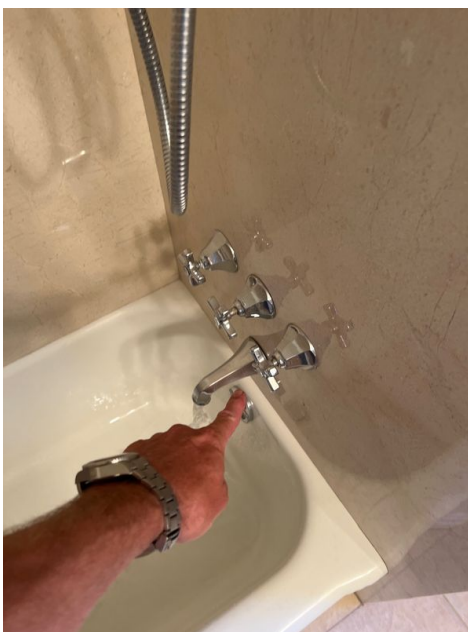
9.6.3 Sinks / Fixtures

WATER SUPPLY VALVES HOSES RUST

Contact a qualified plumbing contractor.

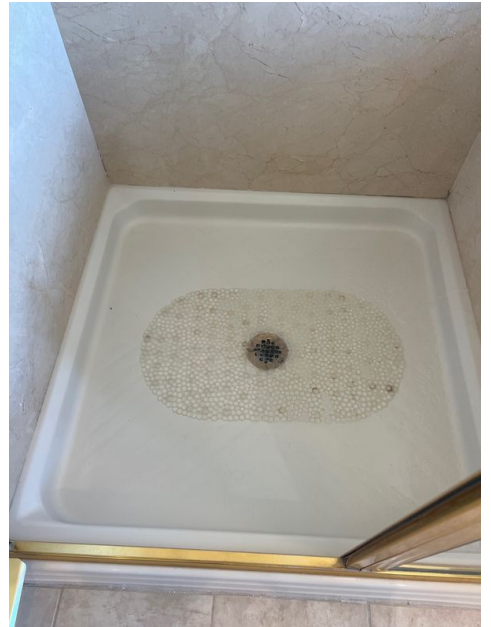
9.8.6 Bathtub / Shower

MIXING VALVE ADJUSTMENT

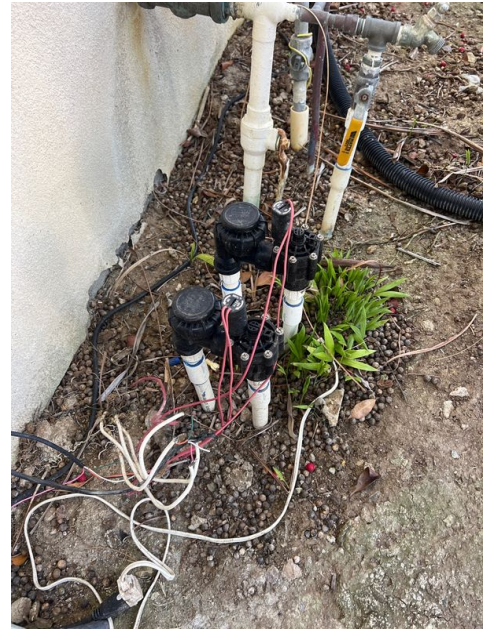
IRRIGATION SYSTEM NOT TESTED

There are a wide variety of irrigation components, such as pipes that could include old galvanized ones, more dependable copper ones, and modern polyvinyl ones that are commercial referred to as PVC. However, among the latter, the quality can range from a dependable thick-walled type to a less dependable thin-walled type, and it is not uncommon to find a mixture of them. To complicate matters, significant portions of these pipes cannot be examined because they are buried. Therefore, we identify a system based on what type of pipe that can be seen. However, our inspection only includes the visible portions of the system, and we do not test each component, nor search below vegetation for any concealed hose bibs, actuators, risers, or heads. We test every visually accessible manual sprinkler actuator and evaluate its coverage, but due to the variety and complexity of many automatic control panels we do not test them. However, inasmuch as the actuators are under pressure, we look for any evidence of damage or leakage, but recommend that you have the sellers demonstrate an automatic sprinkler system before the close of escrow and indicate any seasonal changes that they may make to the program.

Contact a qualified professional.

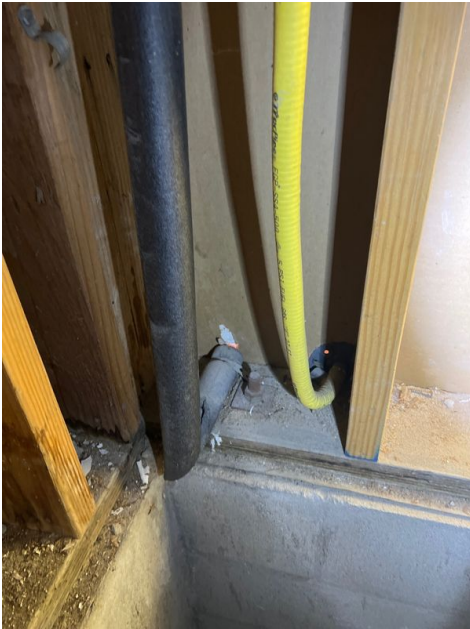
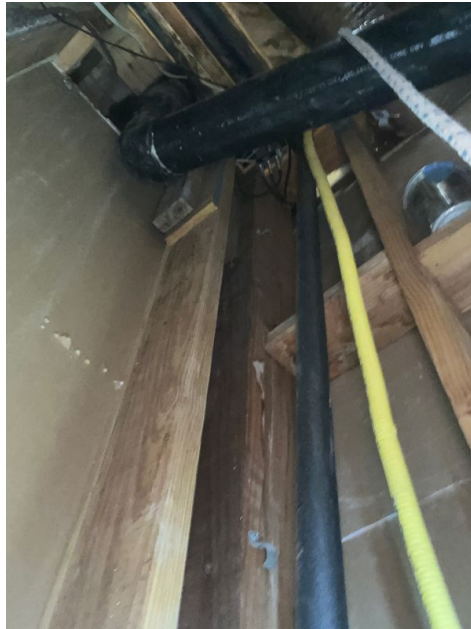
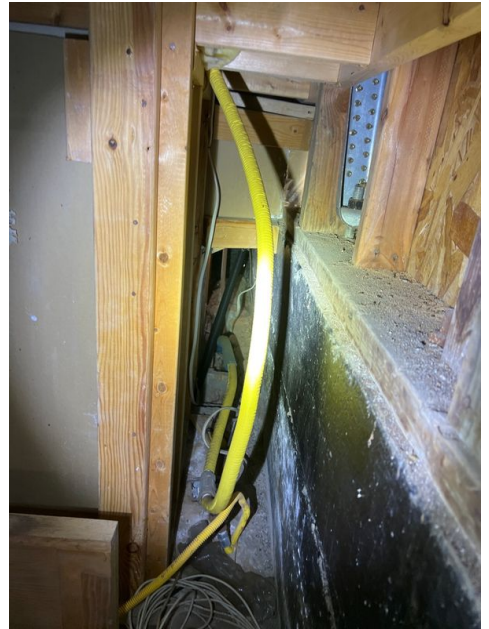
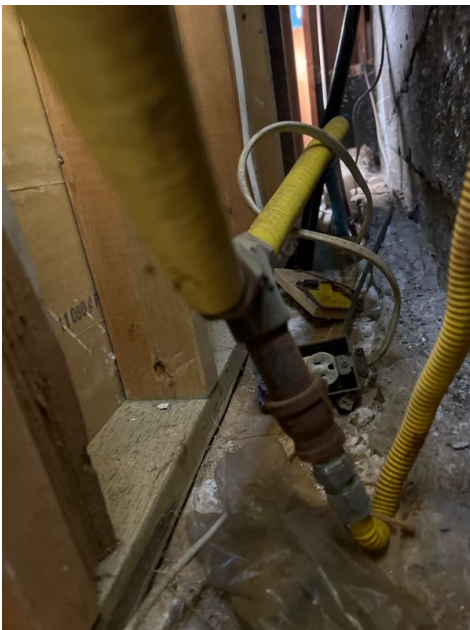
9.12.2 Fuel Systems

MISSING SEDIMENT TRAP

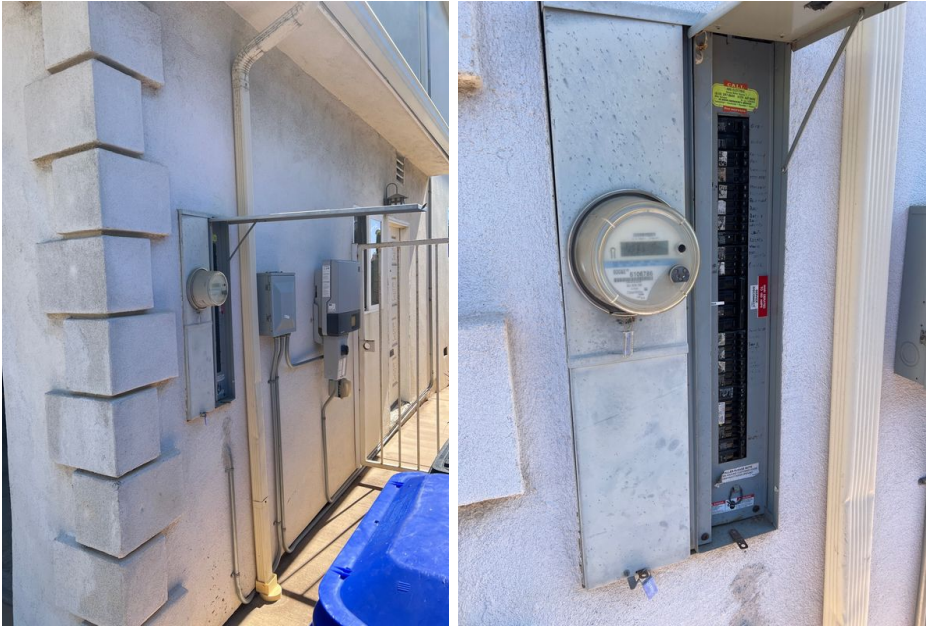
View of the electrical sub panel and components" at the time of inspection. Circuit breakers are functional and no burn marks on screw heads or wiring. Monitor conditions.

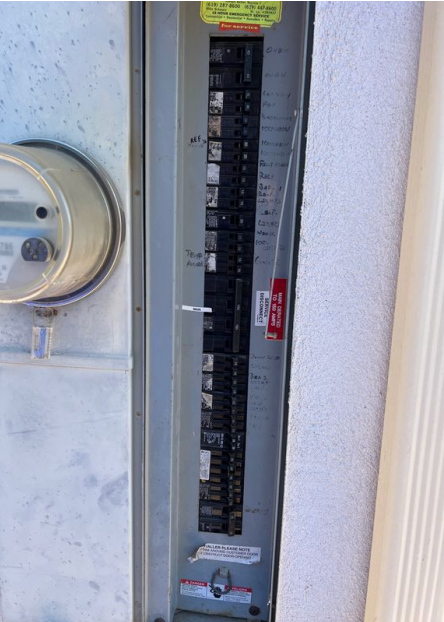
020

GFCI / AFCI Protection: Lack of Adequate AFCI Protection

The *electrical service is not equipped with adequate AFCI protection as per today's building requirements. Recommend that a qualified electrician evaluate and install AFCI protection if necessary and per standard building practices. General guidelines for AFCI-protected receptacles include the following locations:

- 1. Bedrooms (since 1999)
- 2. Kitchens, laundry areas, family rooms, dining rooms, living rooms, parlors, libraries, dens and recreation rooms, sunrooms, closets and hallways (since 2014)

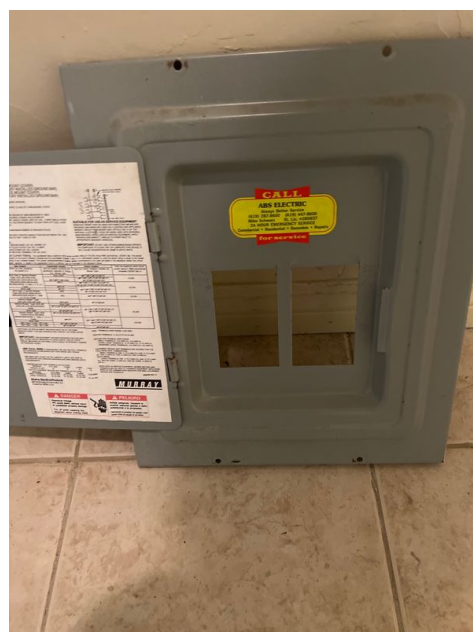
10.3.1 Panels

LEGEND SUBSTANDARD

Panel legend(s) was/were missing, incomplete, illegible or confusing. This is a hazard in the event of an emergency when power needs to be turned off. Recommend correcting the legend so it's accurate, complete and legible. Evaluation by a qualified electrician may be necessary.

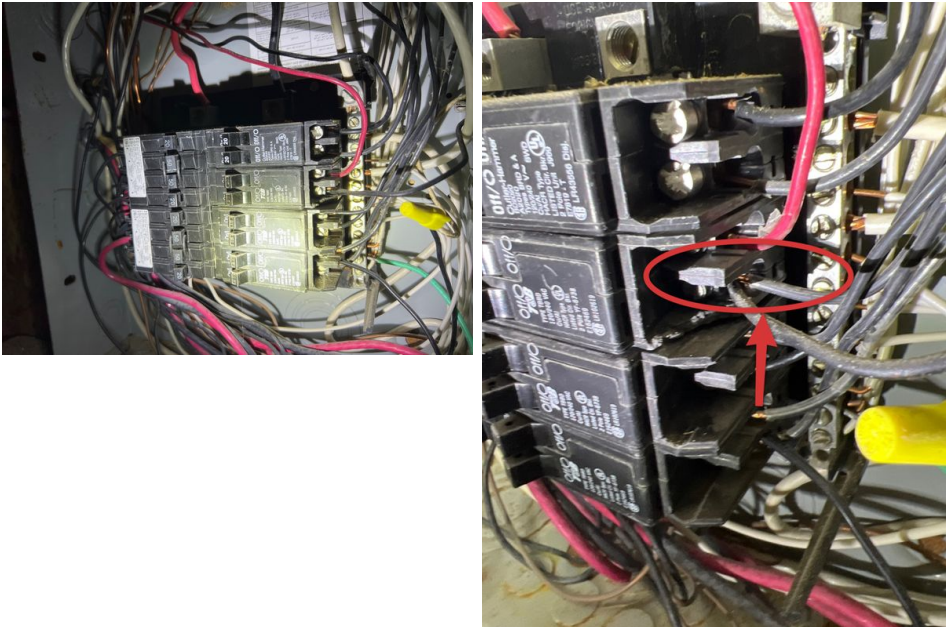
10.4.1 Panel Wiring & Breakers

DOUBLE TAP BREAKER / FUSE

One or more circuit breakers and/or fuses were "double tapped," where two or more wires were installed in the breaker's / fuse's lug. Most breakers / fuses are designed for only one wire to be connected. This is a safety hazard since the lug bolt can tighten securely against one wire but leave other(s) loose. Arcing, sparks and fires can result. Recommend that a qualified electrician repair as necessary.

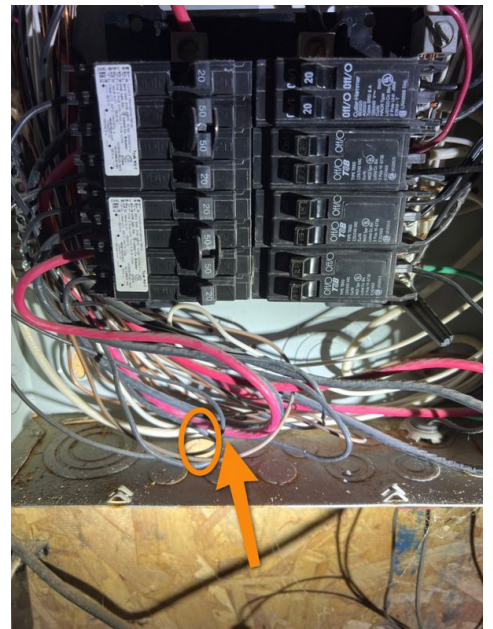
10.4.2 Panel Wiring & Breakers

The electrical panel has open voids/slots. Caution ⚠ area is prone to rodents nesting inside the electrical panel and wall cavity. Safety hazard Refer to licensed electrical contractor for repairs.

Contact a qualified electrical contractor.

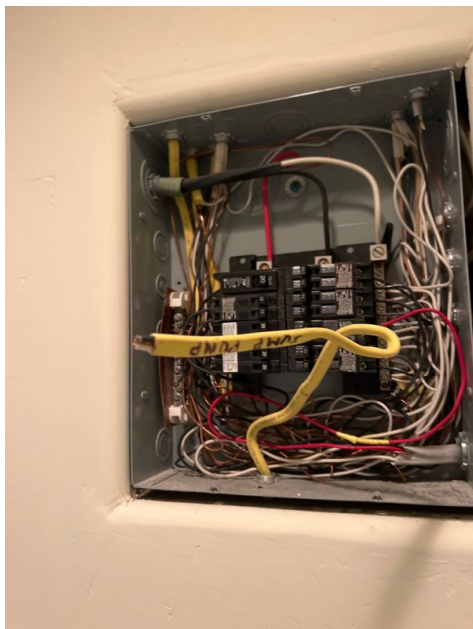
10.4.3 Panel Wiring & Breakers

The electrical sub panel has abandoned/ floating wire(s). Caution. Potential safety hazard. Seek a licensed electrical for maintenance and repairs.

Contact a qualified electrical contractor.

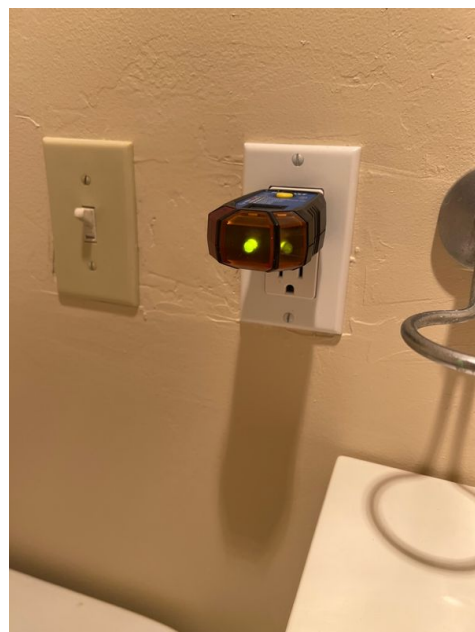
10.5.1 GFCI / AFCI Protection

GFCI BREAKER ISSUE

One or more ground fault circuit interrupter (GFCI) circuit breakers in panel(s) were not functioning properly (wouldn't trip / wouldn't reset) when tested. GFCI breakers reduce the chance of shock when using equipment in wet areas. This is a potential shock hazard. Recommend that a qualified electrician evaluate and repair as necessary.

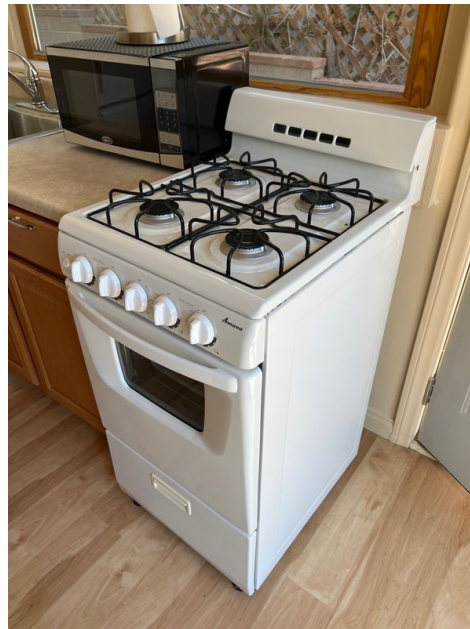
ANTI TRIP BRACKET MISSING

An anti tip bracket was not installed at the range. This bracket prevents the range from tipping forward which could cause the range to fall over. We recommend installation of an anti tip bracket by a qualified person for safety and to help prevent injury.

Contact a handyman or DIY project

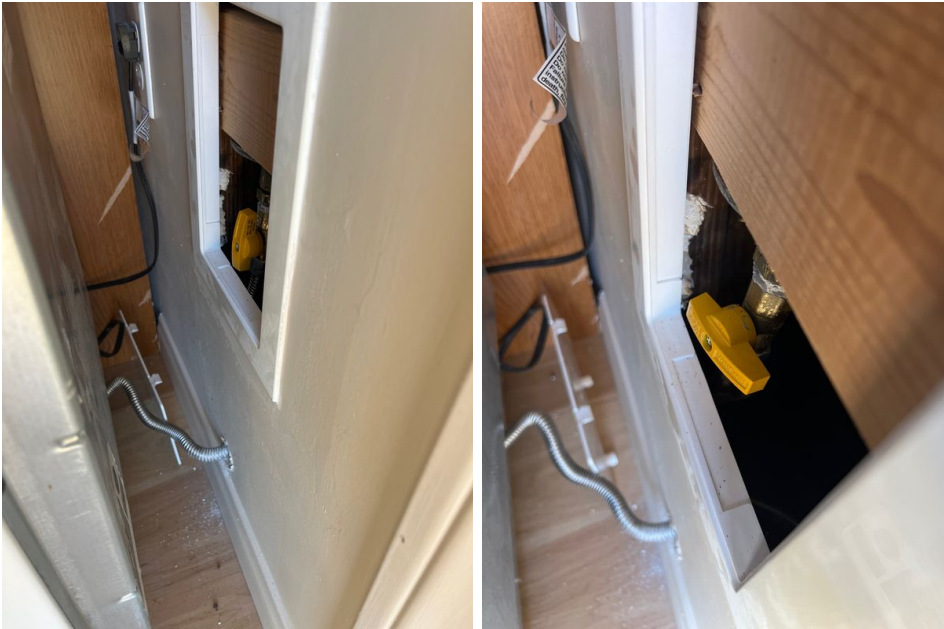
The kitchen gas pipe connection is inadequately installed through rear wall. Safety hazard. Refer to a licensed contractor for repairs.

Contact a qualified general contractor.

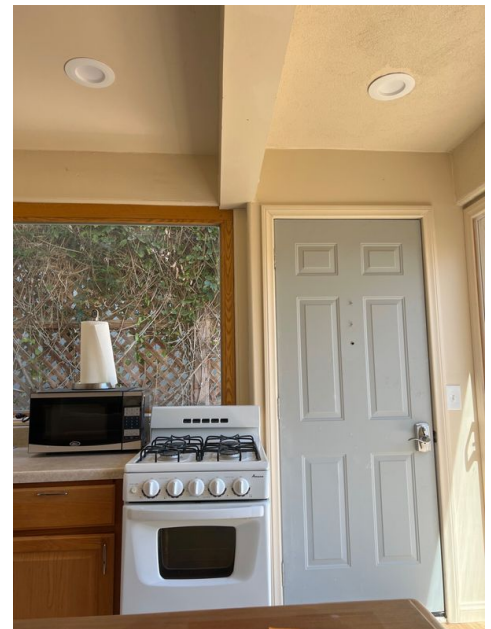
11.3.4 Range/Oven/Cooktop

KITCHEN GAS STOVE MISSING EXHAUST VENT

The kitchen gas cook top surface is missing approved ventilation "exhaust hood" above the *gas cook top surface. Caution uniform standards require ventilation above gas cook-top appliance. Safety hazard. Susceptible to carbon monoxide poisoning. Refer to licensed contractor for cost of repairs.

Contact a qualified appliance repair professional.

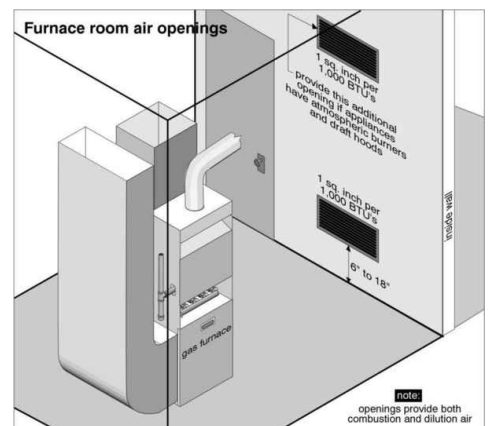
12.2.2 Heating / Forced Air

INSUFFICIENT COMBUSTION AIR SUPPLY

Based on the location and the visible venting, the furnace had a substandard source of combustion and/or dilution air. All gas and oil-fired appliances require adequate air for combustion, dilution and ventilation. This is a potential safety hazard and may result in combustion fumes entering living spaces. Recommend that a qualified HVAC contractor evaluate and repair per standard building practices. For example, by extending one of the supply tubes downward.

Contact a qualified HVAC professional.

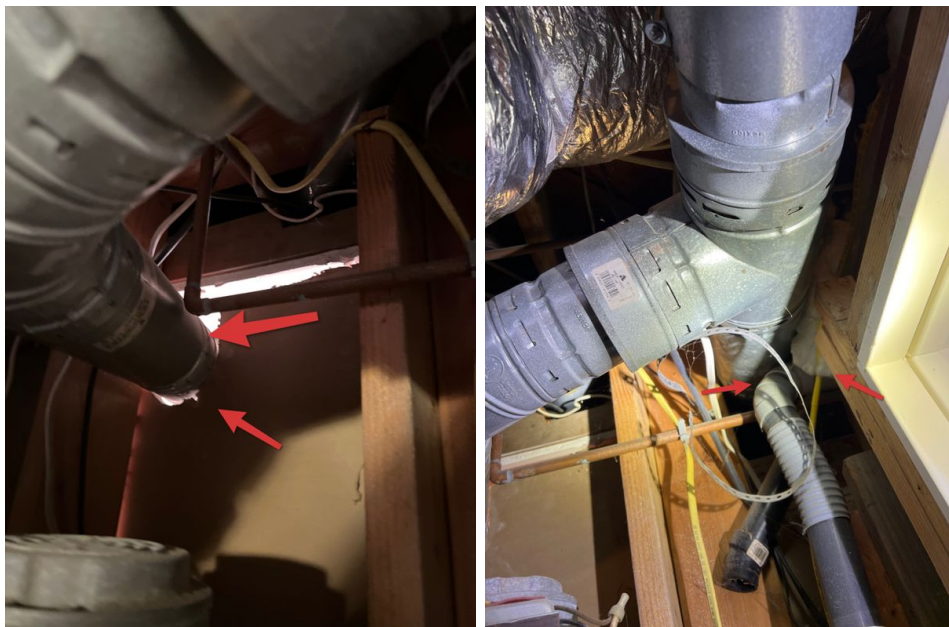
12.2.3 Heating / Forced Air

COMBUSTIBLE MATERIAL TOO CLOSE

The Type B vent for the furnace lacked adequate clearance from combustibles. These vents are required to have a minimum of 1 inch clearance from combustibles. Repairs are recommended as needed by an HVAC contractor to gain proper clearance for safety.

Contact a qualified professional.

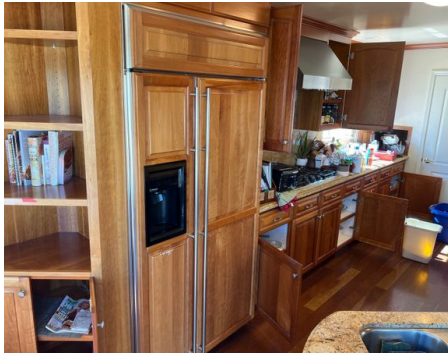
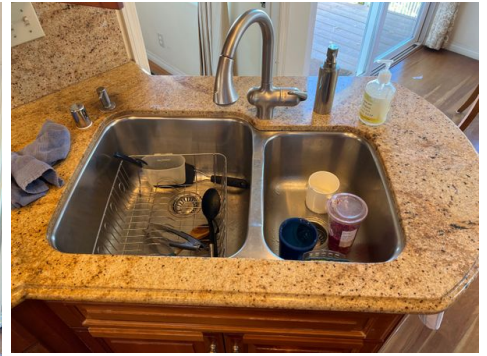
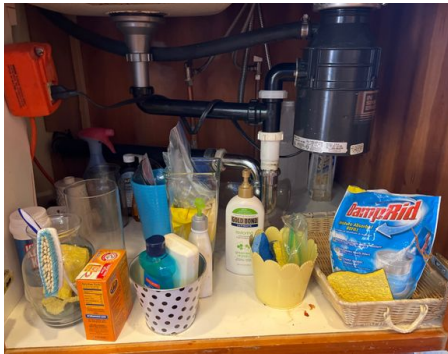
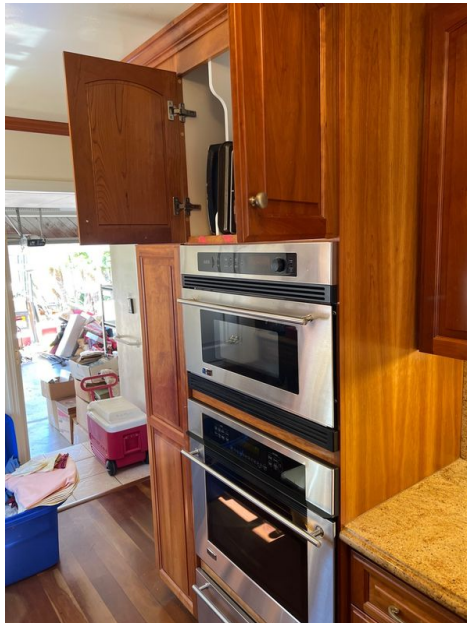
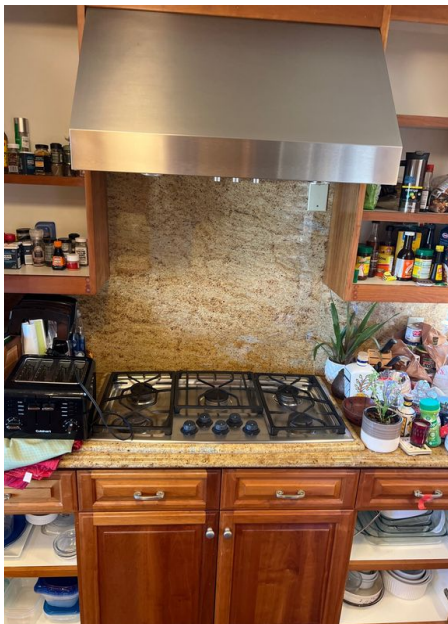
Kitchen

View of the kitchen and its components during the inspection. This kitchen appliance and cabinets are worn, dated and not fully functional. Caution. Seek further evaluations by a licensed contractor prior to sale for cost of replacement.

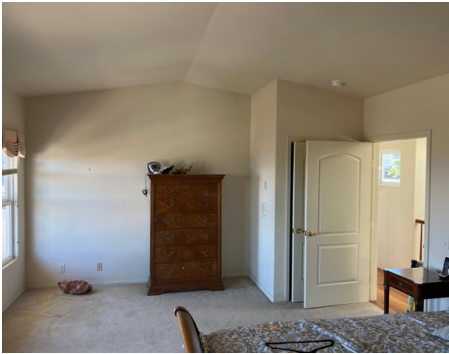
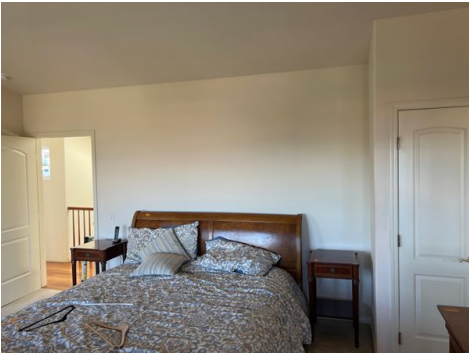
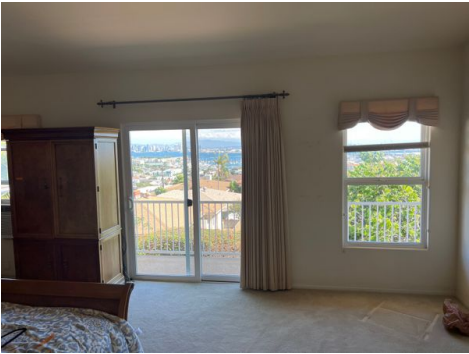
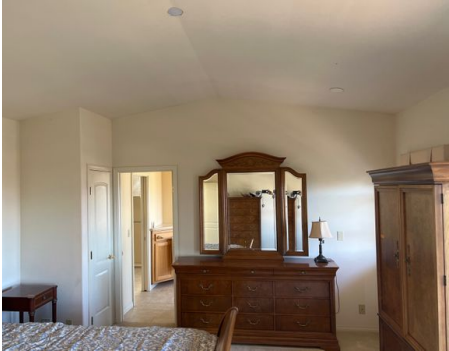
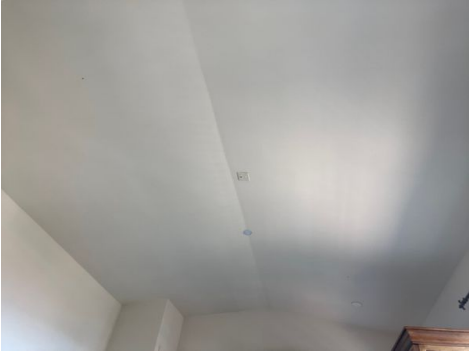
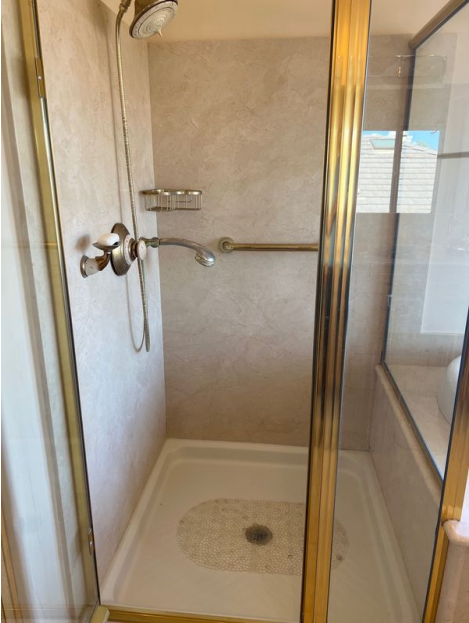
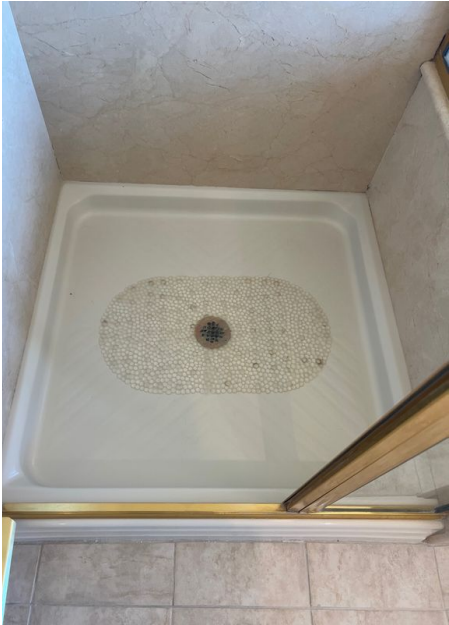
View of bedroom ceiling and walls at the time of inspection.

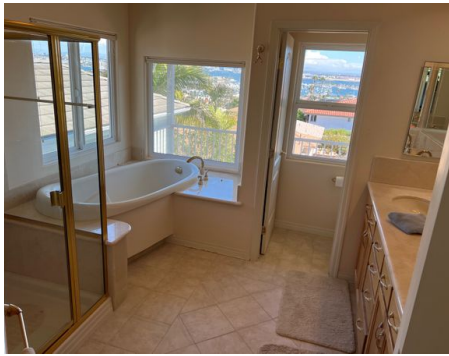
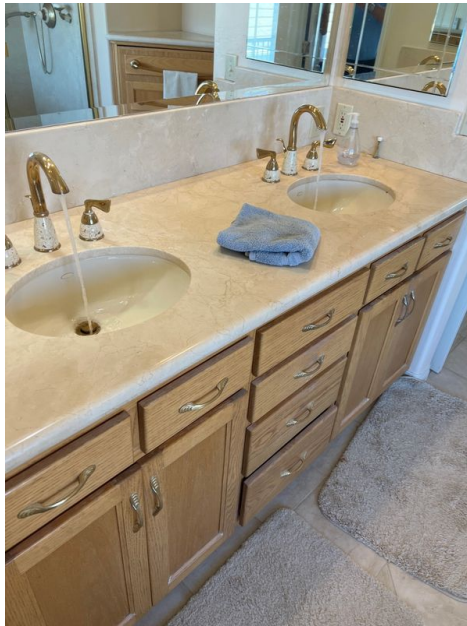
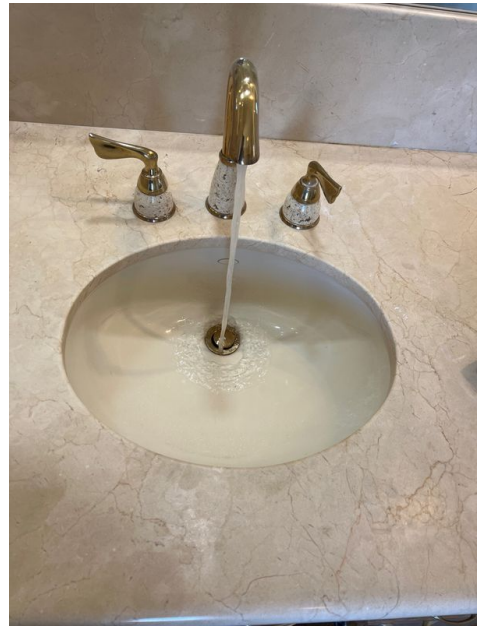
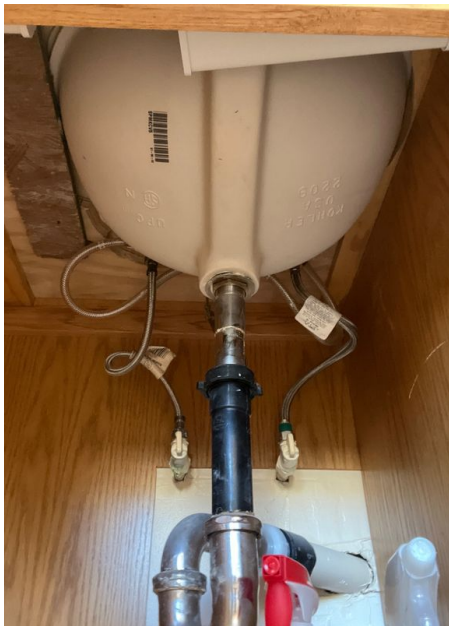
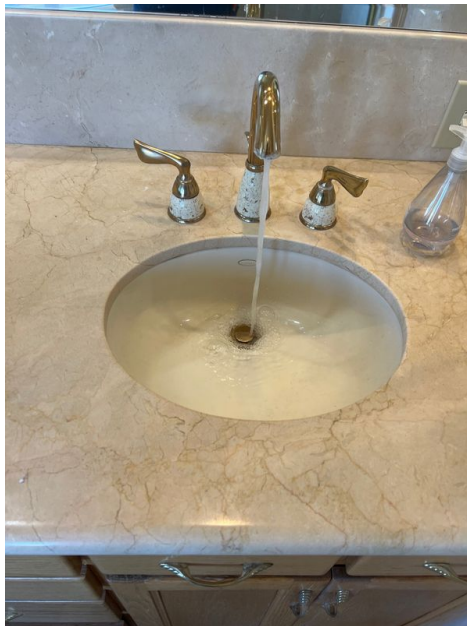
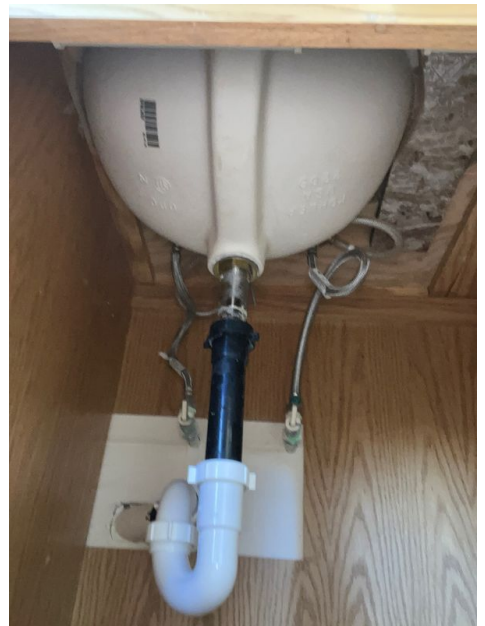
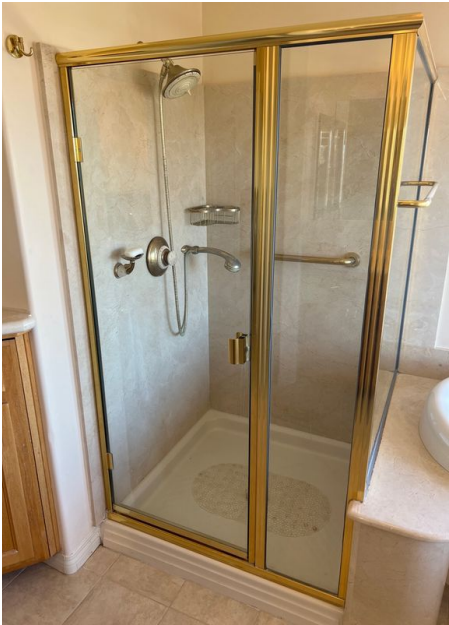
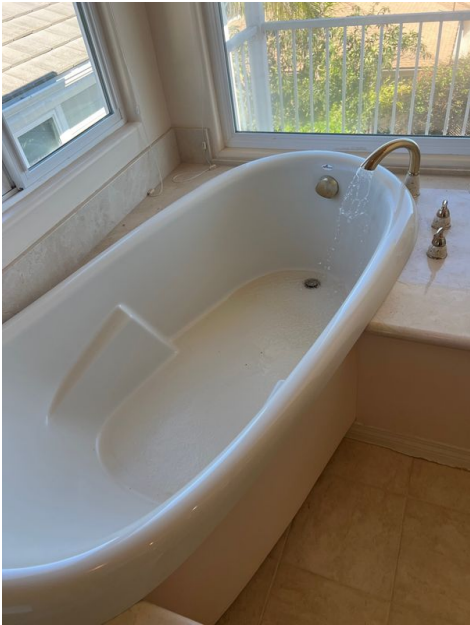
Master Bathroom Suite

The bathroom shows no adverse conditions. There were no cracked or damaged plumbing fixtures or signs of present or past water intrusion at the time of the field evaluation. Monitor conditions and refer to sellers disclosure to advise.

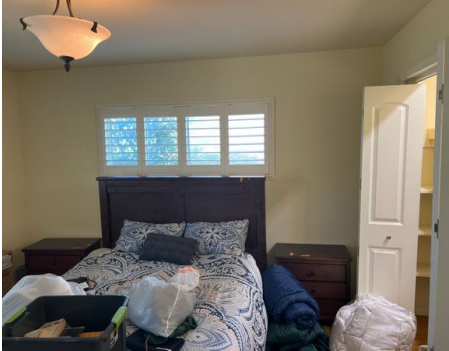
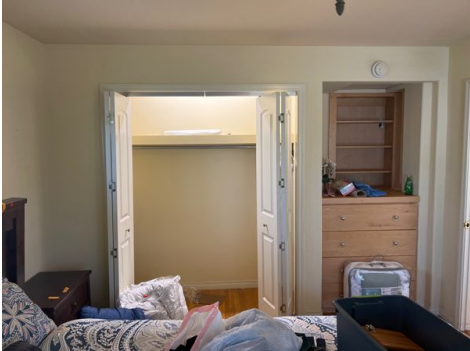
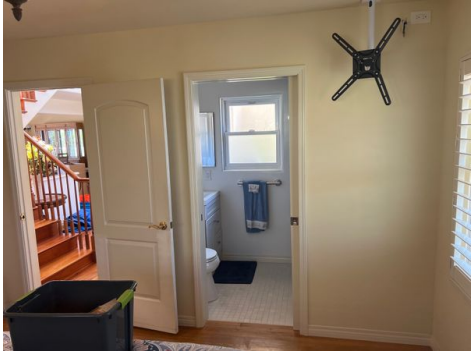
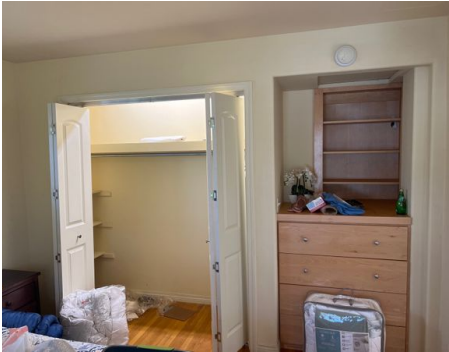
Bedroom 1

View of bedroom ceiling and walls at the time of inspection.

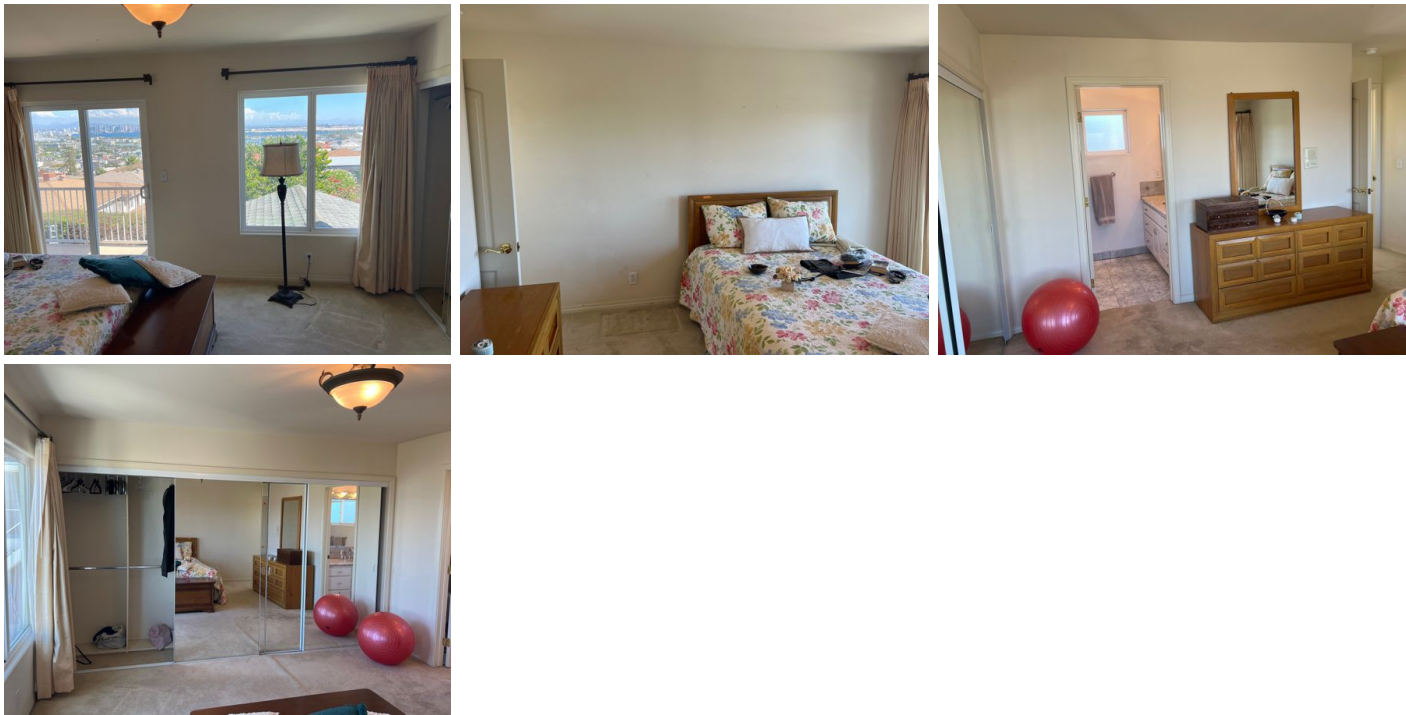
Bedroom 2

View of bedroom ceiling and walls at the time of inspection.

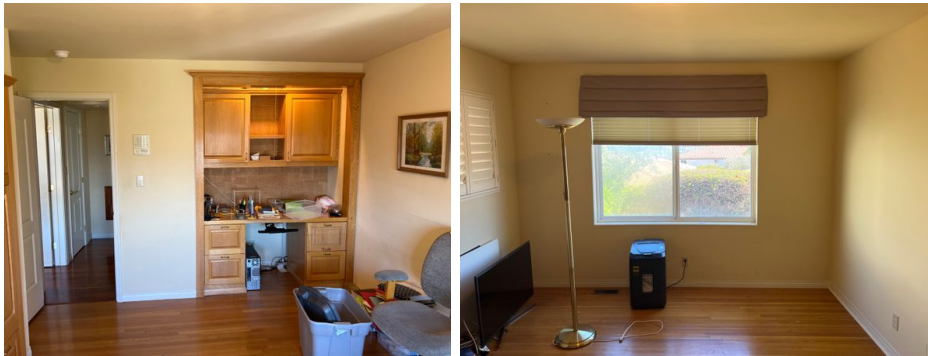
Bedroom / Office

View of bedroom ceiling and walls at the time of inspection.

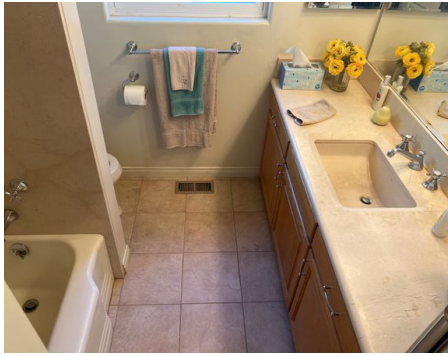
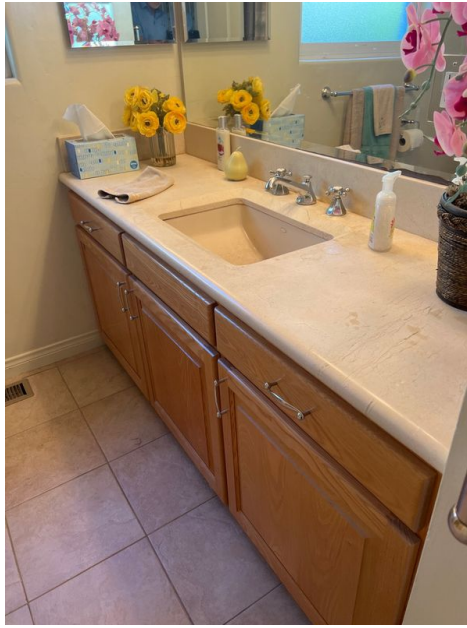
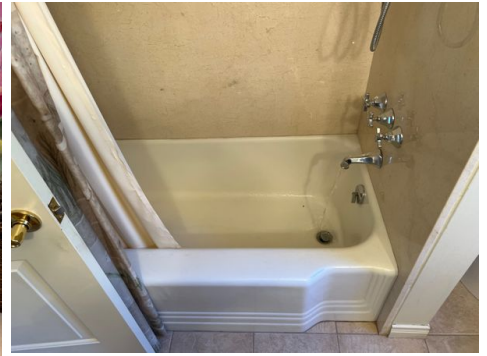
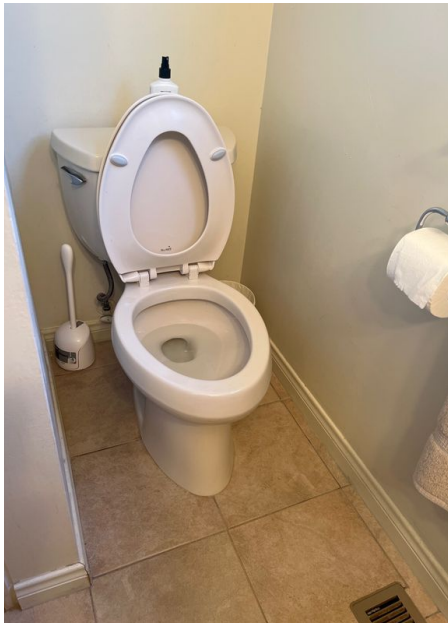
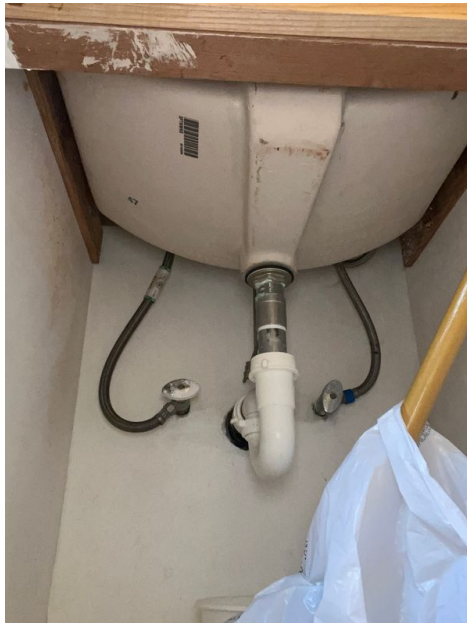
Hallway Bathroom

View of *bathroom space, during the time of inspection.
