BUILDINGSPECSPRO'S LLC

RESIDENTIAL REPORT BY : JOHN BOWLEY, ACI,CRI, CRMI,

1325 Clove St
San Diego, CA 92106

SEPTEMBER 23, 2022

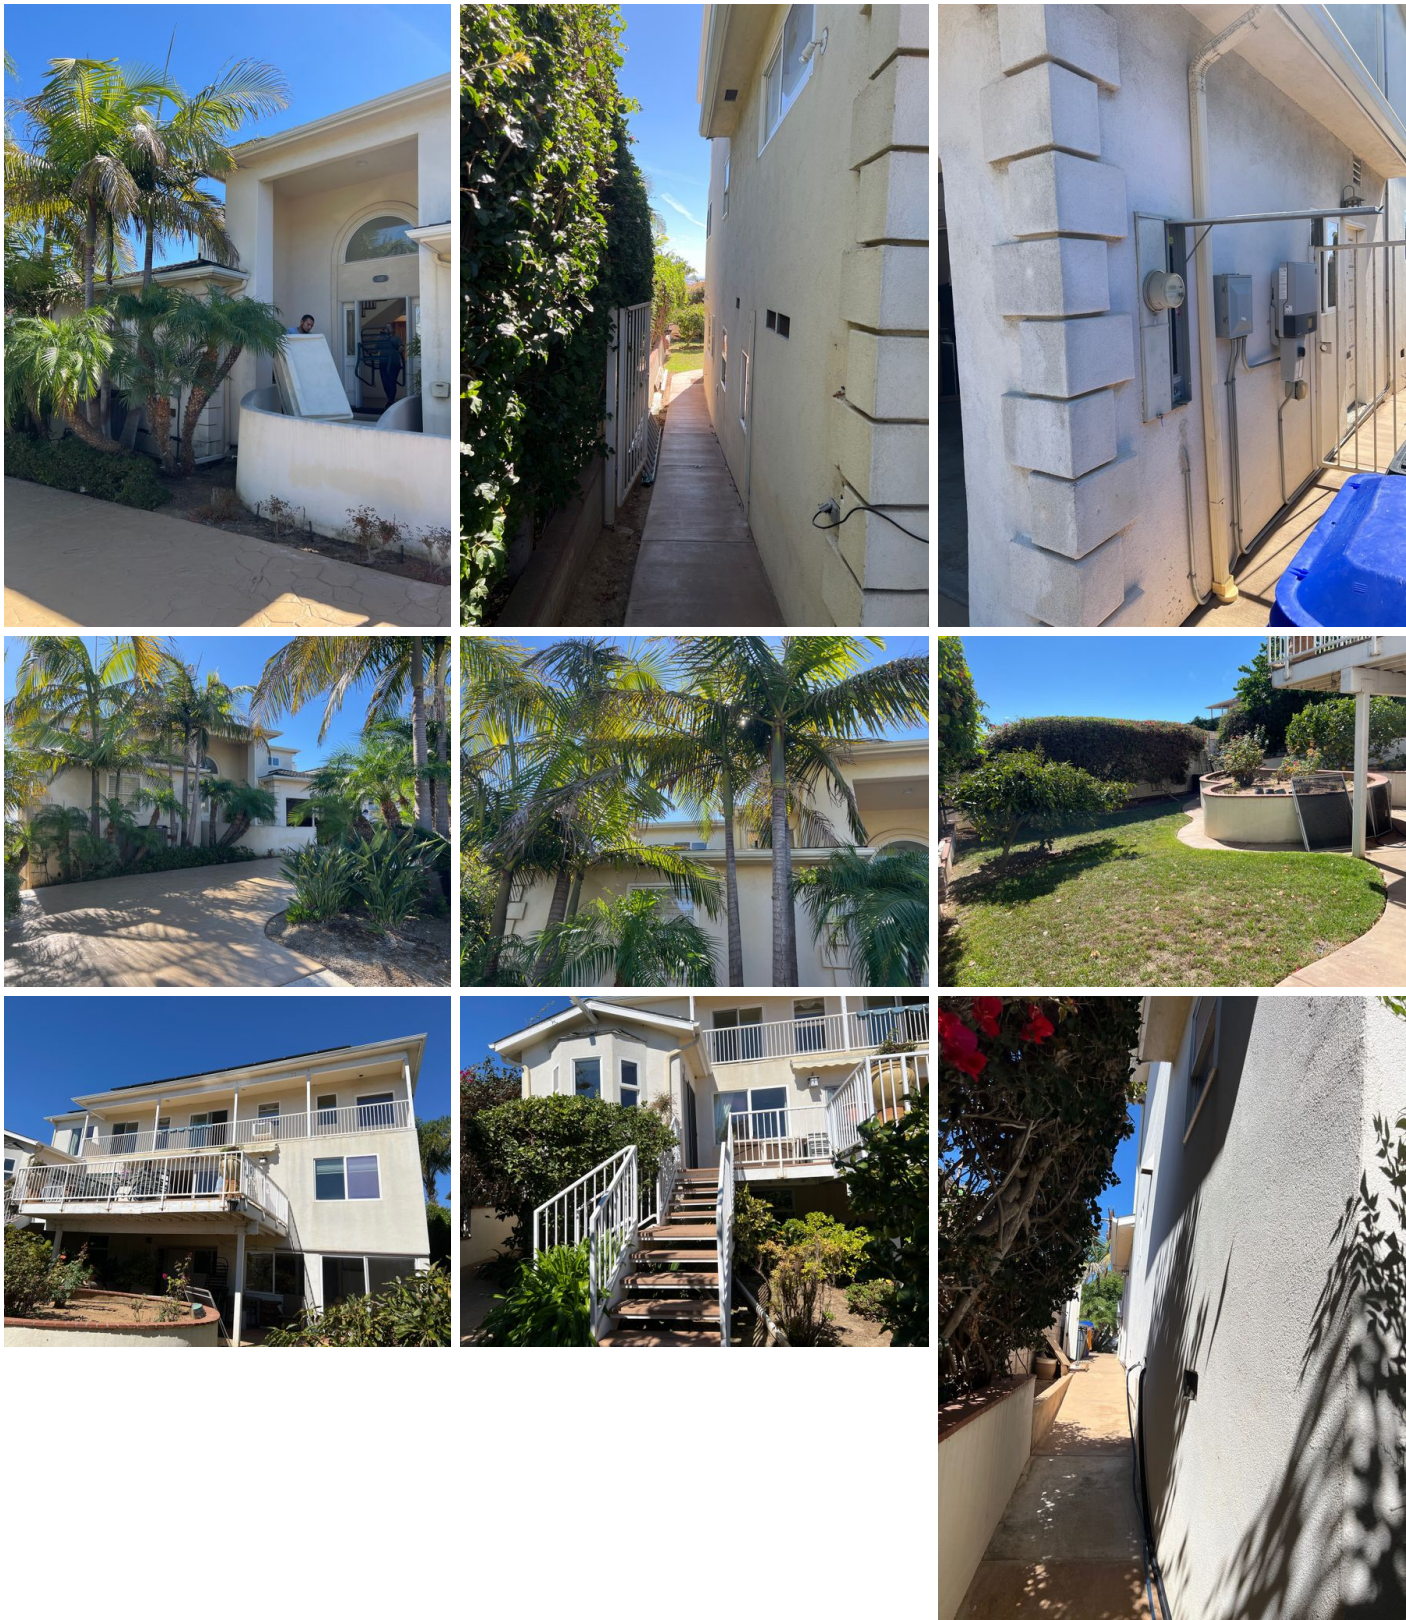
Exterior View

Exterior outdoor view of the structure/property during inspection.

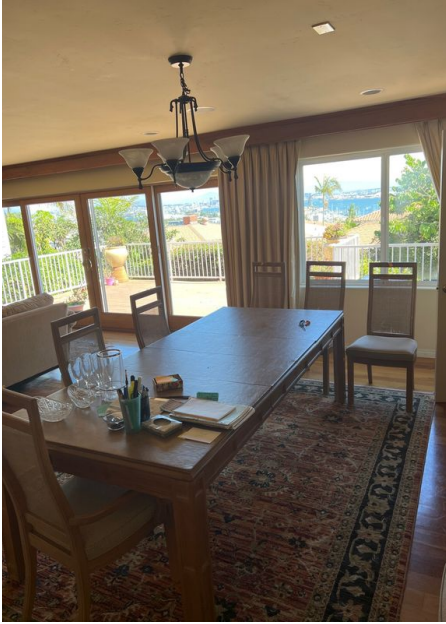
Dining Room

View of *Dining room ceiling, walls, and floor during the time of inspection.

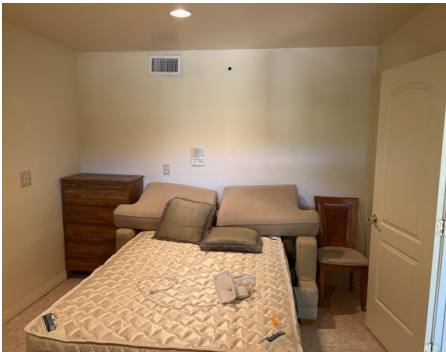
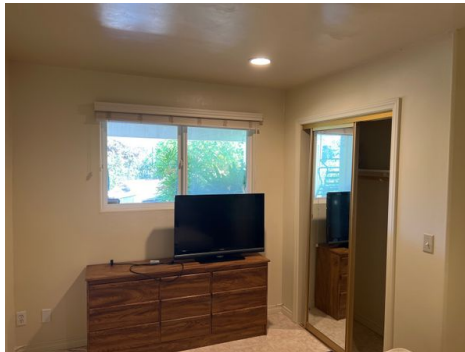
Basement Work Space #1

The *work space has been remodeled and/or changes and/or altered into more space. Therefore, you should request documentation that should include permits and any warranties or guarantees that might be applicable, because we do not approve of, or tacitly endorse, any work that was completed without permits, and latent defects could exist. To be determined by buyer.

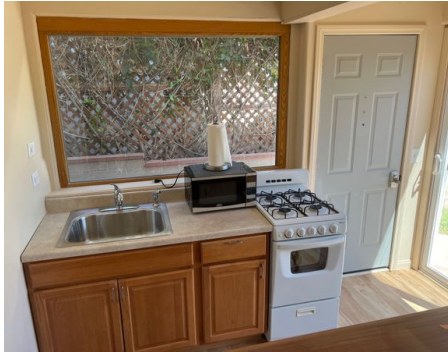
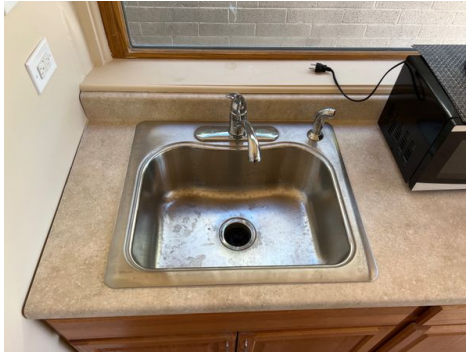
Lower Level Kitchenette

The basement has been remodeled and/or changes and/or altered into more space. Therefore, you should request documentation that should include permits and any warranties or guarantees that might be applicable, because we do not approve of, or tacitly endorse, any work that was completed without permits, and latent defects could exist. To be determined by buyer.

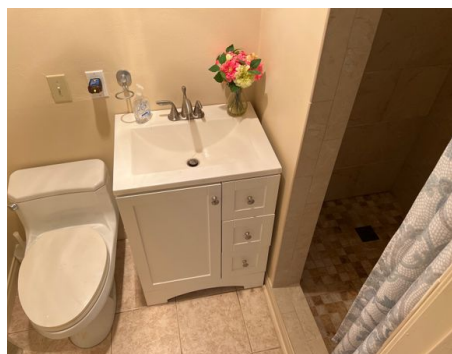
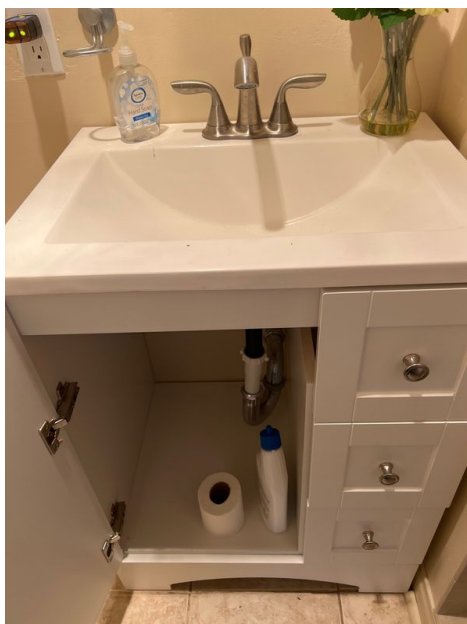
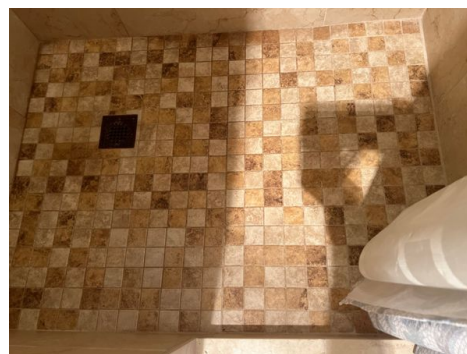
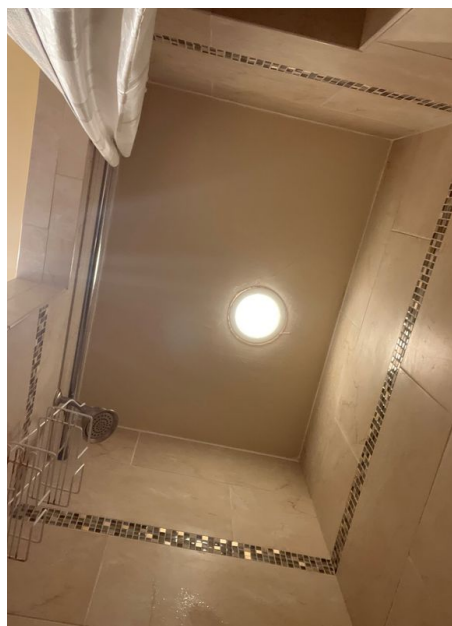
Lower Level Bathroom #1

The *bathroom has been remodeled and/or changed /altered. Therefore, you should request documentation that should include permits and any warranties or guarantees that might be applicable, because we do not approve of, or tacitly endorse, any work that was completed without permits, and latent defects could exist. To be determined by the buyer.

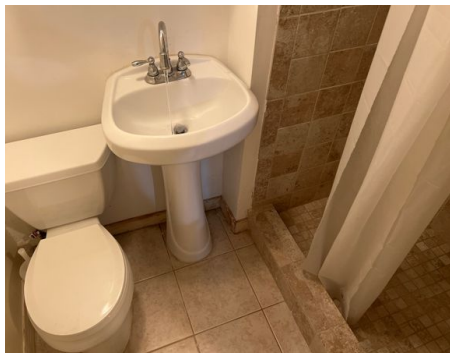
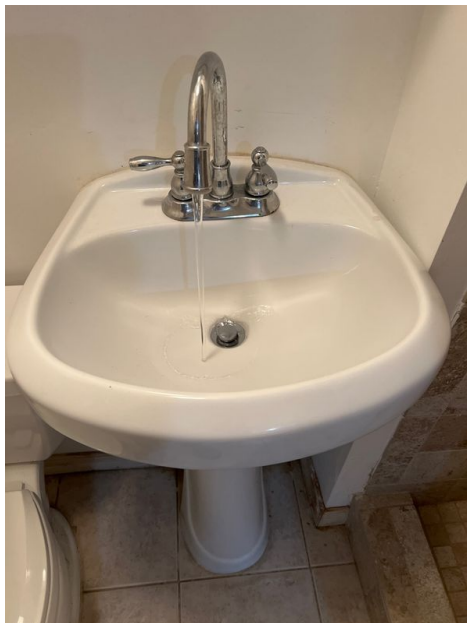
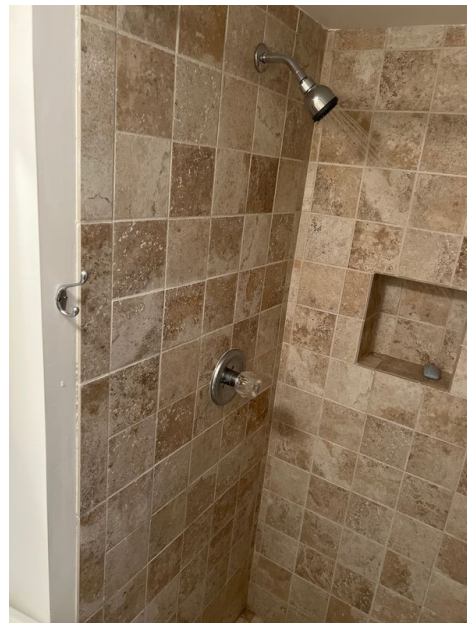
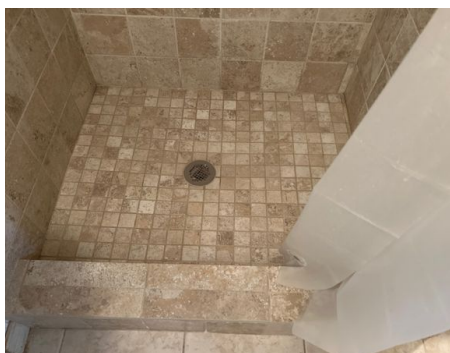
Lower Level Bathroom #2

The *bathroom has been remodeled and/or changed /altered. Therefore, you should request documentation that should include permits and any warranties or guarantees that might be applicable, because we do not approve of, or tacitly endorse, any work that was completed without permits, and latent defects could exist. To be determined by the buyer.

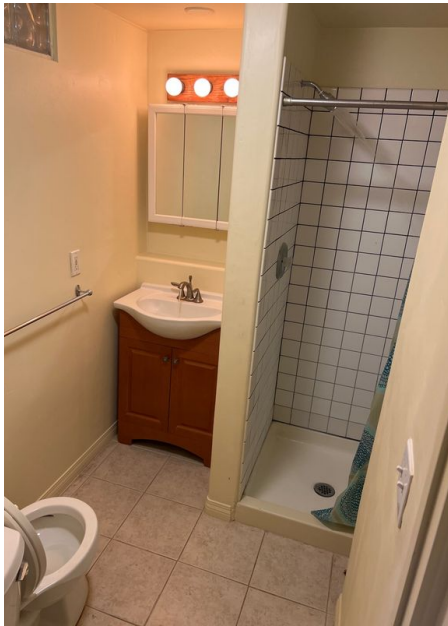
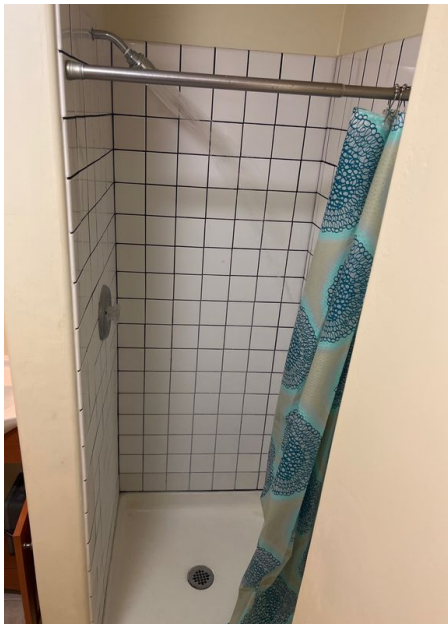
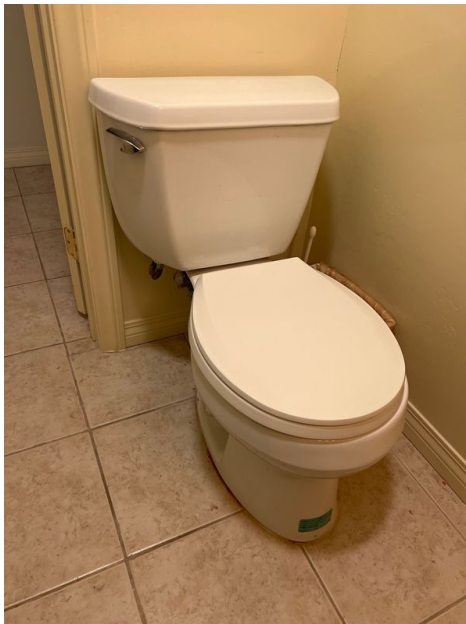
Lower Level

The *bathroom has been remodeled and/or changed /altered. Therefore, you should request documentation that should include permits and any warranties or guarantees that might be applicable, because we do not approve of, or tacitly endorse, any work that was completed without permits, and latent defects could exist. To be determined by the buyer.

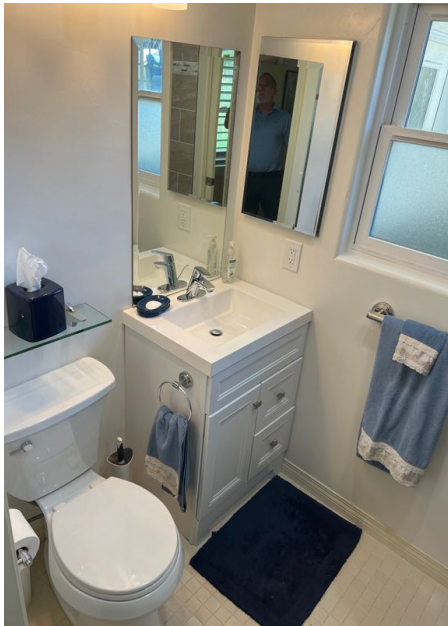
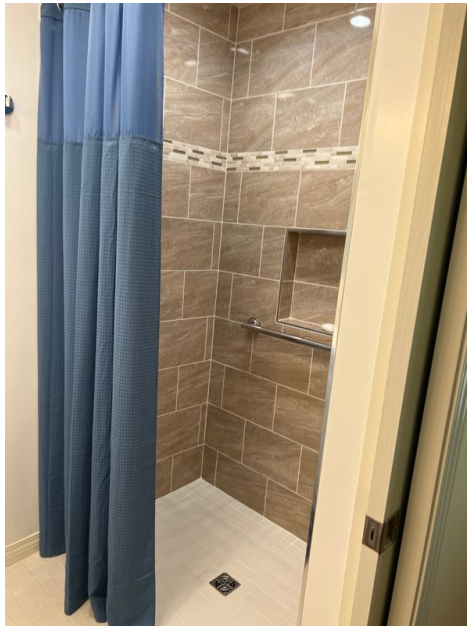
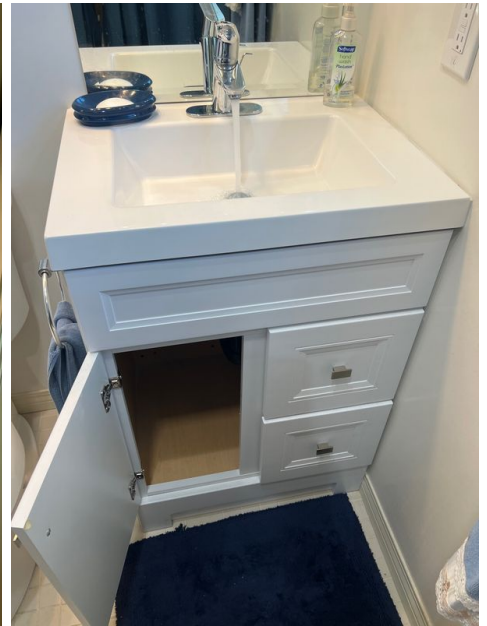
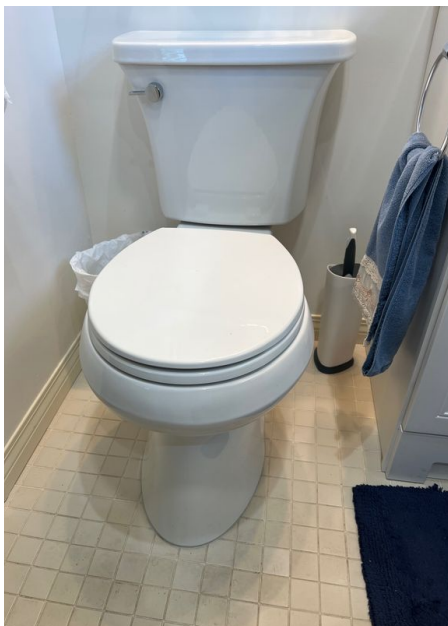
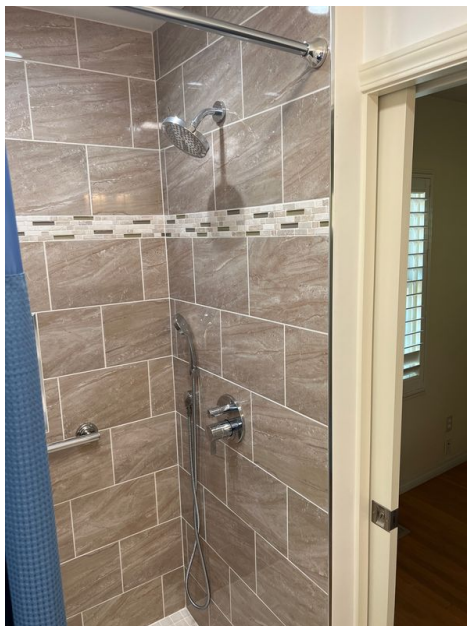
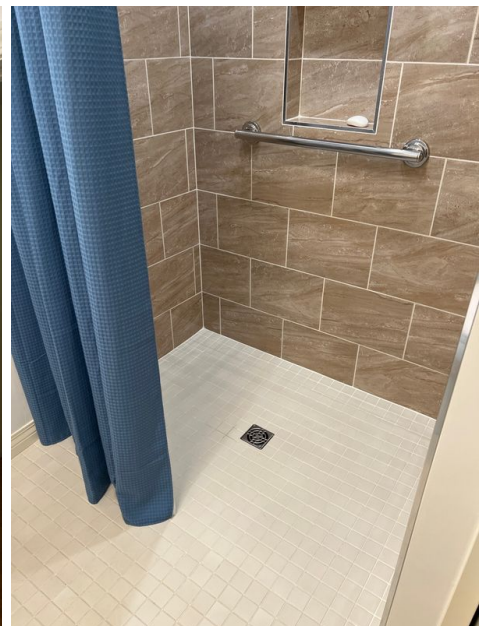
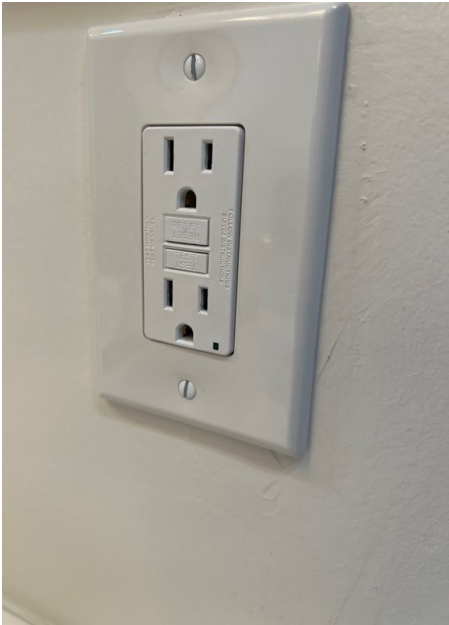
Guest Bedroom Bath ADU

The bathroom shows no adverse conditions. There were no cracked or damaged plumbing fixtures or signs of present or past water intrusion at the time of the field evaluation. Monitor conditions and refer to sellers disclosure to advise.

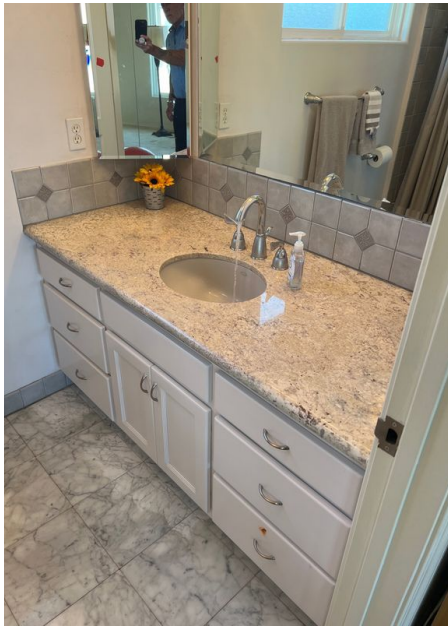
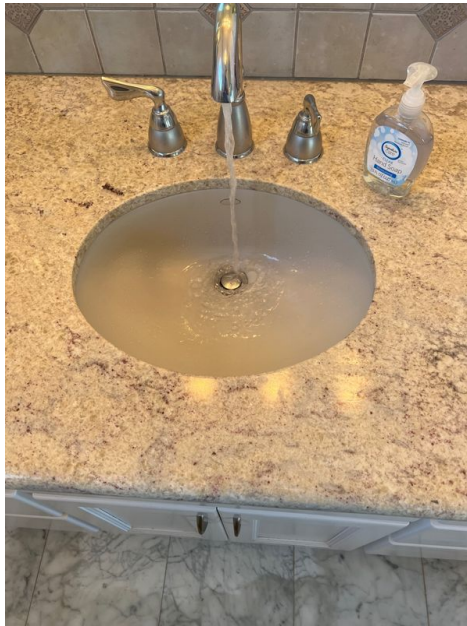
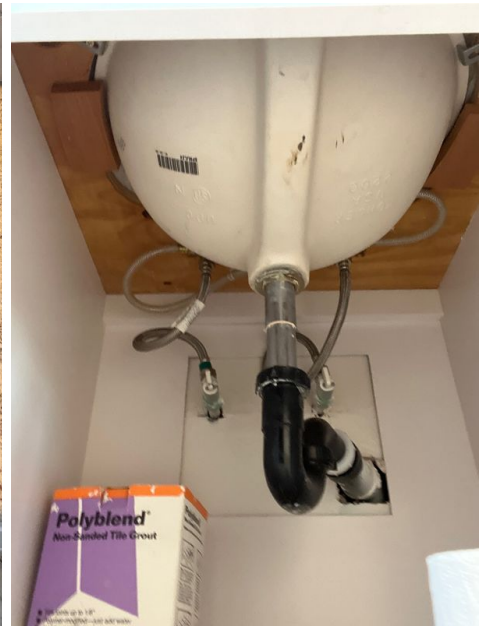
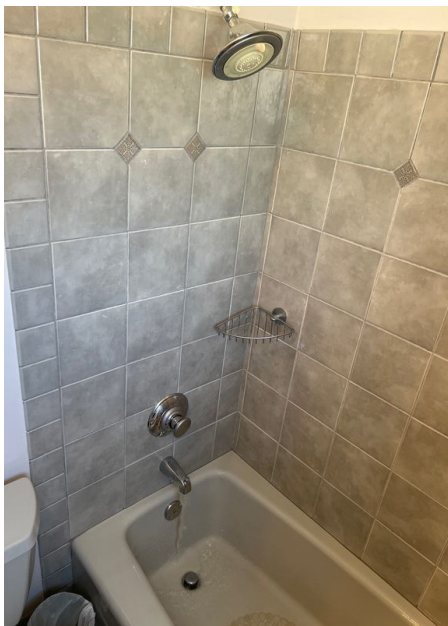
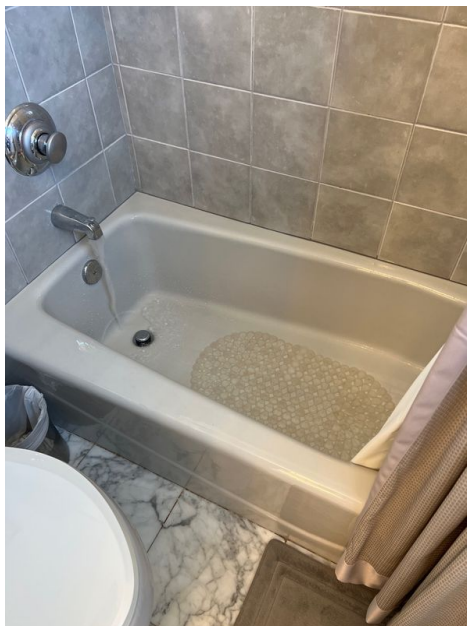
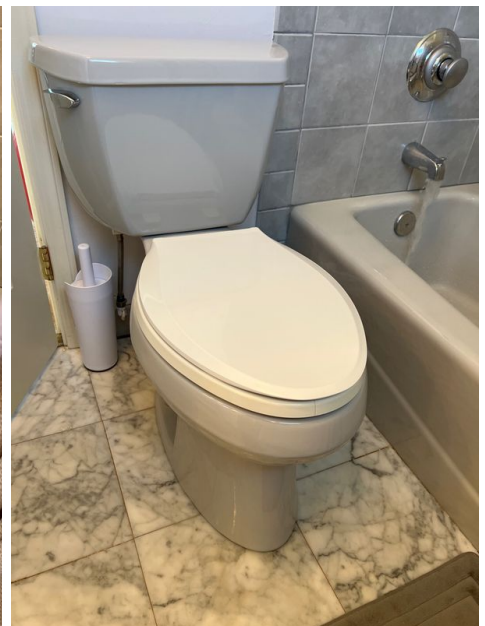
Secondary Floor Guest Bath

The bathroom shows no adverse conditions. There were no cracked or damaged plumbing fixtures or signs of present or past water intrusion at the time of the field evaluation. Monitor conditions and refer to sellers disclosure to advise.
