Sunset Property Inspection

Confidential - Property Inspection Report - Confidential

3640 Promontory St
Inspection Prepared For: Robert Blumenshine
Agent: -

Date of Inspection: 2/18/2022
Year Built: 1983 Size: 1680

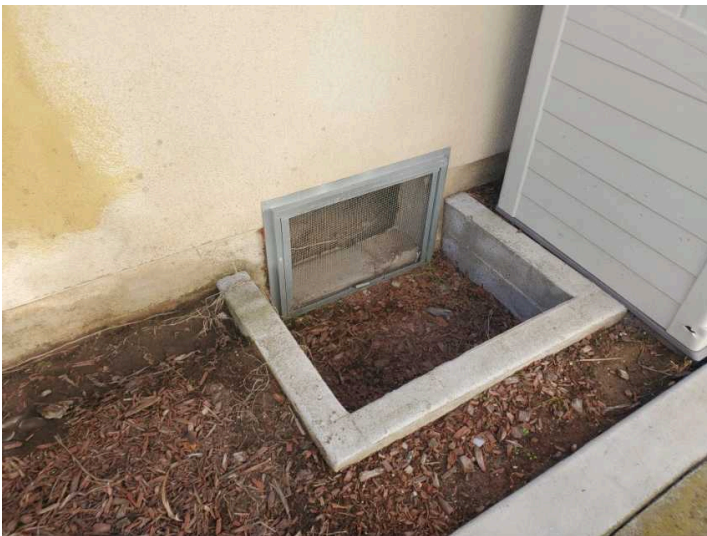
Crawlspace access

- **Insulation Support Failing.** The insulation at the underside of the house is not properly secured at some locations and has begun to fall. Improperly hung, missing or failing insulation can allow the house to inefficiently heat and cool. It is recommended that any displaced insulation be properly supported.
